**Brevard County, FL  
Gazebo  
Structural Assessment**

# MEMO

TO: Brevard County Facilities Department  
ATTN: Michael Dunlap – Facilities Construction Coordinator  
FROM: Nikos Moschovakis E.I.  
DATE: September 26, 2022  
RE: Structural Inspection

Gazebo  
Viera Wetlands, West of 10001 N Wickham Rd,  
Melbourne, FL 32940

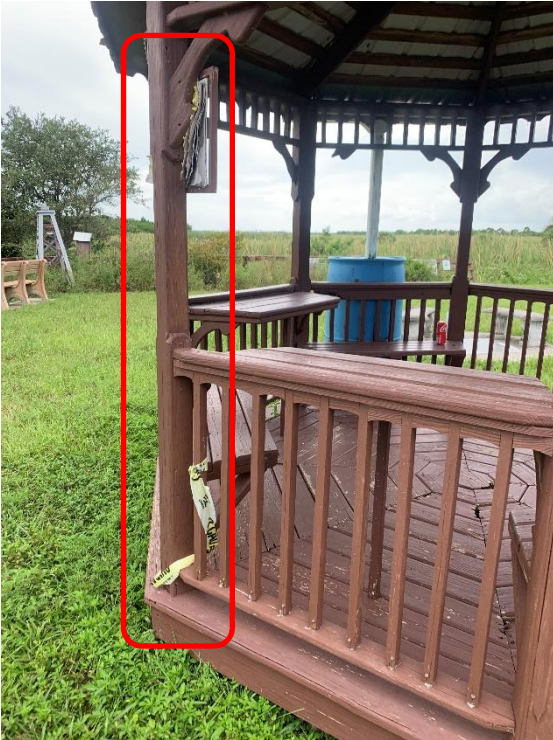
Picture 1

Surface cracks with the possibility of grain shear on wood posts.

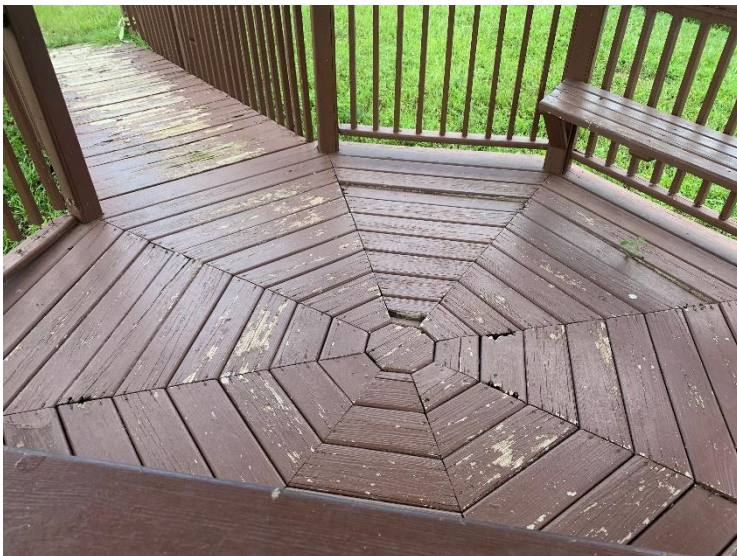
Picture 2

Damaged-cracked wood floor planks. Excessive deflection while walking on the deck.

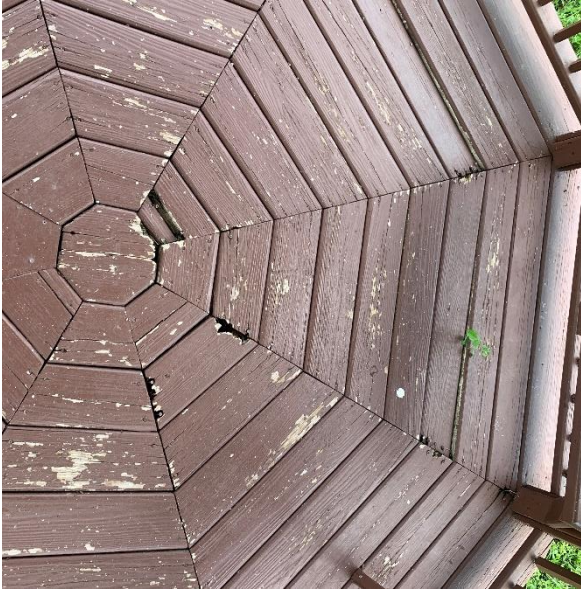
Picture 3

Damaged-cracked wood floor planks.

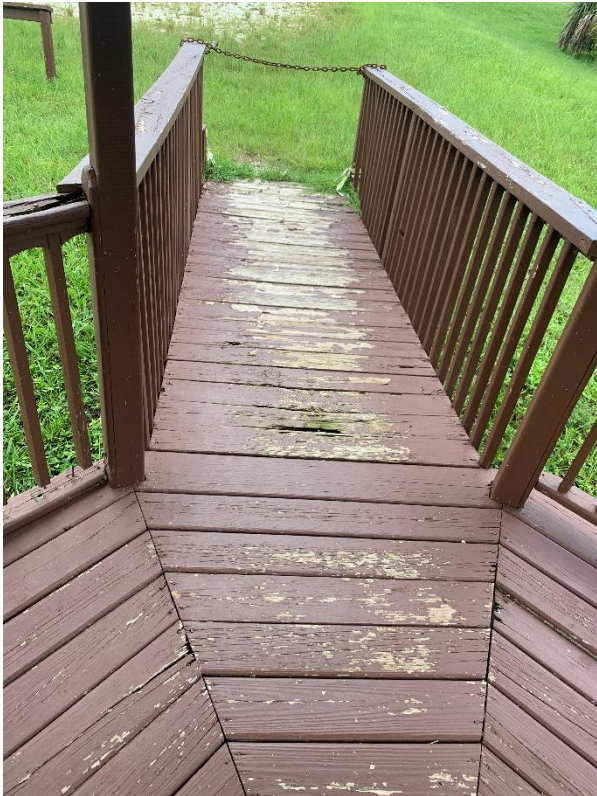
Picture 4

Damaged wood planks on the walkway. An excessive deflection was noticed while walking on the deck.

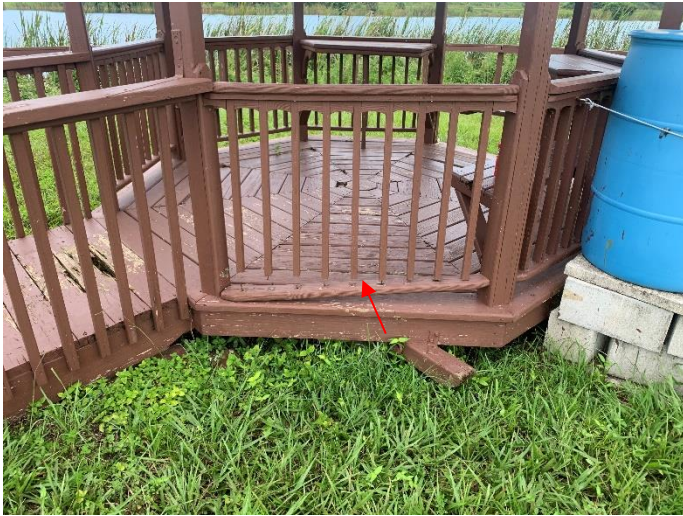
Picture 5

Damaged railing.

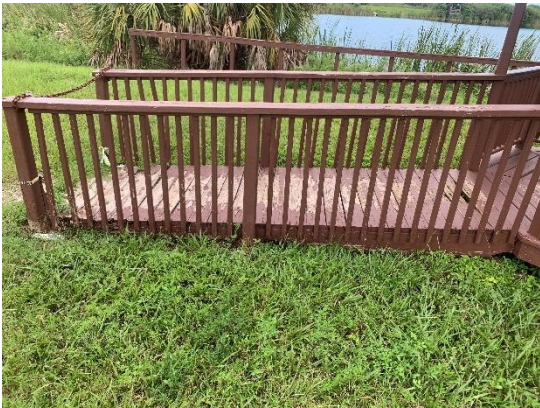
Picture 6

Damaged walkway railing and walkway beam in bad condition.

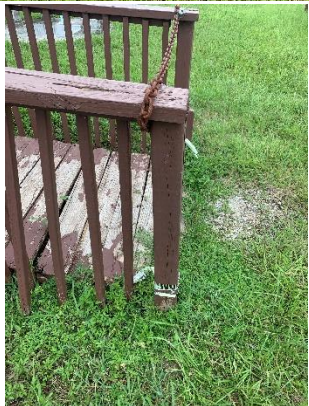
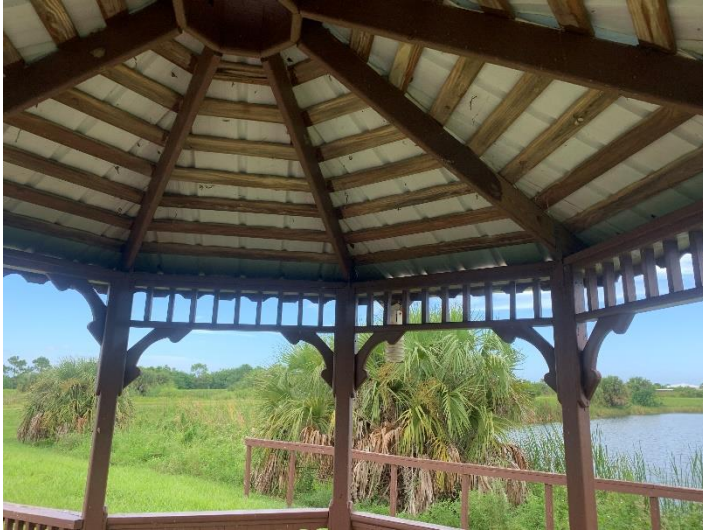
Picture 7

Moisture signs and surface cracks on multiple roof beams and rafters. Screws connecting the metal seam with the rafter appeared rusted and possibly not adequate on uplift forces in an extreme event.

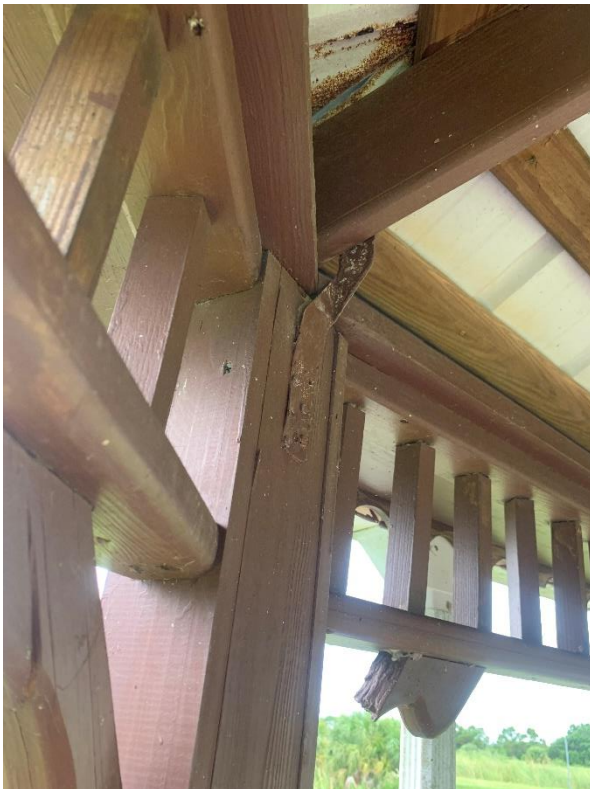
Picture 8

Hurricane ties appeared in bad condition and deflected. Rusted metal seam roof and signs of a water leak.

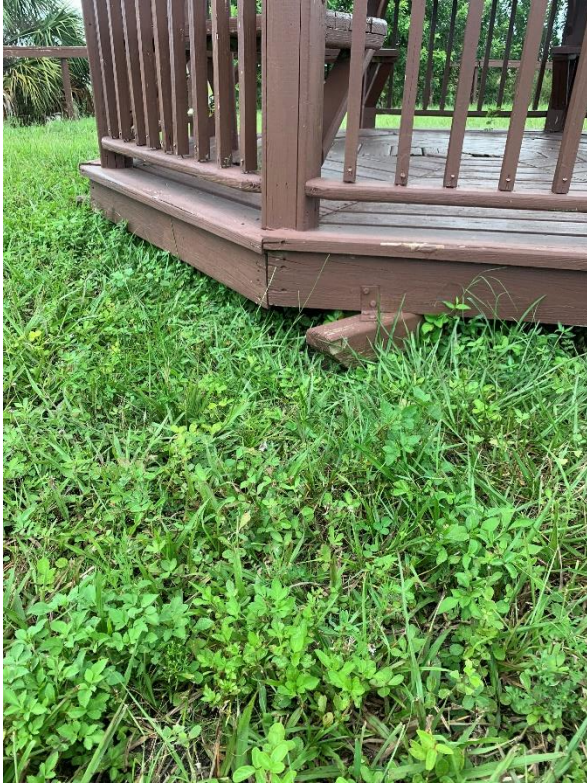
Picture 9

Grade beams and perimeter low beams are in bad condition. Surface cracks and possible further damage due to weather and moisture.

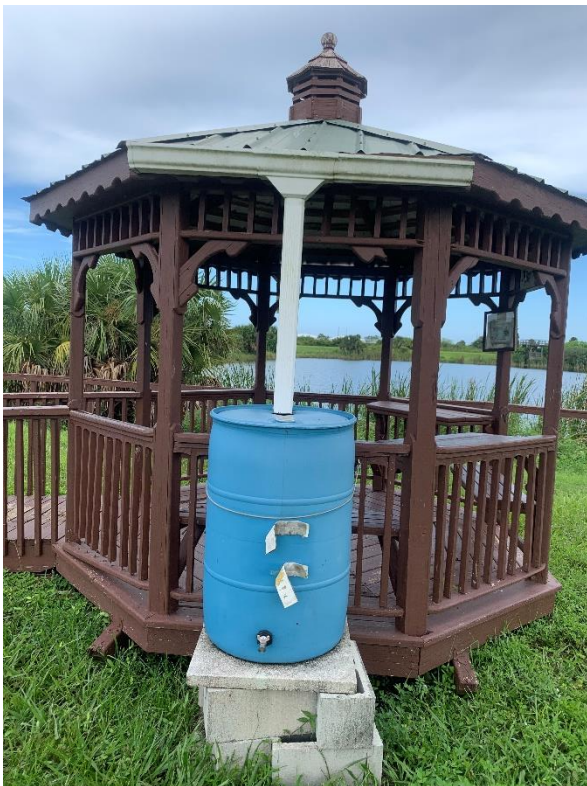
Picture 10

A damaged exterior structure that supports the water barrel.

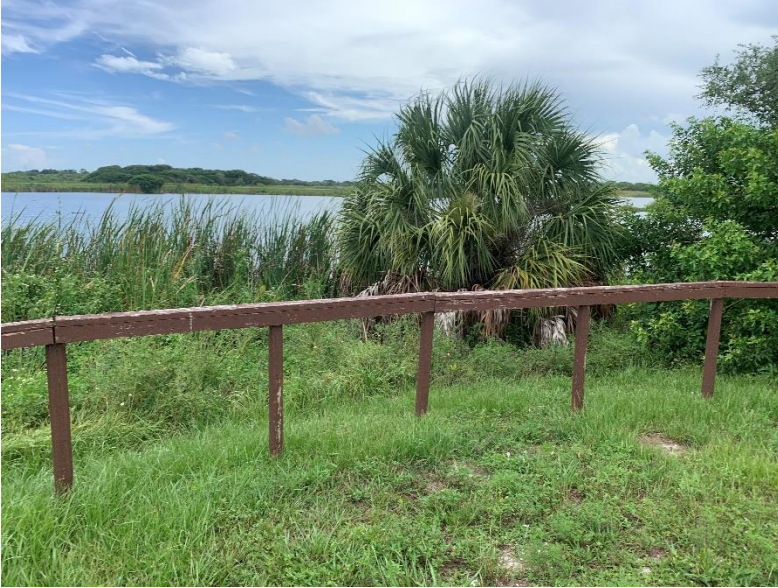
Picture 11

Damaged and unstable perimeter area wood railing.
