880 Montego Bay Dr N, Merritt Island, FL 32953

This report is prepared exclusively for **Jeni Hauer** On: **2022-08-29**

Dock(s) and Seawall

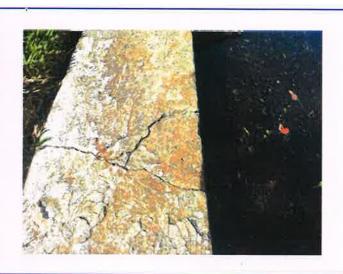
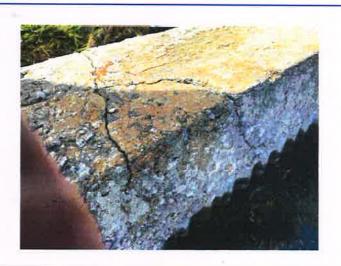
Sea Wall Cap

The seawall cap had some typical, and moderately small, cracks that are may be a

There was evidence of prior repairs to some areas of the seawall cap.

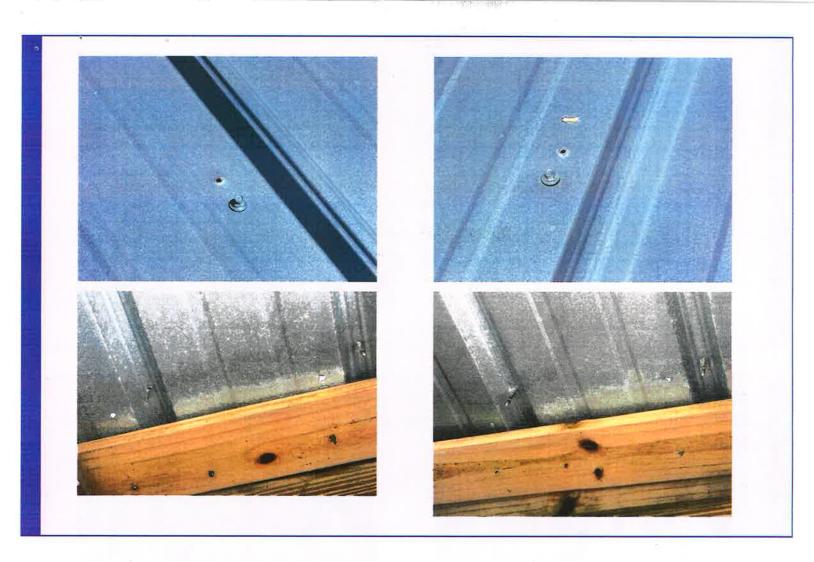
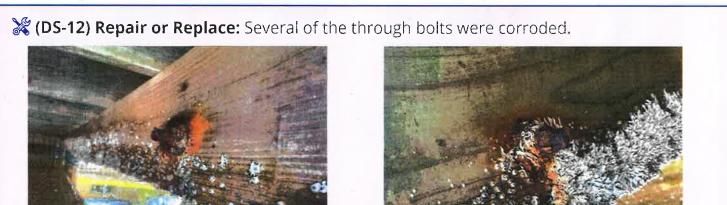
Dock Structure

There were older, corroded clips in place, however new stainless clips were installed on the opposite sides of the rafters, and the older ones were not removed; for your information.
