**Brevard County, FL
Bird Watching Tower 2
Structural Assessment**

TO: Brevard County Facilities Department
ATTN: Michael Dunlap – Facilities Construction Coordinator
FROM: Nikos Moschovakis E.I.
DATE: September 26, 2022
RE: Structural Inspection

Bird Watching Tower 2 – North East Tower
Viera Wetlands, West of 10001 N Wickham Rd,
Melbourne, FL 32940

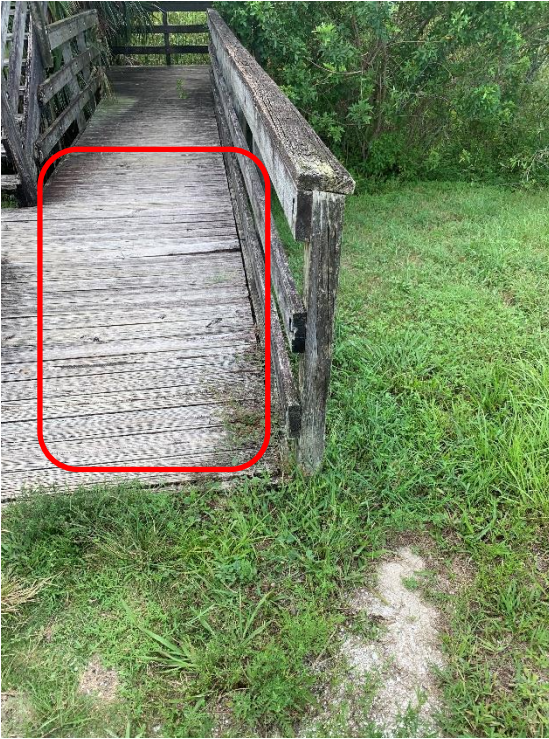
Picture 1

Damaged wood planks from weather and moisture.

2. Repair/replace all the wood railing in the structure along with the bolted connections.
3. Replace all wood floor planks, on both levels.
4. Repair/replace stair girder and all primary wood beams.

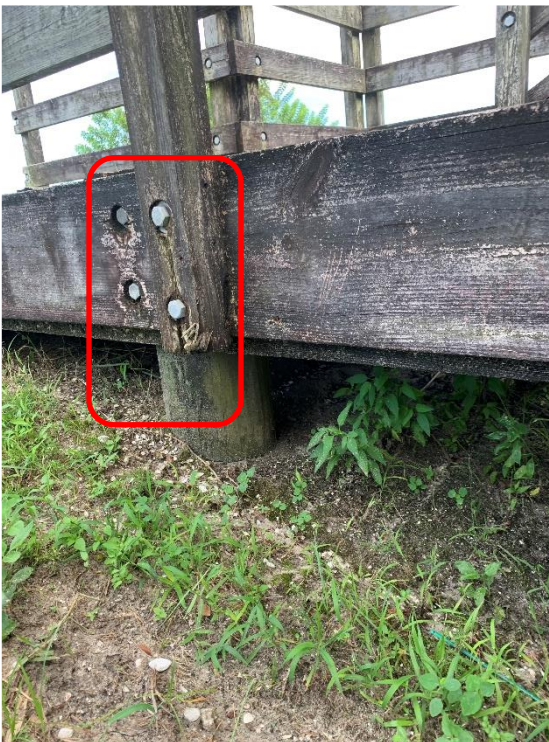
Picture 2

Multiple damaged railing posts. Shear cracks show at bolted connections.

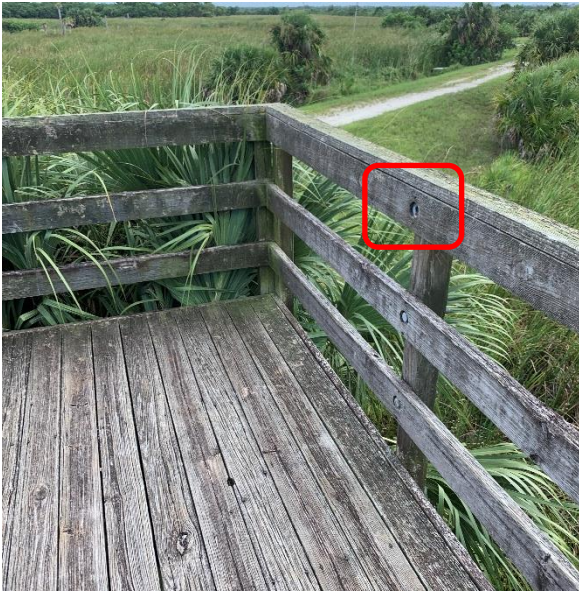
Picture 3

Missing railing bolt on the top deck railing.

5. Replace all rusted nails and bolts.
6. Replace all rusted and damaged Simpson connections (Hurricane ties and beam bucket connections). Connections might fail in the case of an extreme event.

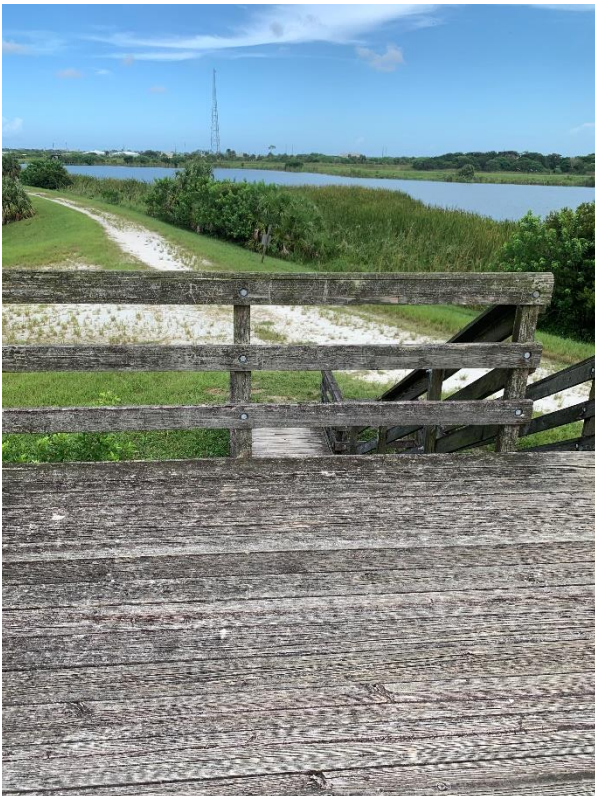
Picture 4

Damaged wood planks from weather and moisture. An excessive deflection was noticed while walking on the deck.

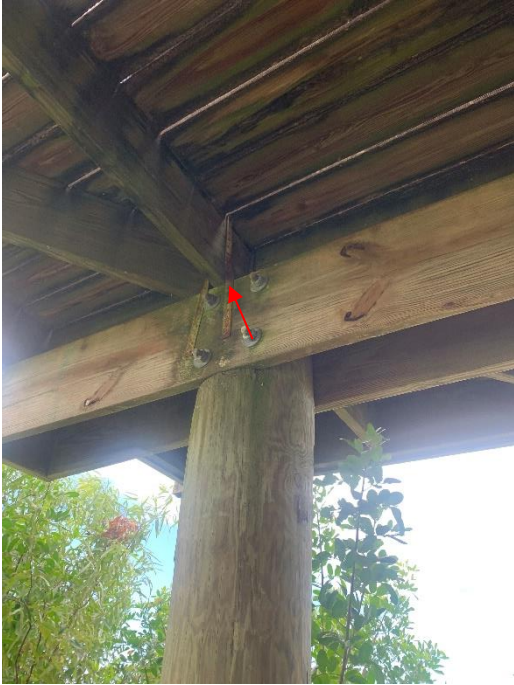
Picture 5

Several hurricane ties and bolts appeared rusted.

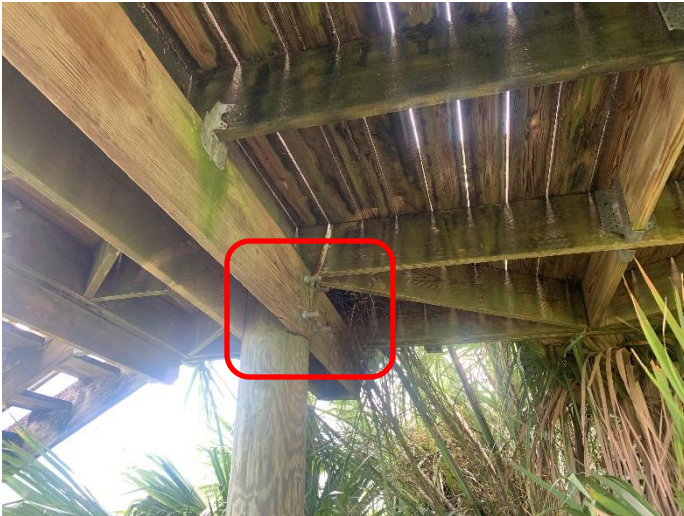
Picture 6

Rusted Simpson hurricane ties in multiple locations.

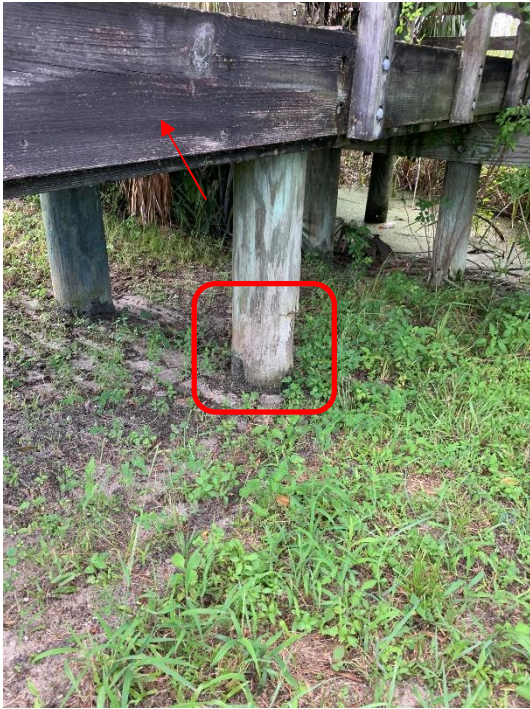
Picture 7

Timber foundation pile surface damage.
Excessive moisture on primary wood beam.

7. Additional special inspection and analysis are required for the wood piers and columns. Visual inspection cannot guarantee the adequacy of the members.

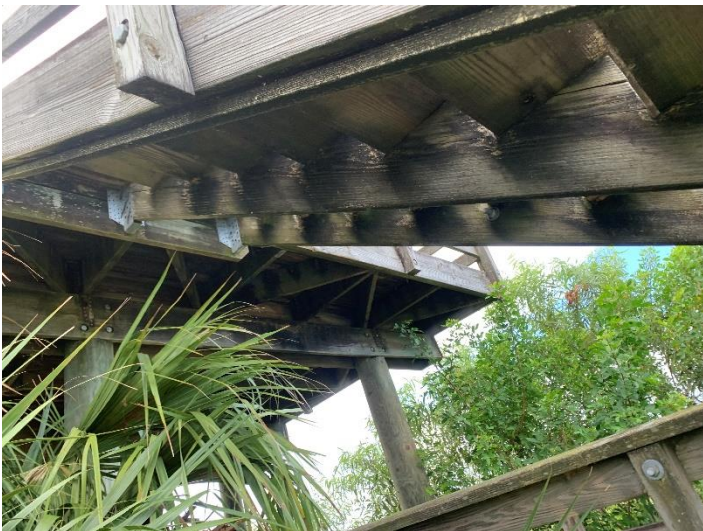
Picture 8

Damaged stair stringers and an excessive deflection
was noticed while walking on the stairs.

8. Repair/replace wood stairs and stair stringers.

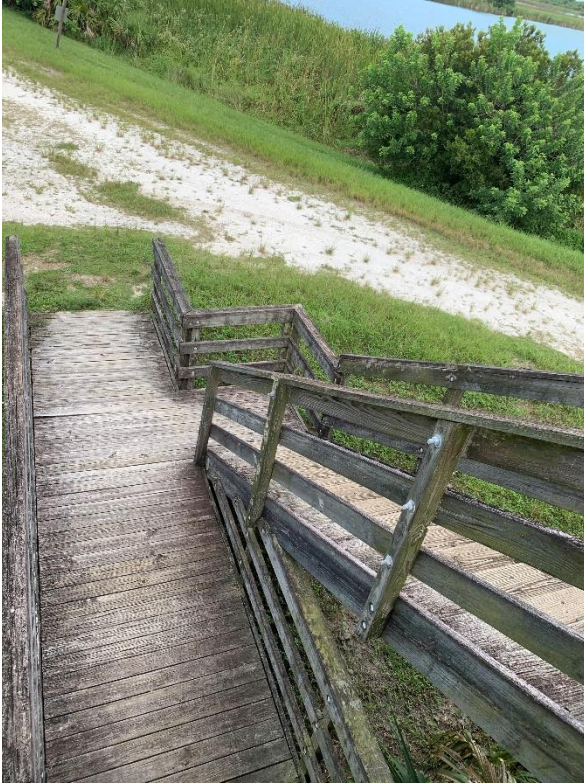
Picture 9

Stairs and deck railing and floor deck planks are in bad condition due to excessive moisture and weather.
