**Brevard County, FL
Bird Watching Tower
Structural Assessment**

RE: Structural Inspection

Bird Watching Tower
Viera Wetlands, West of 10001 N Wickham Rd,
Melbourne, FL 32940

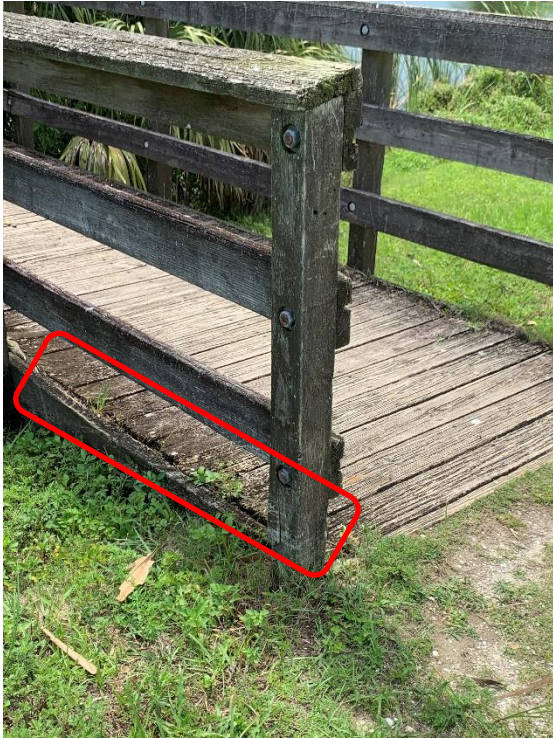
Picture 1

Damaged wood planks from weather and moisture.

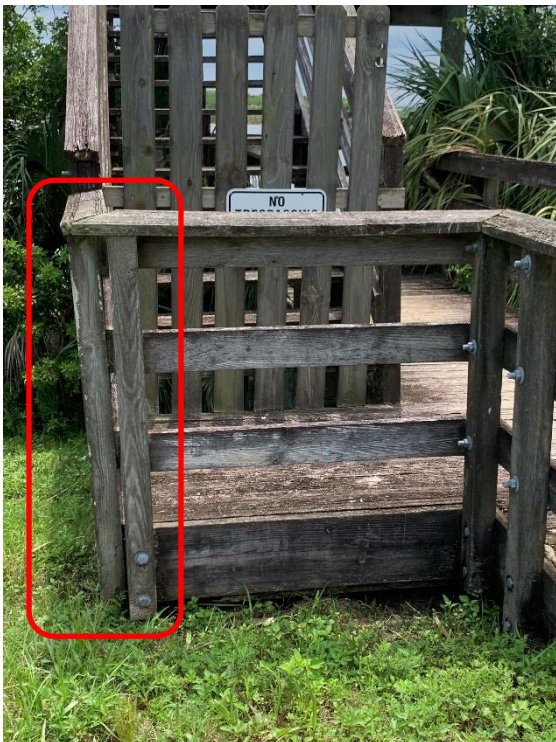
Picture 2

Bended railing posts.

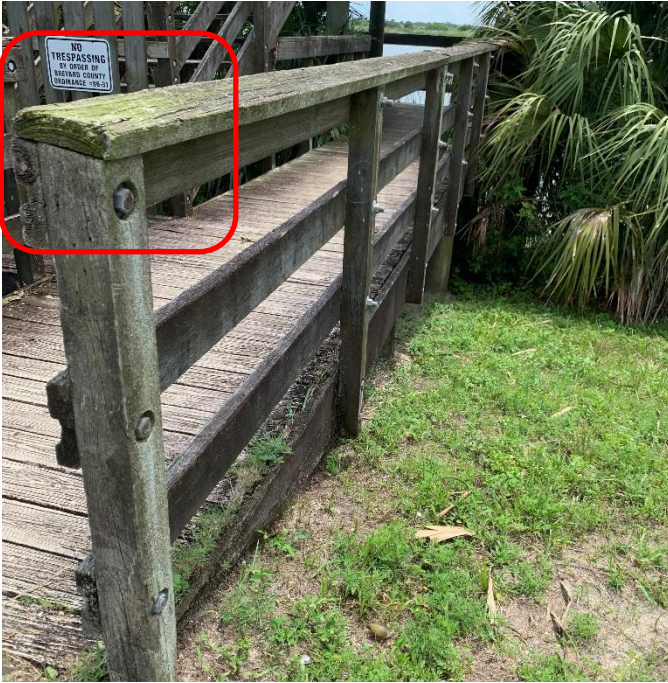
Picture 3

Damaged railing top plywood.

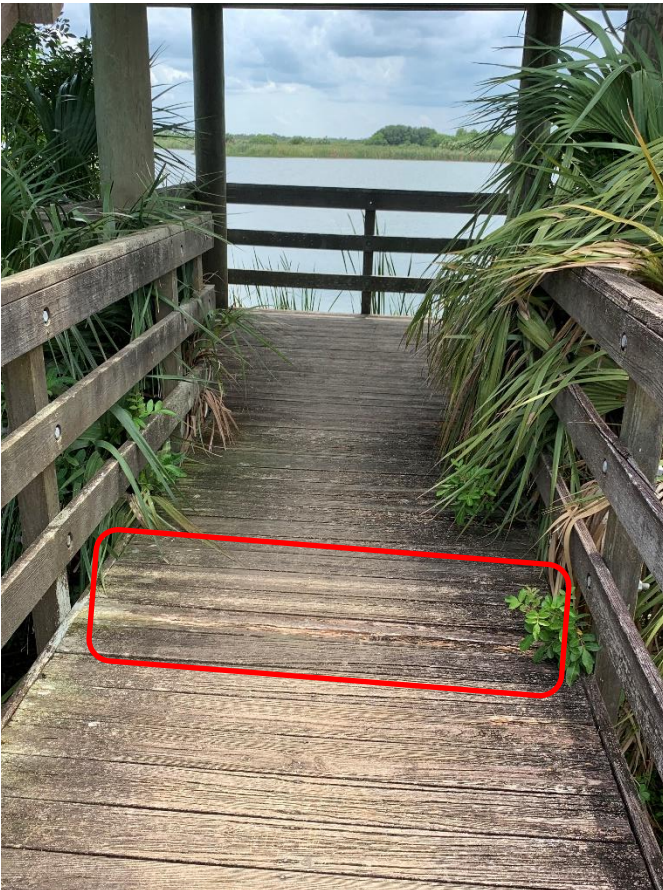
Picture 4

Damaged and "dry" floor planks.

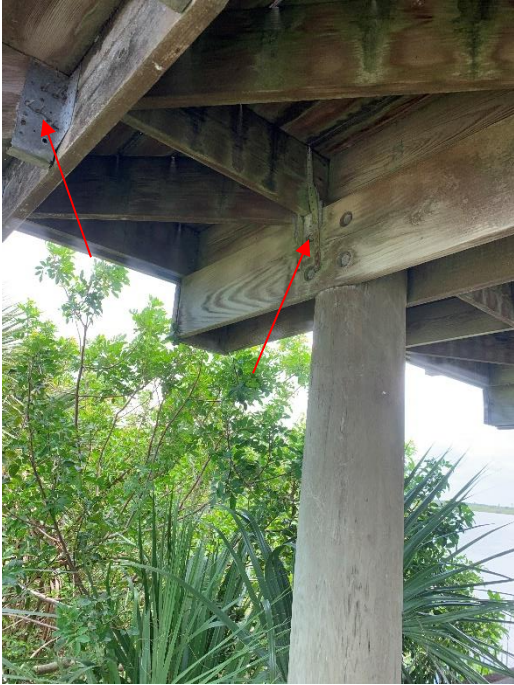
Picture 5

Rusted Simpson hurricane ties and floor beam connections
nails all over the structure.

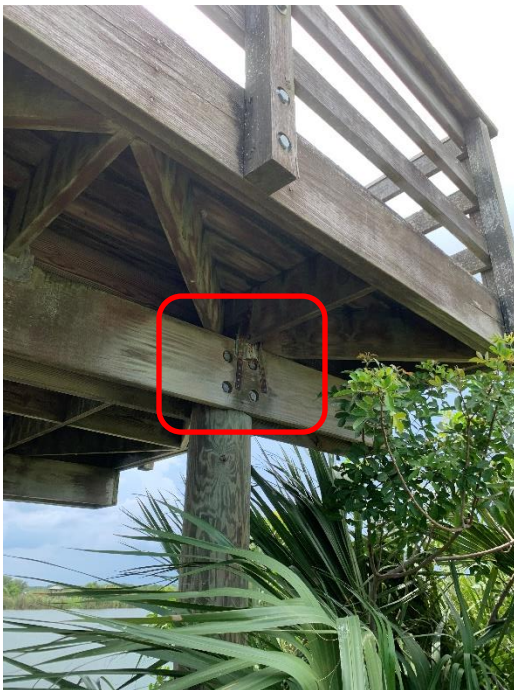
Picture 6

Rusted Simpson hurricane ties in multiple locations.

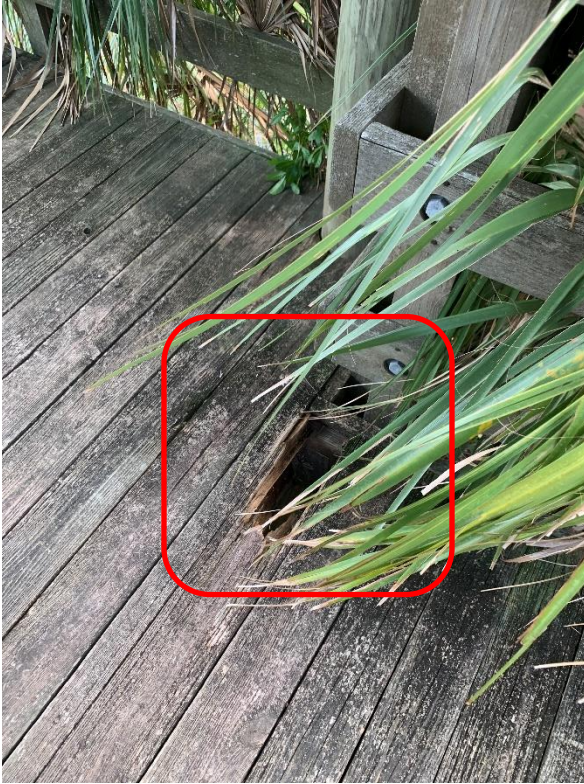
Picture 7

Broken floor plank. Many planks appeared at risk of collapse.

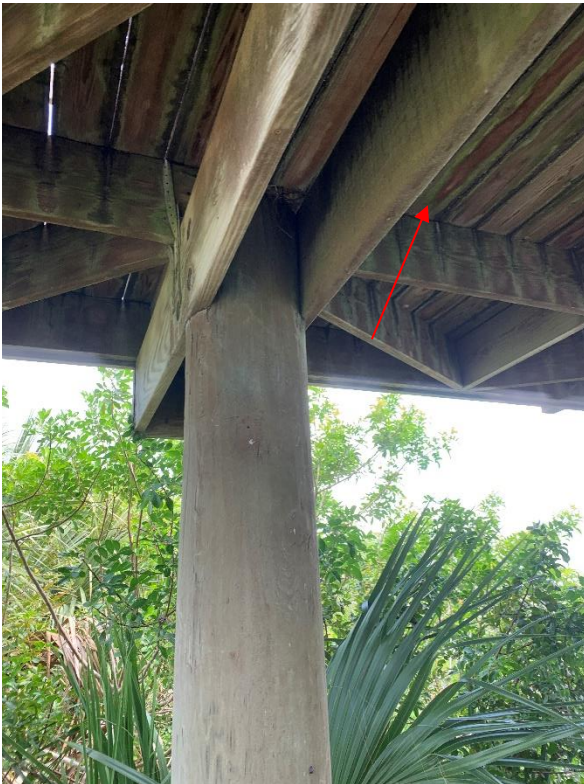
Picture 8

Excessive moisture and mold in multiple wood members.

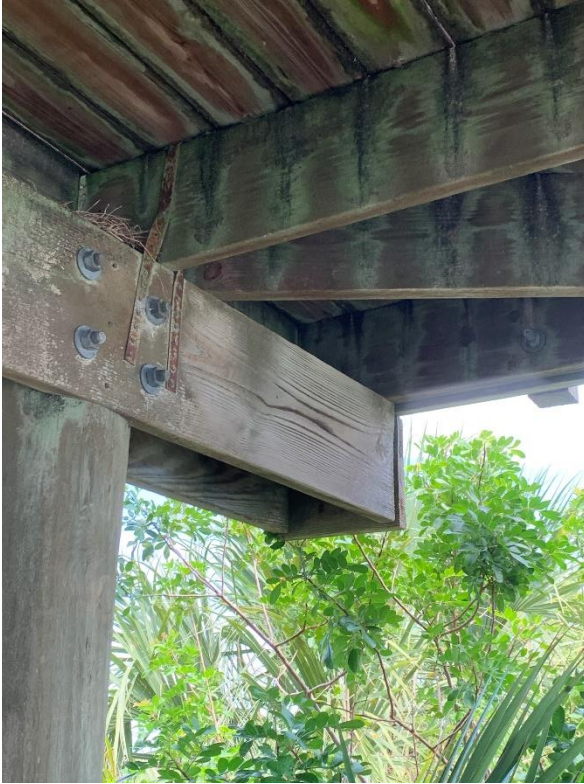
Picture 9

Excessive moisture and stains on wood members and rusted Simpson hurricane ties.

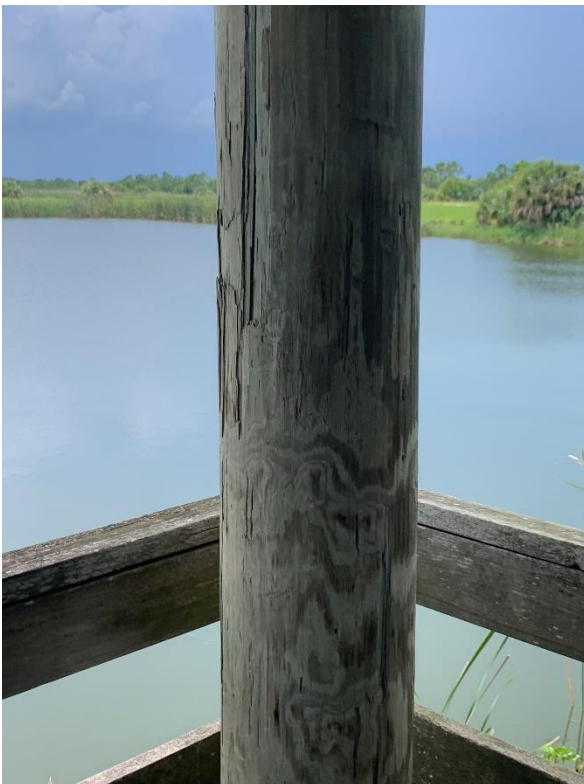
Picture 10

Surface damaged on the round wood column. Larger core shear cracks might occur.

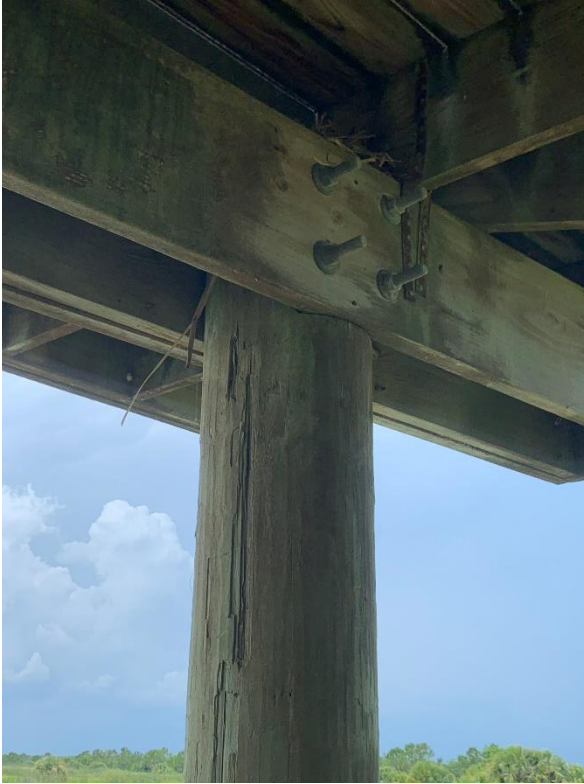
Picture 11

Wood column surface damage and rusted Simpson hurricane ties.

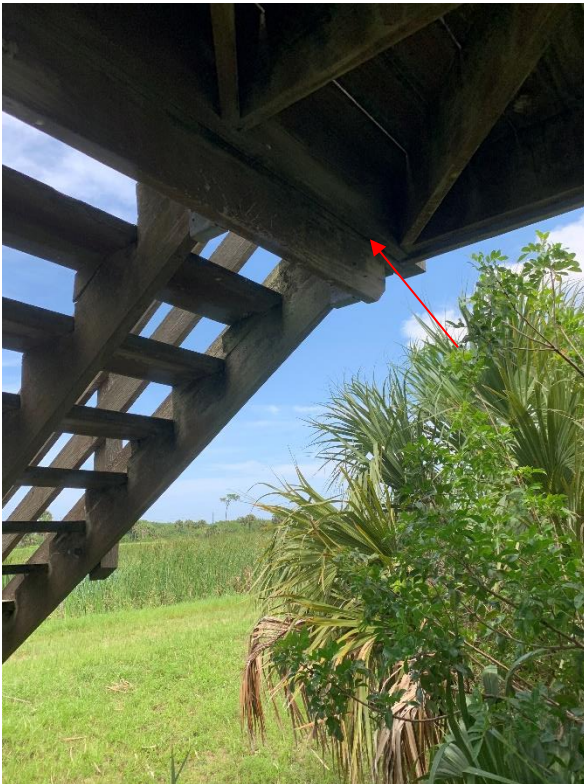
Picture 12

Damaged and deflected stair girder.

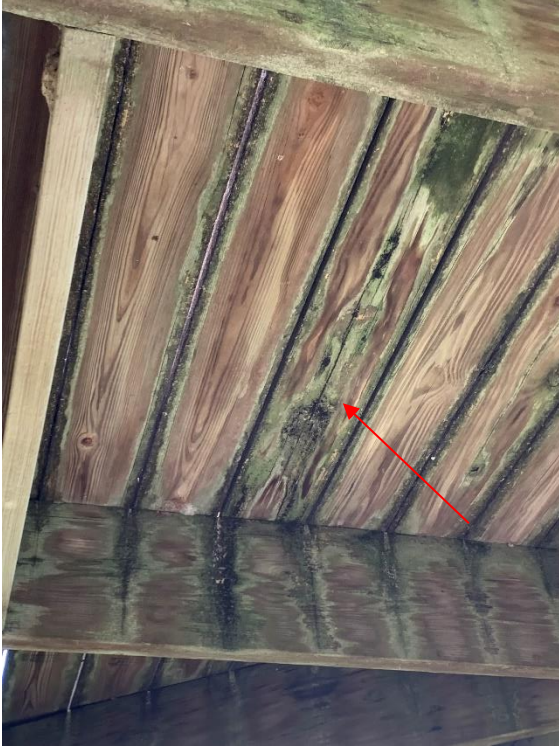
Picture 13

Cracked wood plank.

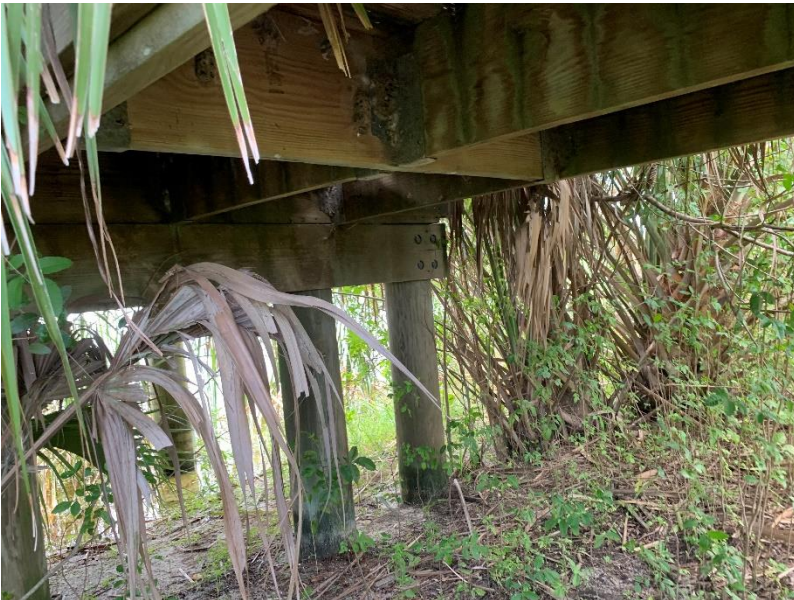
Picture 14

Round wood piles. Additional analysis and special inspection are required for the pile adequacy.
