North Merritt Island

HydroDEM Update Memo

prepared by Atkins, September 2020

Subject: **Draft North Merritt Island HydroDEM update**

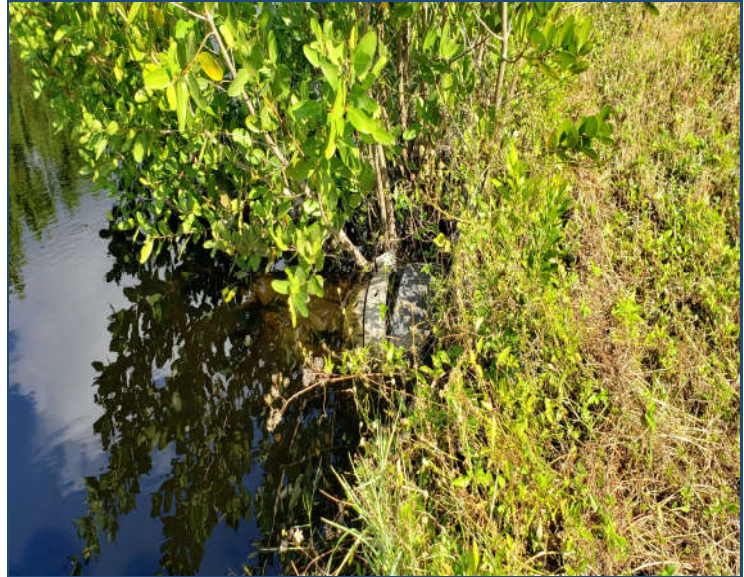
SWAMPid: 0000CU0000

Field Visit Notes: Tideflex product does not appear to be function optimally, the rubber appears still from oxidation. It is recommended that the manufacturer provide an opinion as to how well the structure will function in this condition. Upstream side is mostly silted. Estimate crown is 1 ft below roadway.

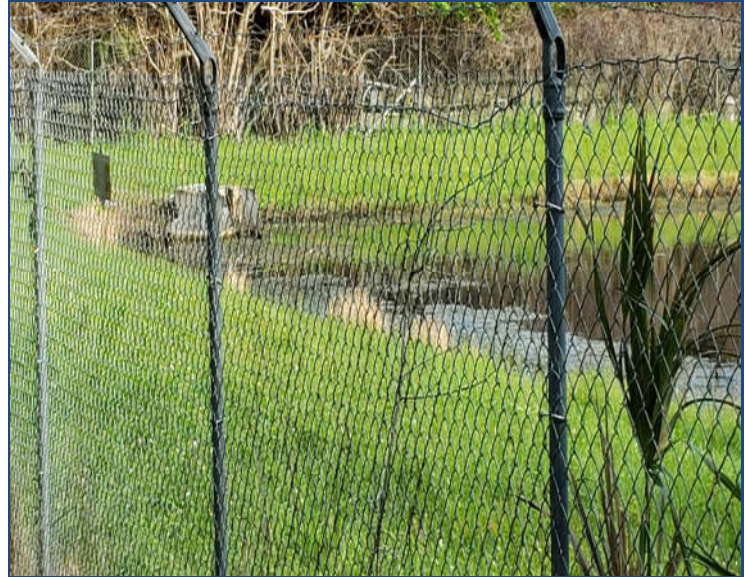
SWAMPid: BCD623CS135

Field Visit Notes: FDOT pond 133 (ph 321-634-6100). SWAMP has elevations missing top dimension and orifice dimension. Field estimated as a Type C structure with a 3 inch orifice
