# North Merritt Island H&H Modeling Study Report

June 2022

SINGHOFEN & ASSOCIATES INCORPORATED

PROJECT NAME: North Merritt Island H&H Modeling Study Report - FINAL

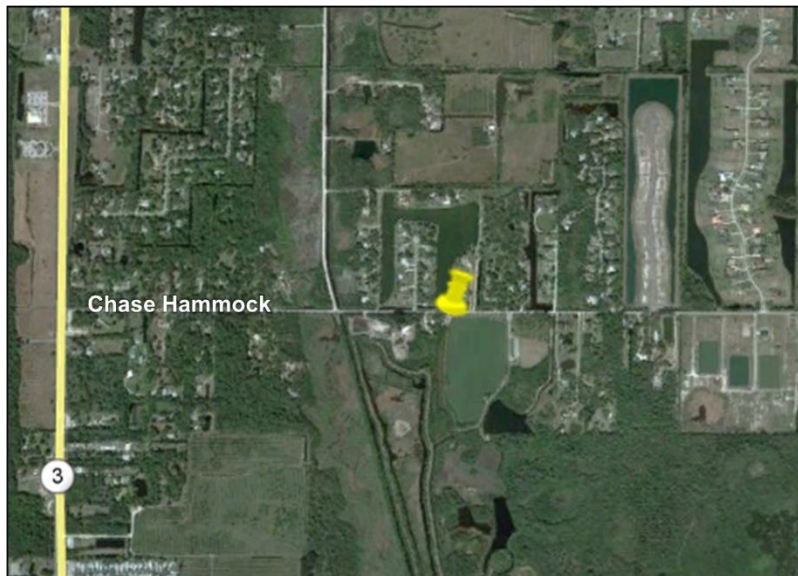
**Figure 2.4: SJRWMD Well Location**

**2.4.1 SJRWMD Gage Data:** Gage data was obtained from the SJRWMD Upper Floridan Aquifer Well located at Kings Park in Merritt Island (ID: BR2115). Data was collected for the surficial aquifer (POR 3/12/2009-8/11/2020) and for the upper Floridan (POR 12/4/1985-8/11/2020). See **Figure 2.4**.

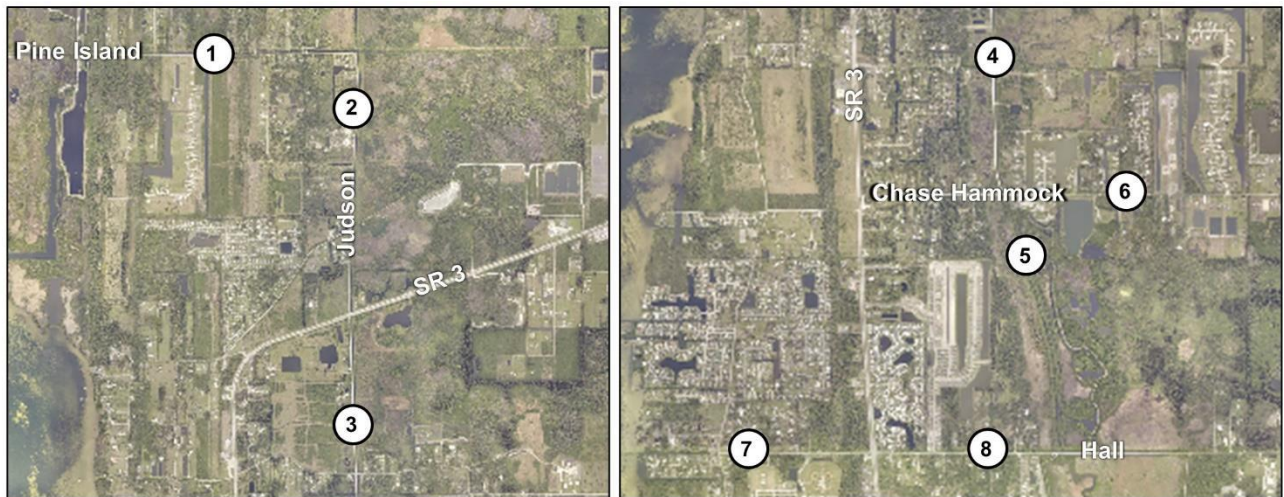
Figure 2.6: Cross Section Survey Locations

The County requested that the SAI Team obtain survey data for several channel systems throughout the watershed that had recently been dredged and/or cleared of vegetation. This included a total of eight (8) channel cross sections throughout the watershed, including ditches along Hall Road, Judson Road, Pine Island Road, and Chase Hammock Road. This work was conducted in August 2020 by Morgan & Eklund, Inc. (M&E). Cross sections provided included both the ground surface and bottom of muck elevations at each cross section. **Figure 2.6** on the following page shows the location of the 8 cross sections. The survey data is included in the electronic deliverable accompanying this report.

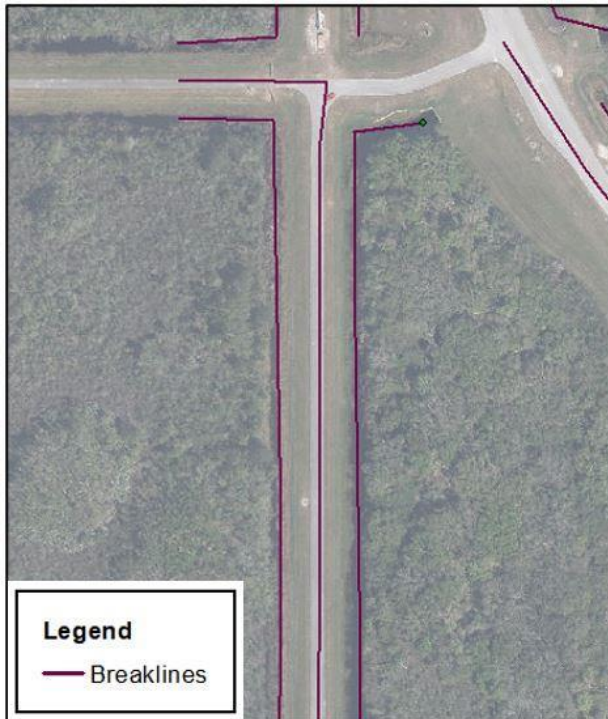
**Figure 3.10: Roadway Breaklines**

- **Roadways** – Breaklines were placed at along the centerline of roadways and along the adjacent swales (See **Figure 3.10**). In some cases, control volumes were drawn along the centerline and breaklines were limited to the roadway swales.
- **Ditches/Channels** – Breaklines were placed along the centerline of minor swales and ditches that were not modeled with a 1D channel link to provide conveyance within the 2D overland portion of the watershed (See **Figure 3.11**).
- **Within Ponds and Wetlands** – Breaklines were drawn within stormwater ponds and large wetland areas to ensure the groundwater mesh was aligned with the surface water mesh for groundwater-surface water interaction within the waterbodies (See **Figure 3.12**).

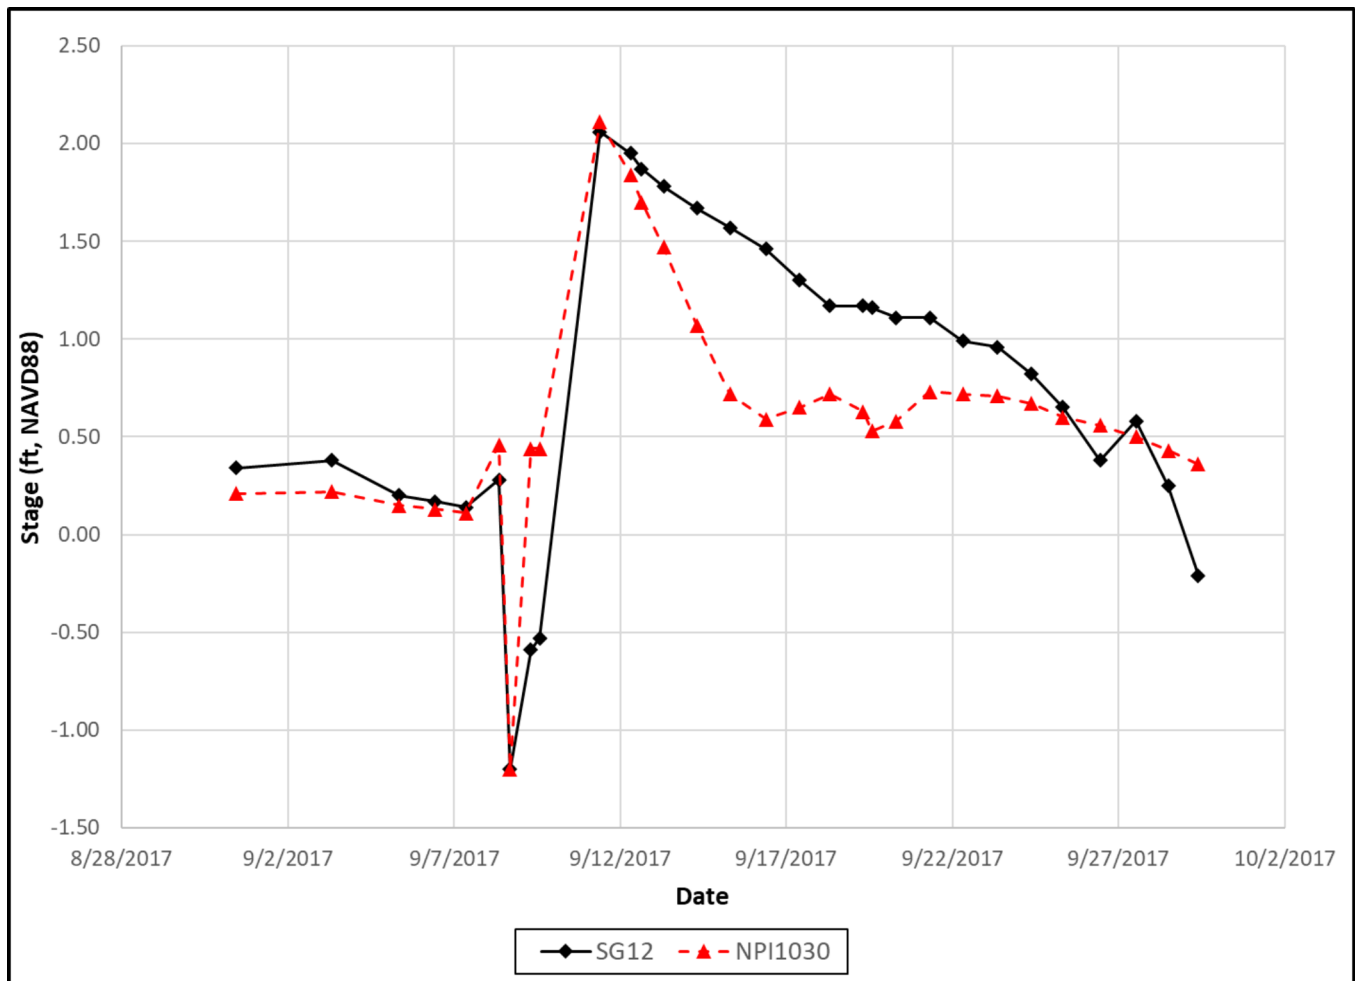
**Figure 6.21: Gage SG12 PICA South Calibration #1 Comparisons**

Gage SG12 is located at the downstream side of the Pine Island Pump House. The stage hydrograph comparison for Calibration #1 is provided below in **Figure 6.21**. Like the comparisons for SG11, the modeled and measured peak stages compare quite well. The Calibration #1 modeled peak stage is 2.11-ft (NAVD88), which is 0.6-inches above the measured peak stage (2.06-ft, NAVD88). Like SG11, the stage hydrograph recovers faster than the measured stage data after the peak. This is also attributed to the unknown pumping operations at the Pine Island Harvey Grove Pumps. No comparisons were conducted for Calibration #2 since node NPI1030 was converted to a time-stage node for that analysis.

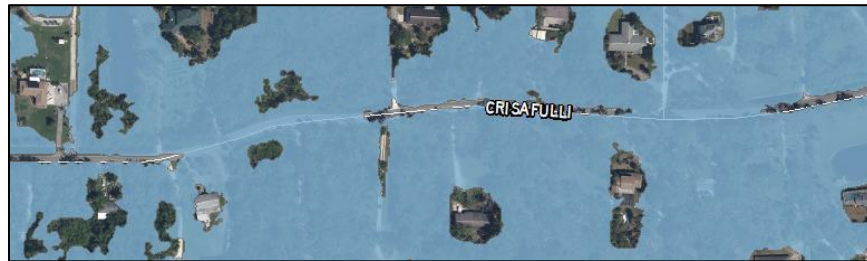
**Figure 8.1: 10-Year, 24-hr Floodplain along E. Crisafulli Rd.**

**Design Storm Simulations:** The floodplains for the NMI watershed depict significant inundation for most simulated storm events, particularly in the low-lying central wetland areas of the watershed. This includes the Sykes Cree/ mosquito impoundment area north towards East Crisafulli Road. Roadway flooding is shown along several collector roads during the 10-year storm event, including East Crisafulli Road (**Figure 8.1**) and West Crisafulli Road (**Figure 8.2**).

Both locations above, along with other areas such as East Hall Road below (**Figure 8.3**), are expected to experience significant inundation of low-lying yards and driveways during the 10-year event.
