ecospatial ANALYSTS

Project Address: MILDRED CT, COCOA, FL 32927
Project Area 0.18 acres + 1.25-acres
Brevard Co Parcel ID: 23-35-35-02-*-A, 23-35-35-00-77
Tax Accounts: 2322697; 2314528
Parcel Description: VERONICA ESTATES PHASE ONE TRACT A FUTURE DEVELOPMENT and S 1/2 OF SW 1/4 OF NE 1/4 OF SW 1/4 OF NE 1/4 AS DES IN ORB 1622 PG 243

Subject: Environmental Report for Wetlands and Protected Species

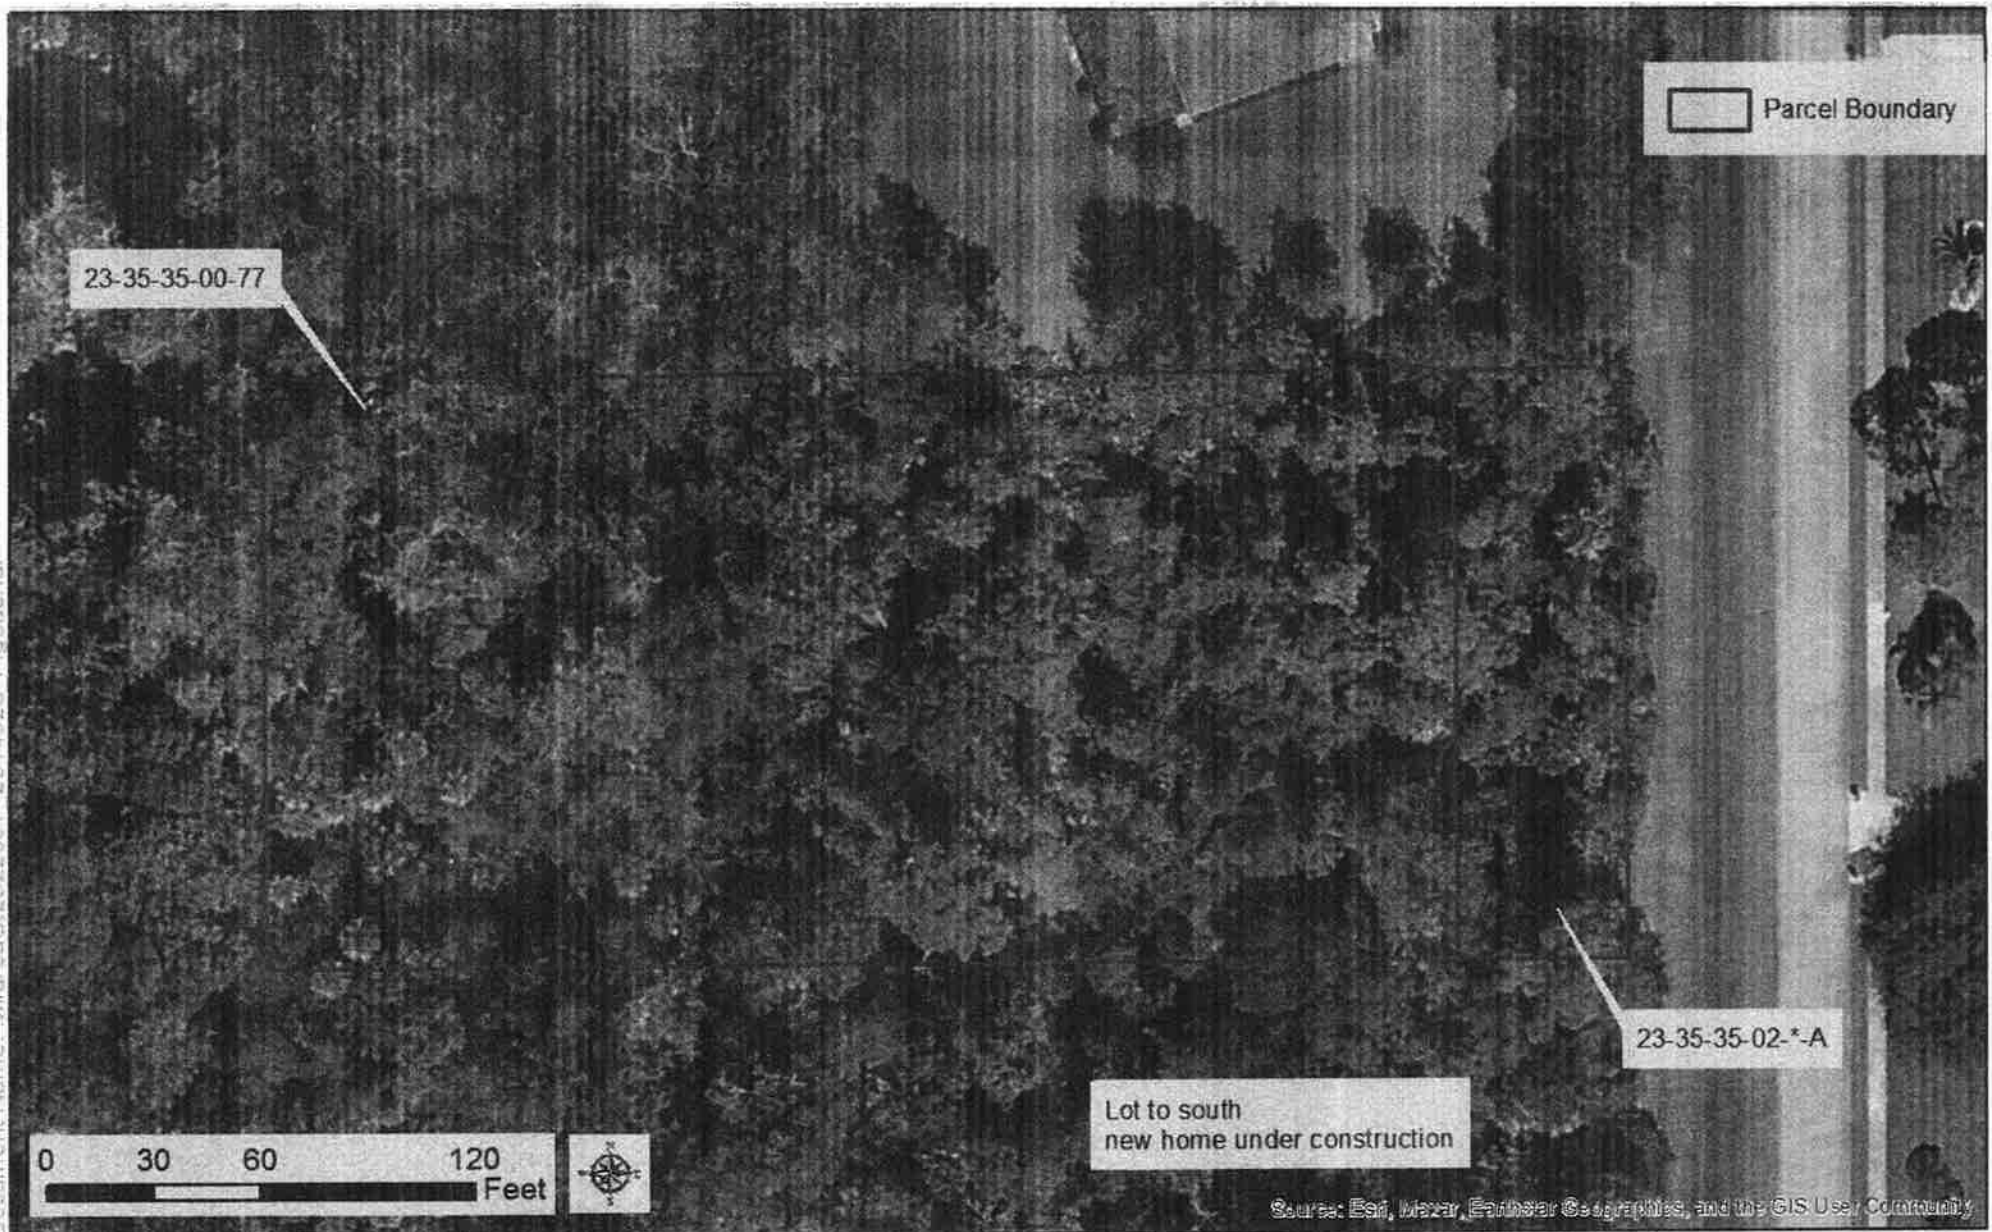
3

Ecospatial Analysts, Inc. conducted an environmental assessment and wetland determination on the above-referenced properties on October 24, 2024. The property is two vacant parcels located in Cocoa, Brevard Co., Florida (Figure 1 and 2). The parcels were bounded by Mildred Ct to the east, vacant land that is designated as a Conservation Easement owned by Brevard Co. and single-family residences to the north and south (Figure 3).

Title: Aerial Imagery (1.43 acre)
Address: Mildred Ct, Cocoa, FL 32927
Parcel ID: 23-35-35-02-*A, 23-35-35-00-77
Source: ESRI Basemap Imagery
Notes: Locations approximate, Reported areas include both parcels.
Site visit 10/24/24

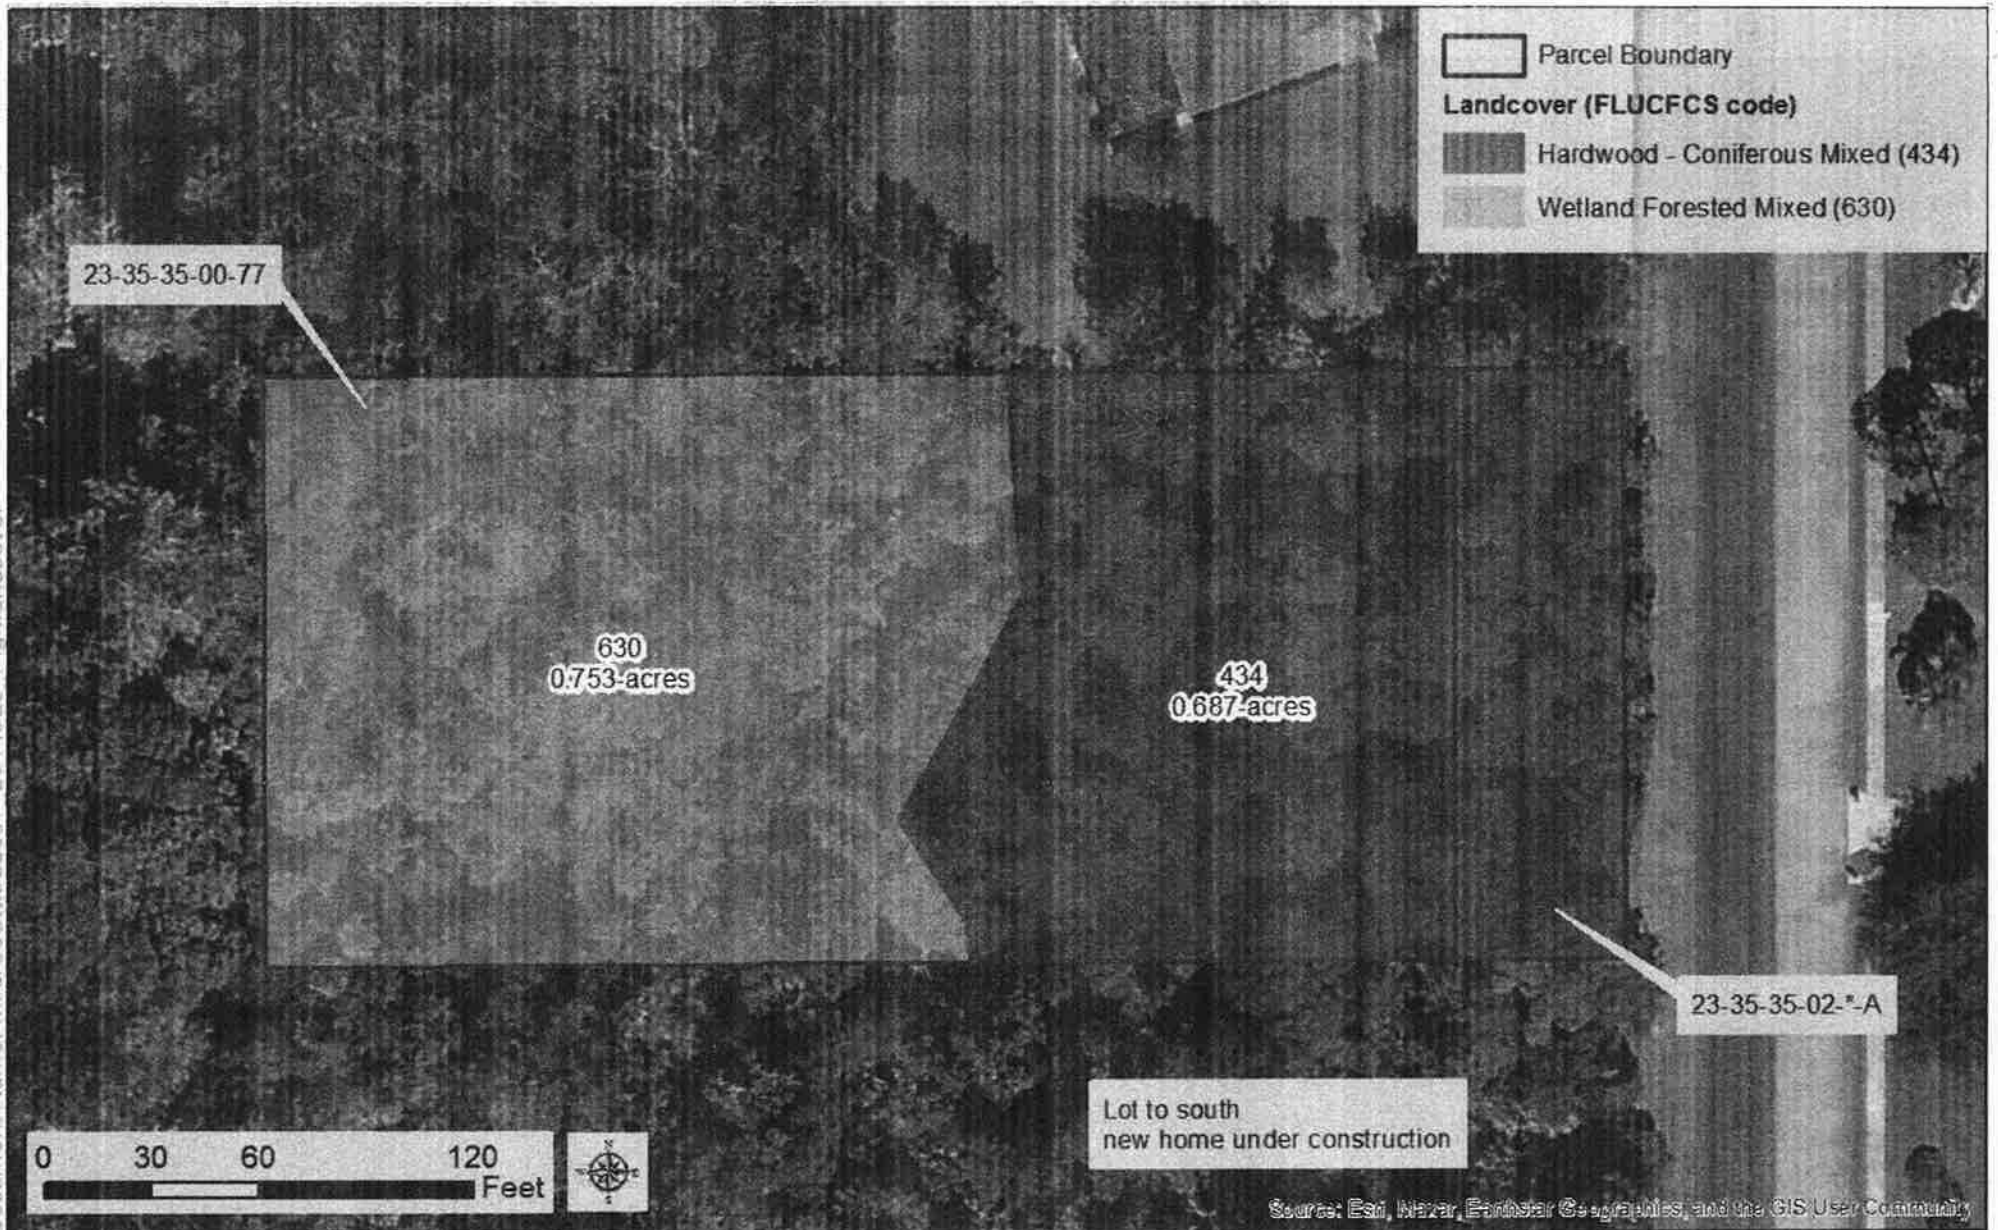
4

LANDCOVER Landcover (Figure 4) was mapped using the Florida Land Use Cover and Forms Classification System (FLUCFCS) (1999) within the Brevard County Parcel boundary as obtained from the Florida Department of Revenue Geographic Information System (GIS) data. The landcover within the property consisted of two landcover types (Table 1).

Uplands on the parcel consisted of ± 0.687 -acres of Hardwood - Coniferous Mixed (FLUCFCS 434). The Hardwood - Coniferous Mixed was dominated by a scattered canopy of pines (*Pinus* spp.), live oak (*Quercus virginiana*), laurel oaks (*Q. laurifolia*), with a midstory comprised mostly of saw palmetto (*Serenoa repens*), gallberry (*Ilex glabra*), rusty staggerbush (*L. ferruginea*), muscadine (*Vitis*

Wetlands included Wetland Forested Mixed (FLUCFCS 630). The forested wetlands were dominated by slash pine, laurel oaks, red maple (*Acer rubrum*), loblolly bay (*Gordonia lasianthus*), Carolina ash (*Fraxinus caroliniana*), hackberry (*Celtis laevigata*), wax myrtle (*Morella cerifera*) and groundsel tree (*Baccharis halimifolia*). Groundcovers consisted of blackberry (*Rhus* spp.), cinnamon fern (*Osmundastrum cinnamomeum*), Virginia chain fern (*Woodwardia virginica*) and swamp fern (*Telmatoblechnum serrulatum*).

Title: Landcover (1.43 acre)
Address: Mildred Ct, Cocoa, FL 32927
Parcel ID: 23-35-35-02-*A, 23-35-35-00-77
Source: ESRI Basemap Imagery
Notes: Locations approximate, Reported areas include both parcels.
Site visit 10/24/24

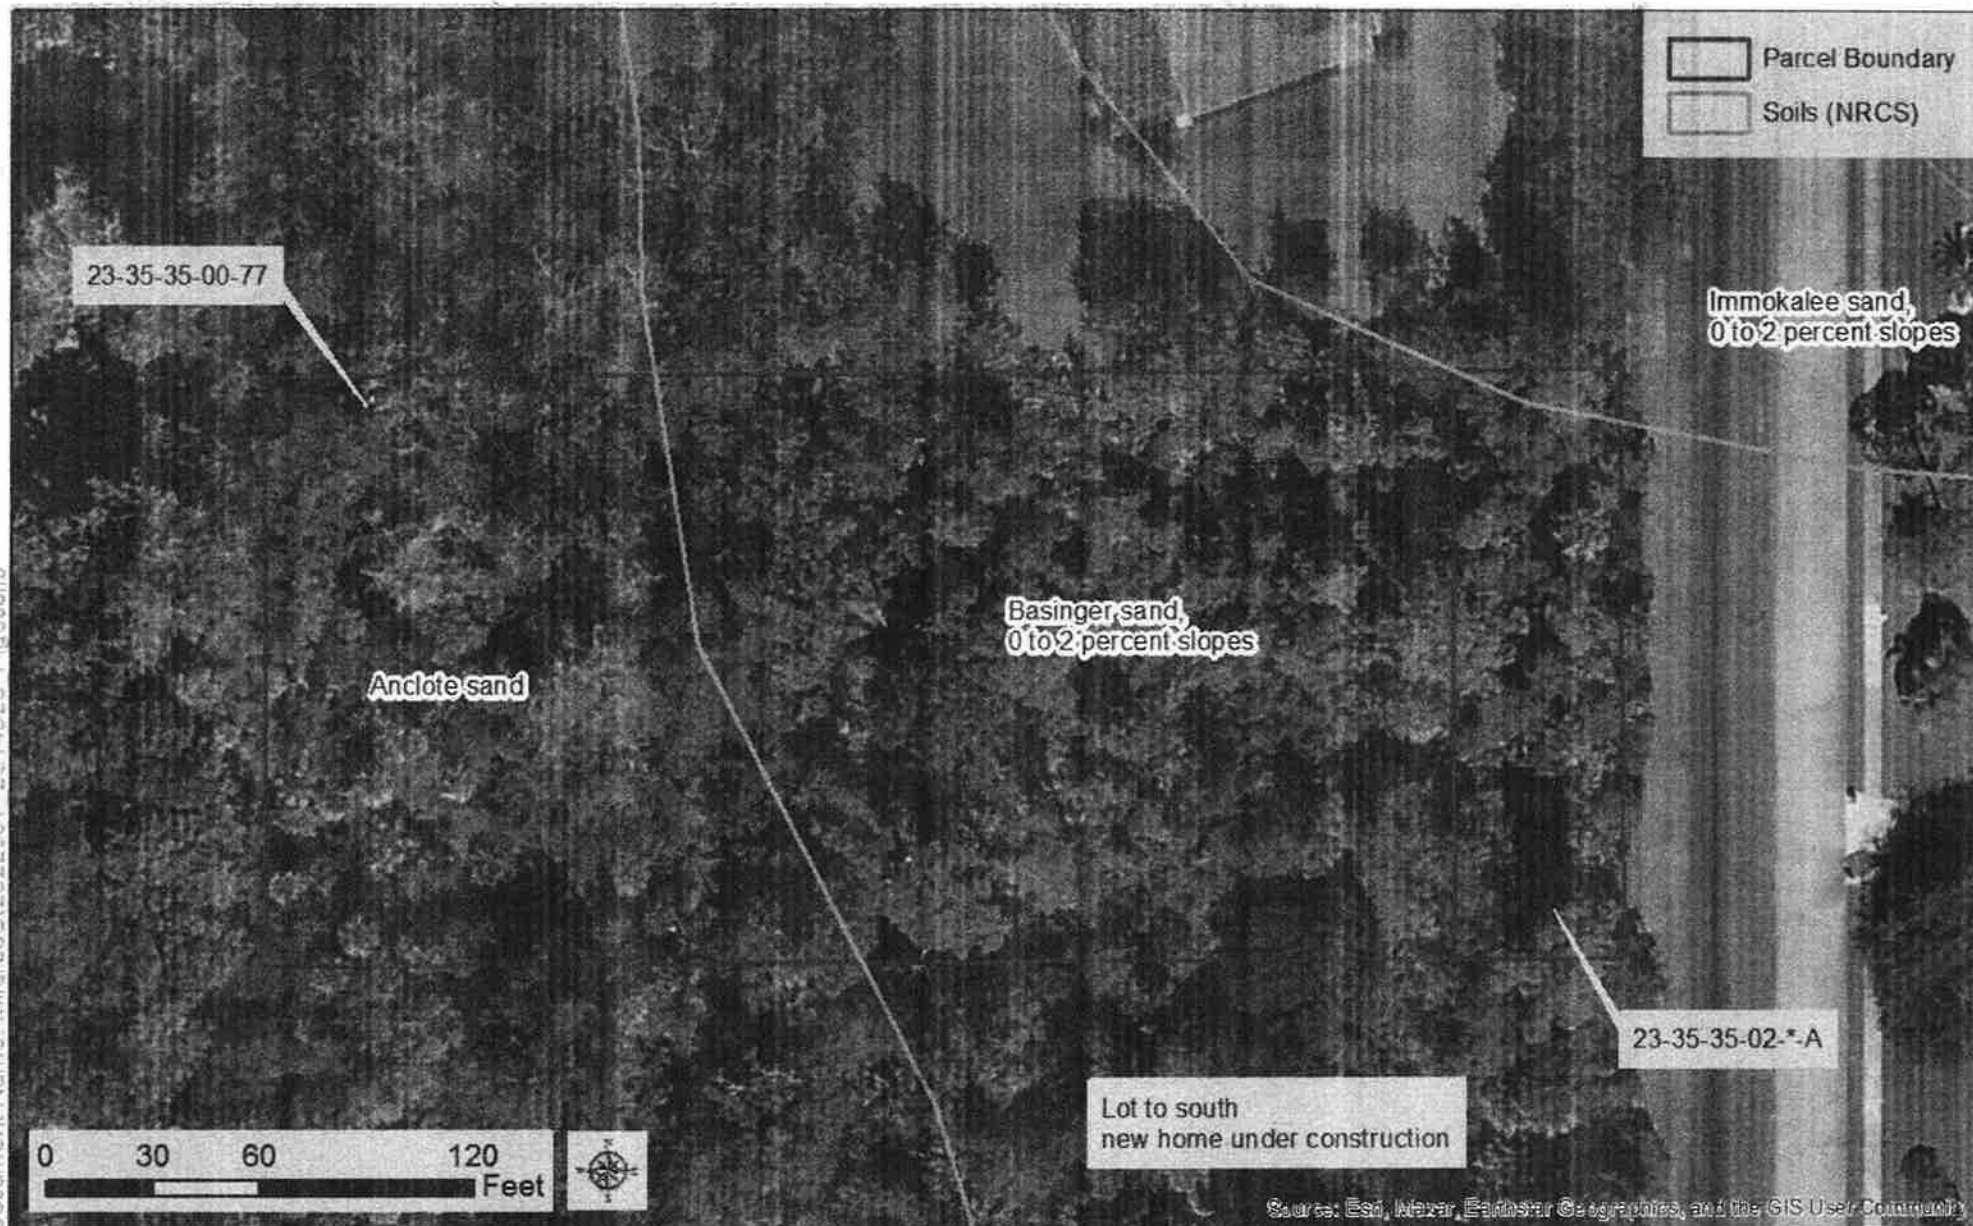
6

SOILS Three soil series occurred within the property (Figure 6); Immokalee sand, 0 to 2 percent slopes, Basinger sand, 0 to 2 percent slopes and Ancloste sand. The soil characteristics derived from soil profiles were somewhat consistent to the soil descriptions within the Soil Survey of Brevard Co. (<http://websoilsurvey.nrcs.usda.gov/>); however, the boundaries of the soils series edges were not consistent. Only the west a portion of the Bassinger sand on these this lot showed hydric soil conditons.

Title: Soils (1.43 acre)
Address: Mildred Ct, Cocoa, FL 32927
Parcel ID: 23-35-35-02-*A, 23-35-35-00-77
Source: ESRI Basemap Imagery
Notes: Locations approximate, Reported areas include both parcels.
Site visit 10/24/24
