## Andrew Conklin Environmental Services, LLC

Re: 5275 Andover Street, Parcel No. 23-35-15-JY-A-3, Port St. John  
ACES File No. 24455

Andrew Conklin Environmental Services, LLC (ACES) has completed a review of environmental issues associated with the above-referenced +/-1.17-acre property. Figure 1 depicts the location of the subject parcel and Figure 2 is a recent aerial photograph of the property depicting current conditions thereon. On July 10, 2024, ACES inspected the site for the presence of wetlands, protected species, and indications of protected species habitat. To assess the presence and extent of wetlands, we implemented the jurisdictional wetland identification methodology of the Florida Department of Environmental Protection (DEP), which incorporates an analysis of on-site vegetation, soils, and hydrology to determine the presence or absence of jurisdictional wetlands. The likelihood of protected species habitation was determined by identifying the various vegetative communities and habitat types currently present on the site and referencing these against standards and indicators used by the Florida Fish and Wildlife Conservation Commission (FWC) and the U.S. Fish an

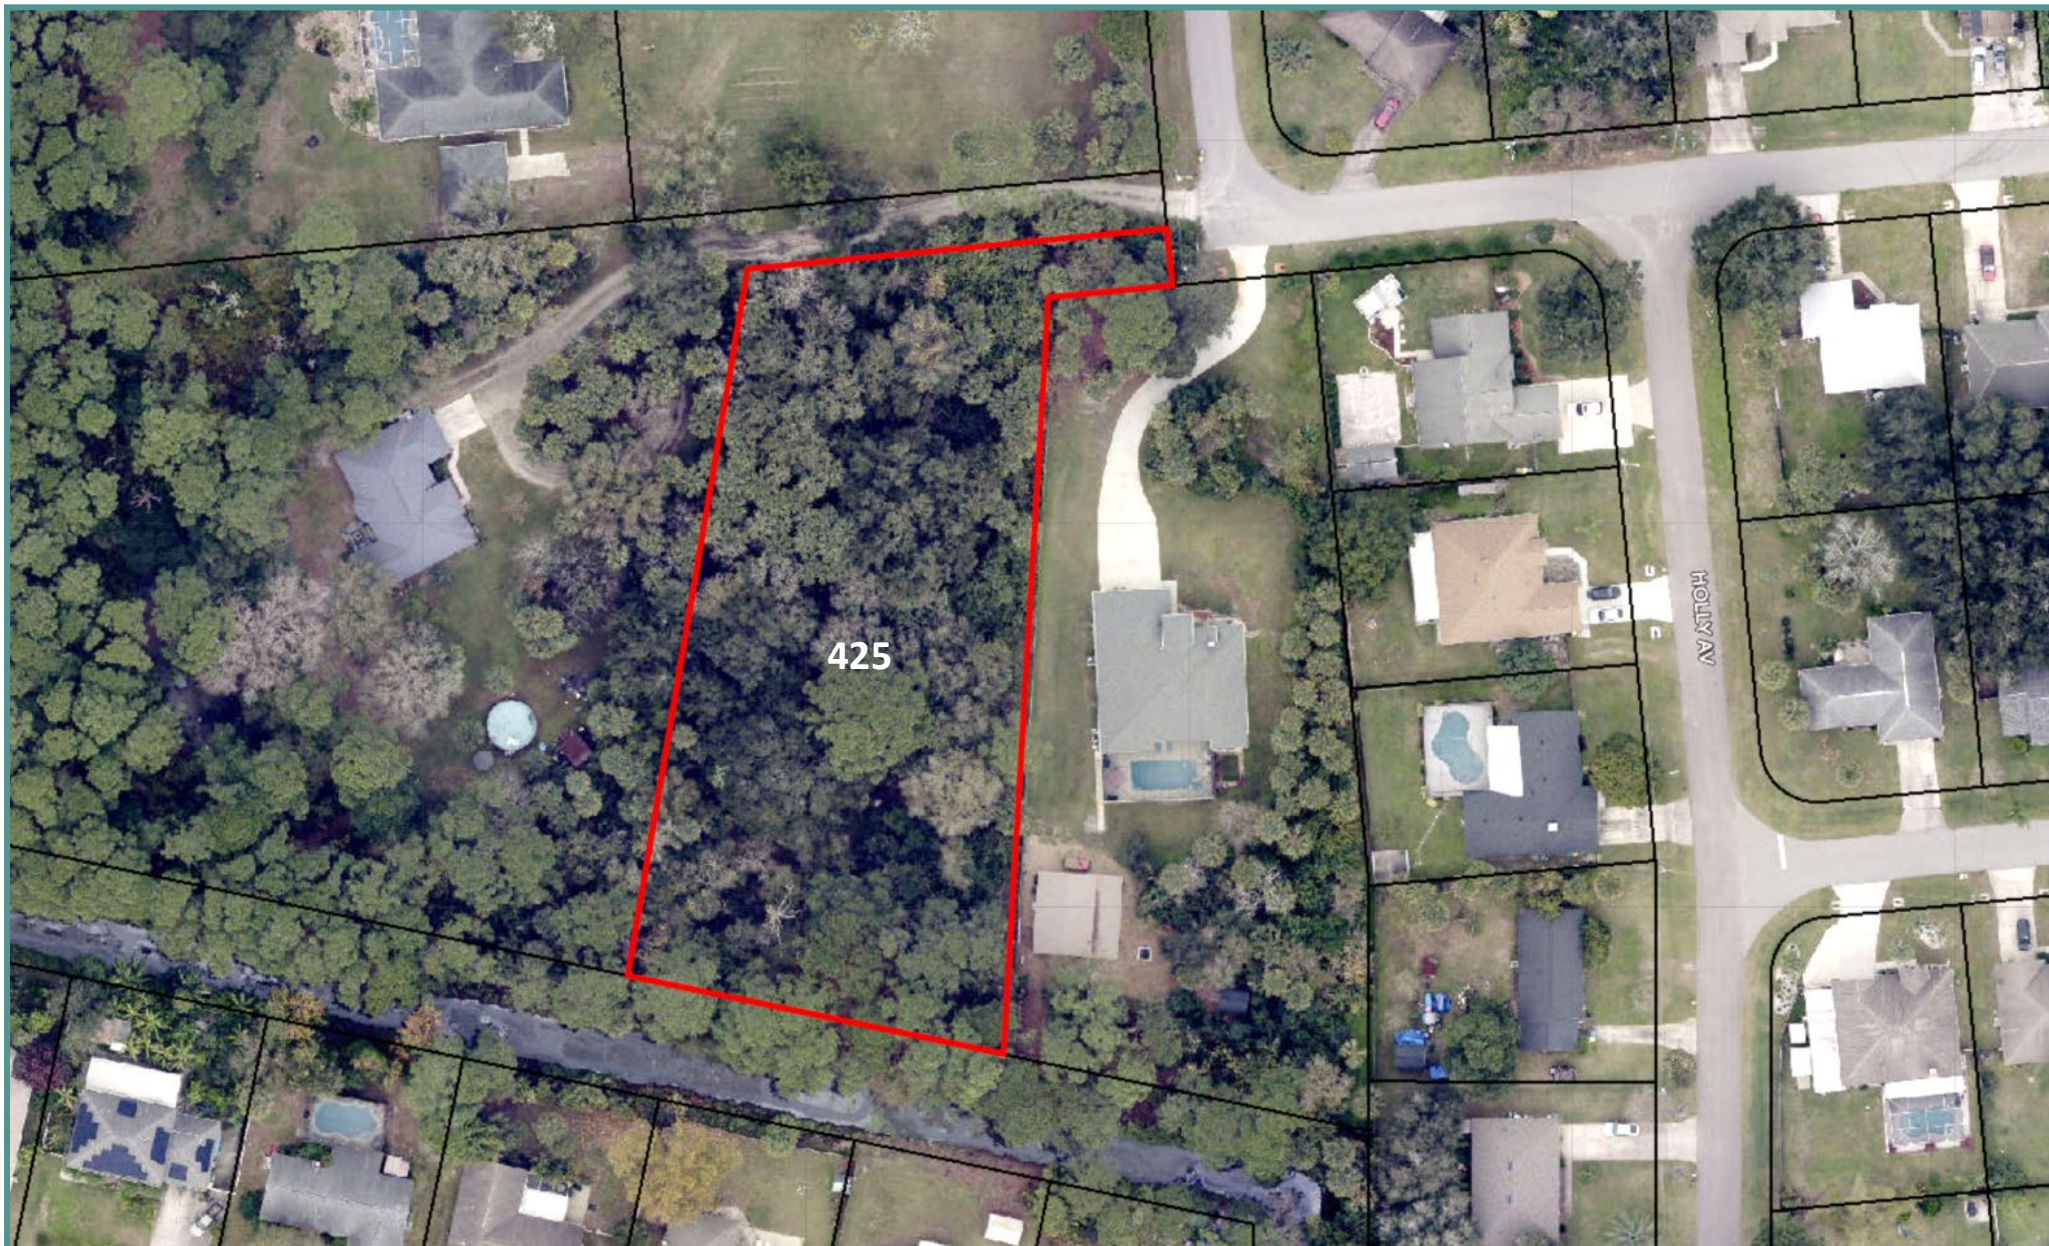
## Figure 4 – Environmental Survey Map

Using the Florida Land Use, Cover and Forms Classification System (FLUCFCS) as a guideline, ACES categorized the site for the presence of distinct natural communities and land uses according to FLUCFCS designations and code numbers. Figure 4 depicts the FLUCFCS code designation on the property. This is:

Temperate Hardwoods – FLUCFCS Code No. 425: This forested mesic upland community covers the entire site. It contains a canopy dominated by cabbage palm, with components of live oak, slash pine, Darlington's oak, laurel oak, and sugarberry. The midstory contains Brazilian pepper, beauty berry, wild coffee, southern magnolia, and cherry laurel, and the ground cover includes air potato, southern fox grape, frostweed, poison ivy, and caesarweed. Underlying soils are composed of non-hydric

425 – Temperate Hardwoods  
(entire site)

Wetlands were not determined to be present on the site. As such, wetland permits and mitigation are not expected to be required prior to site development.
