Ritch Grissom Memorial Wetlands Access Path

Feasibility Study

Task Order No. 10

June 6, 2022

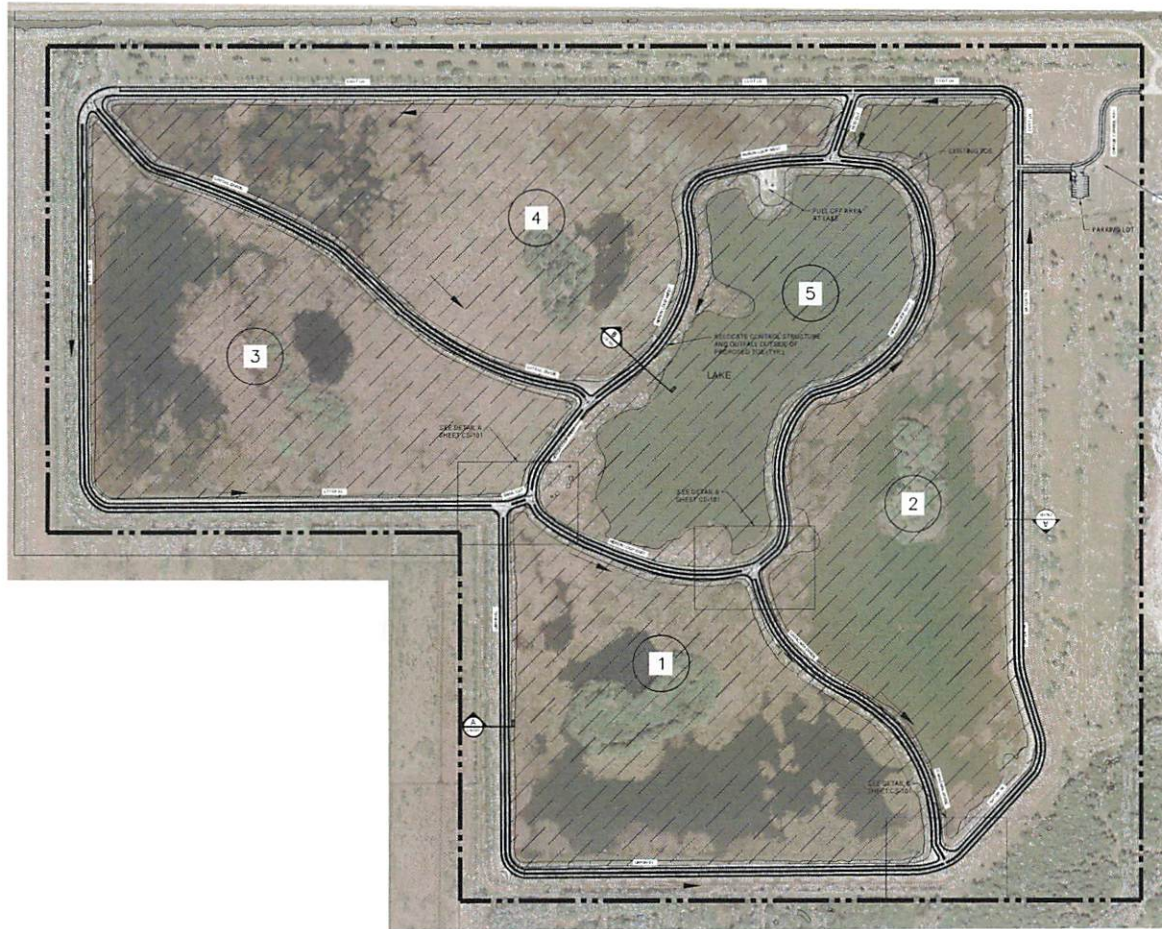
CS-100 0

OPTION A - PAVED MULTI-USE TRAIL & SEPARATE ONE WAY VEHICULAR ACCESS DRIVE

- The similar width and asphalt surface of the vehicular road and shared use path is likely to cause confusion to motorists, pedestrians and cyclists. Options to mitigate the risk of vehicles driving off the road would require a combination of fencing, bollards, signage, curbs and pavement markings that would further increase the project cost, detract from the natural aesthetics and reduce emergency response access.

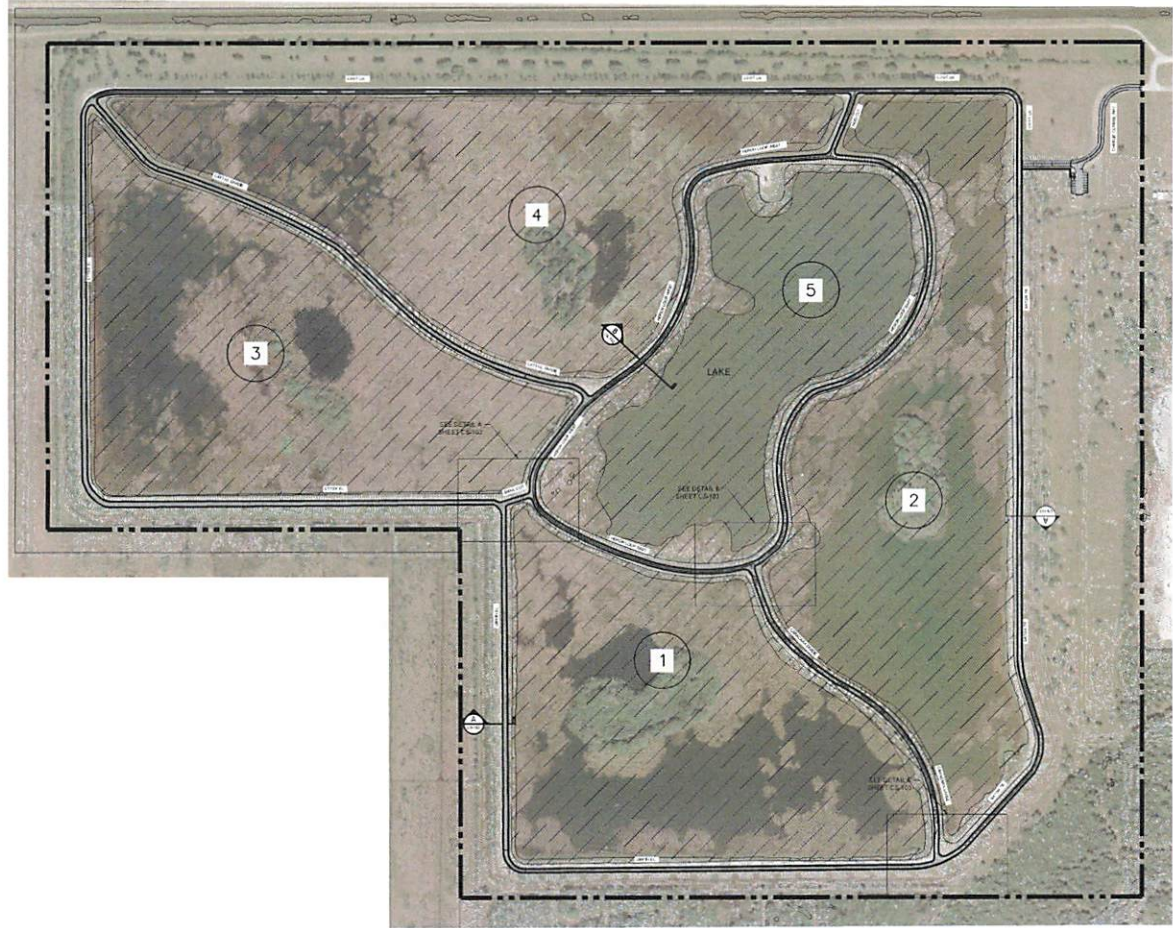
CS-102 0

OPTION B - PAVED MULTI-USE PATH WITH NO PUBLIC VEHICULAR ACCESS

This option consists of the construction of a paved 12 ft wide shared use path connecting all cell containment berms. The path would not be accessible to public vehicles but only to pedestrians, bicyclists, and other recreational users. Since the existing width of berm is 12 ft plus shoulders and used by maintenance vehicles, it is recommended that the paved shared use path also be 12 ft wide, paved with asphalt or concrete. For the purpose of this exercise, the preferred pavement type was assumed to be asphalt. This will allow ample width for maintenance or emergency vehicles as required (12 ft paved width plus 4 ft stabilized shoulders on each side). Some signage will be required at intersections but unlike Option A, there is no risk of accidents with passenger cars. Access by maintenance staff will be provided by a locked gate with fencing. This option is graphically depicted in A.2.

Unlike Option A, the geometry of the existing cell containment berms will remain the same in Option B. Since the paved road will not be designed for public traffic, shoulder width can be reduced, resulting in a proposed section that closely matches the existing condition, greatly simplifying the design, permitting and construction process.

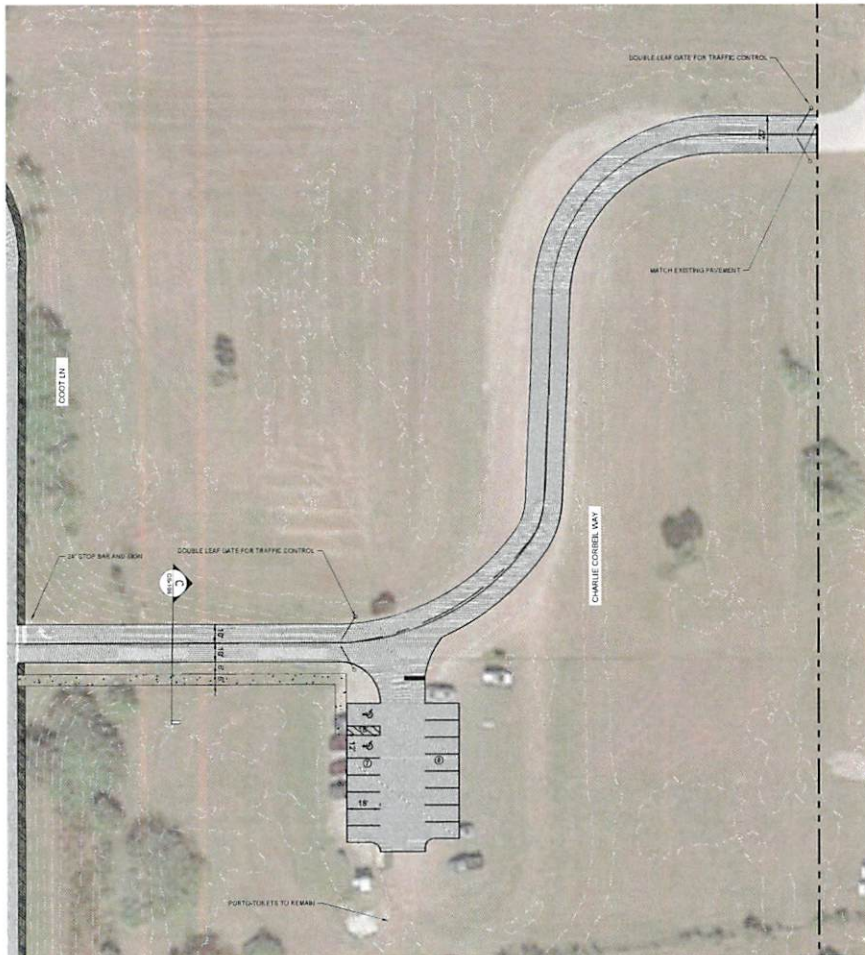
BREVARD COUNTY UTILITIES SERVICES DEPARTMENT	
VIERA WETLANDS ACCESS IMPROVEMENTS	
SECTION AND DETAILS OPTION C	
Drawn by: AS-BHOWAN	Checked by: KLC
Designed by: ARCH D	Scale: 800/121
Date: 8/9/21	Date: 8/9/21
Project No: CS-105	Sheet No: 0
