Reference: BCUD South Central WWTF
DW Facility ID # FL0102679
OGC Case #21-0180
Response to Order 5. a)

Water Sample Location Map
Brevard Wastewater Treatment Facility
Brevard County, Florida

Dominant Vegetative Cover
Brevard Wastewater Treatment Facility
Brevard County, Florida

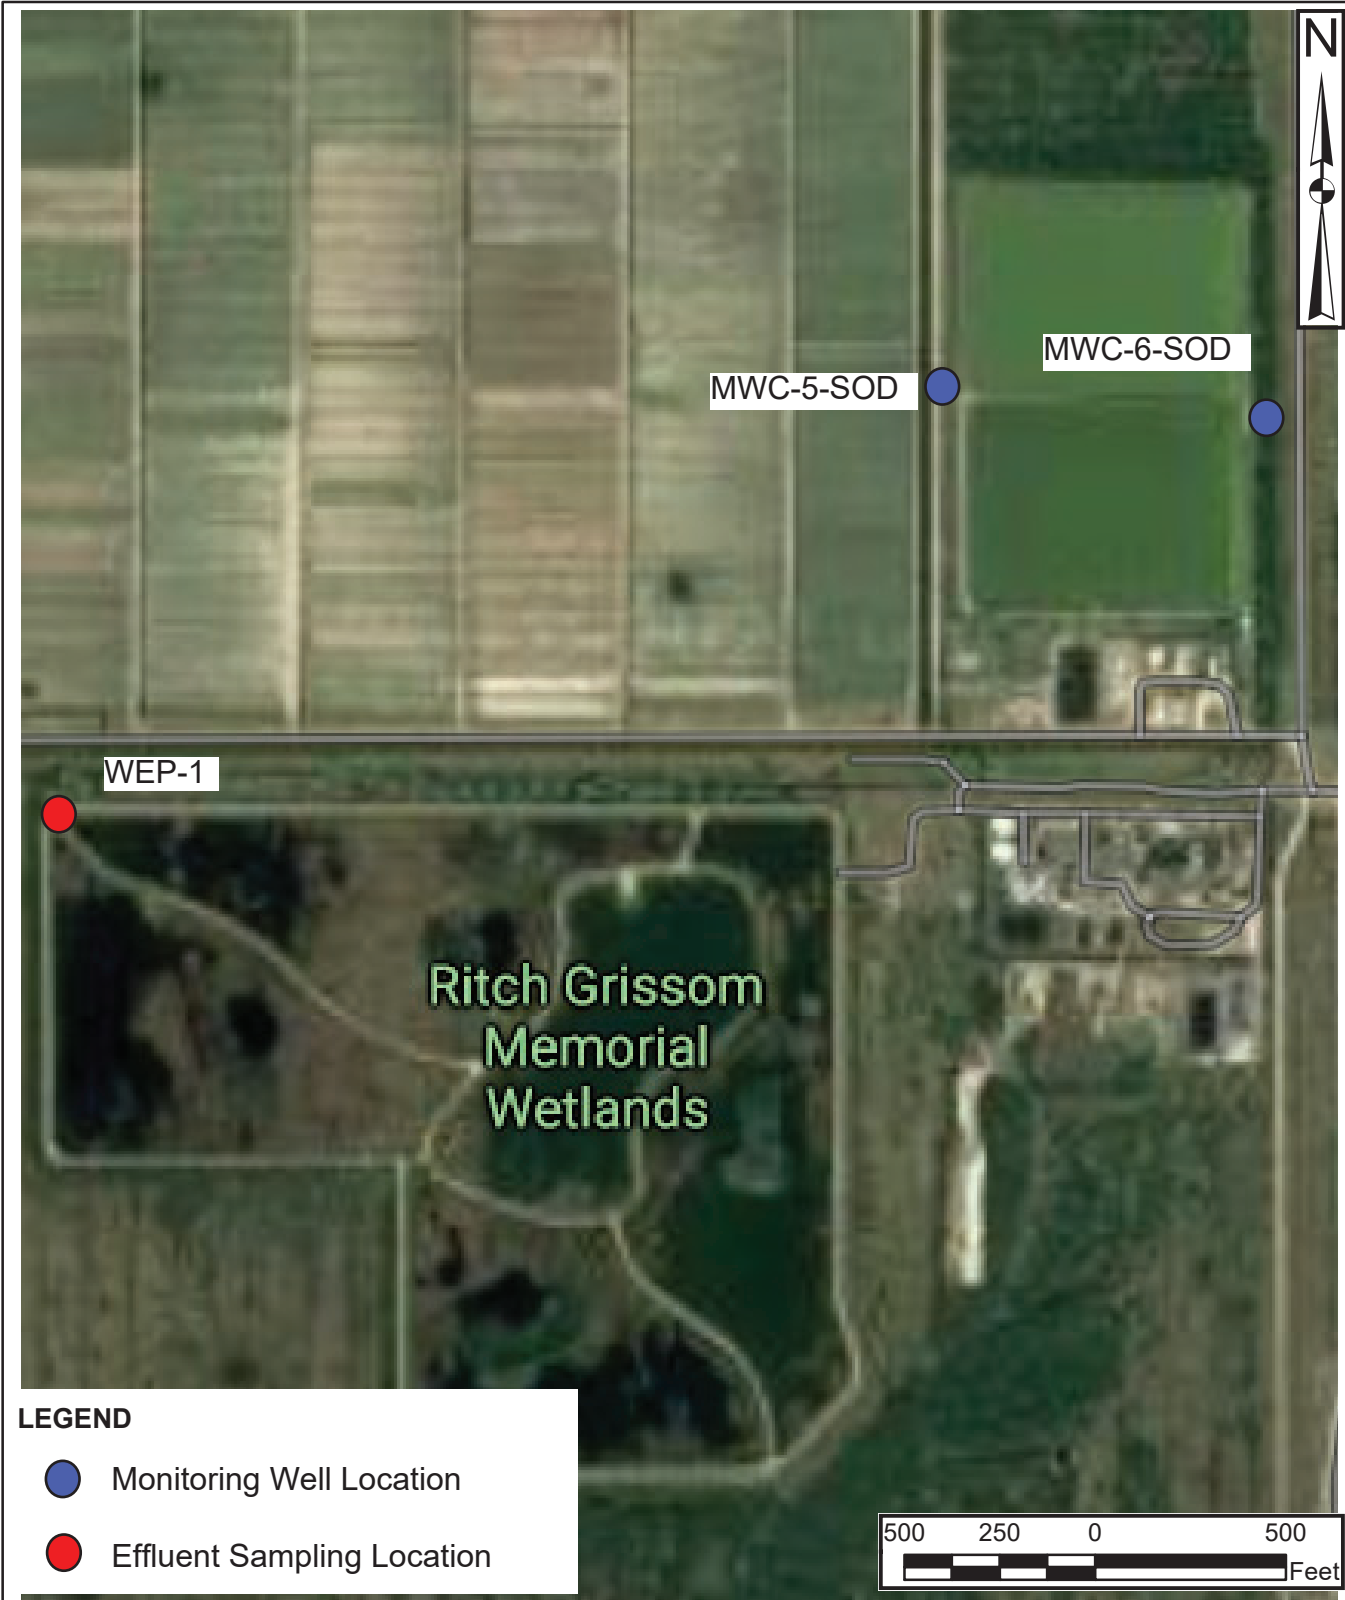
CONTRACT NUMBER	
100-WTR-T41397.01	
APPROVED BY	DATE
FIGURE NO.	
1

- Monitoring Well Location
- Effluent Sampling Location

The location of WEP-1 is provided on Figure 1. A summary of the analytical results compared to the historic analytical results collected since 2018 and the permit limits is provided in Table 1. Laboratory analytical results are provided in Attachment 1.

The monitoring well locations are provided on Figure 1. A summary of the groundwater analytical results compared to the historic analytical results collected since 2018 and the permit limits is provided in Table 2. Laboratory analytical results are provided in Attachment 1. Monitoring well sampling forms and calibration logs are provided as Attachment 2.

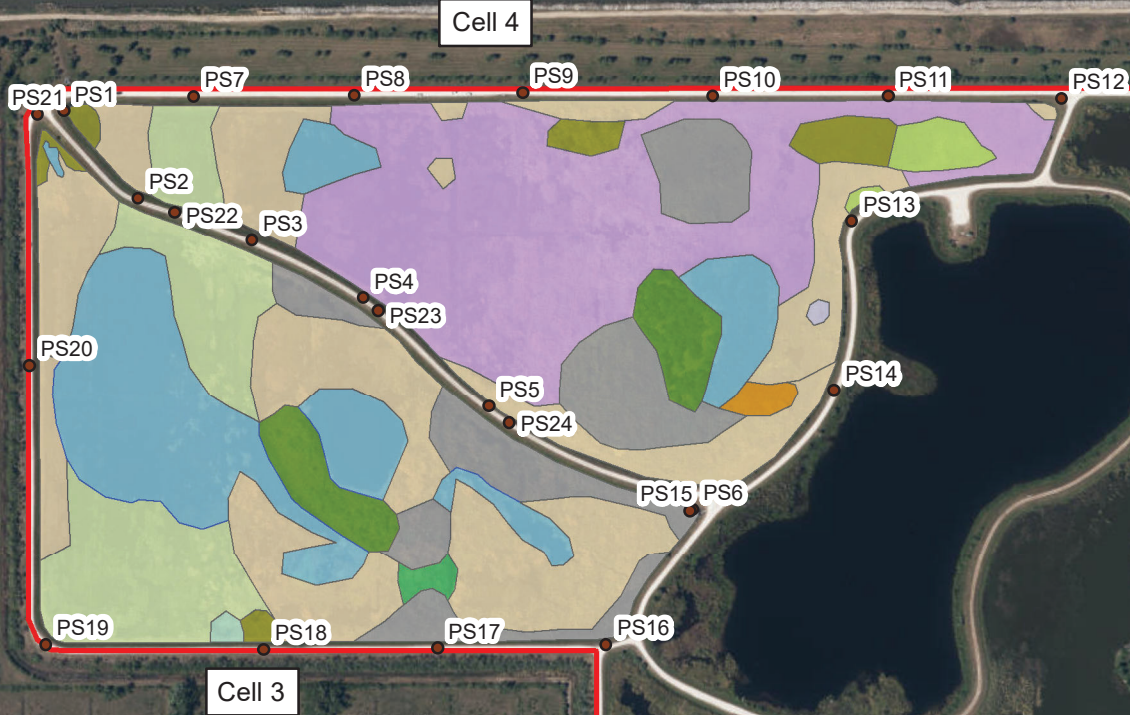
CONTRACT NUMBER	
100-WTR-T41397.01	
APPROVED BY	DATE
H. CAROLAN	5/18/2021
FIGURE NO. 2

- Dead Typha sp. (11.38%)
- Open Water (16.36%)
- Pontederia cordata (0.10%)
- Pontederia cordata and Typha sp. (0.48%)
- Sagittaria lancifolia (2.29%)
- Sagittaria/Typha/Pontederia (24.47%)
- Sagittaria and Pontederia (11.96%)
- Sagittaria and Salix caroliniana (0.44%)
- Scirpus validus (0.21%)
- Panicum repens (1.18%)
- Tree Island (4%)
- Typha sp. (27.14%)

Percent coverage and vegetative boundaries are an estimate based on limited ground truthing using the methods described in the Scope of Work.

The Dominant Vegetative Cover is provided as Figure 2, depicts the vegetative composition of the cells based on observations made during the biological walkdown. Cells 3 and 4 were observed from the bermed paths surrounding each of the cells. Twenty-four total photo stations were

established on the bermed perimeter of the collective cells and documented via GPS. Fourteen photo stations (Dominant Vegetative Cover Map, PS 1-14) were established at Cell 4 and ten (Dominant Vegetative Cover Map, PS 15-24) were established at Cell 3. A vegetative assessment was then conducted at each photo station to determine the approximate percent coverage of each species, contributing to the Dominant Vegetative Cover Figure enclosed with this memo. The dominant species observed included cattail (*Typha* sp.), duck potato, and pickerelweed. Cattail dominated both cells, with both living and dead plants observed. The dead cattail covered approximately 12% of Cell 3 and 11% of Cell 4. Mixed and monotypic stands of cattail were observed in Cell 4, whereas the cattails in Cell 3 were solely monotypic stands. The green algae-like species was determined to be filamentous algae, observed in mats in the areas of open water in both cells. The increased presence of algae is likely due to the decaying material produced by the dead cattails. One area (approximately 0.7 acres) of torpedo grass (*Panicum repens*) was observed in Cell 4. According to the Florida Exotic Pest Plant Council Invasive Plant List, torpedo grass is considered a Category I invasive species.

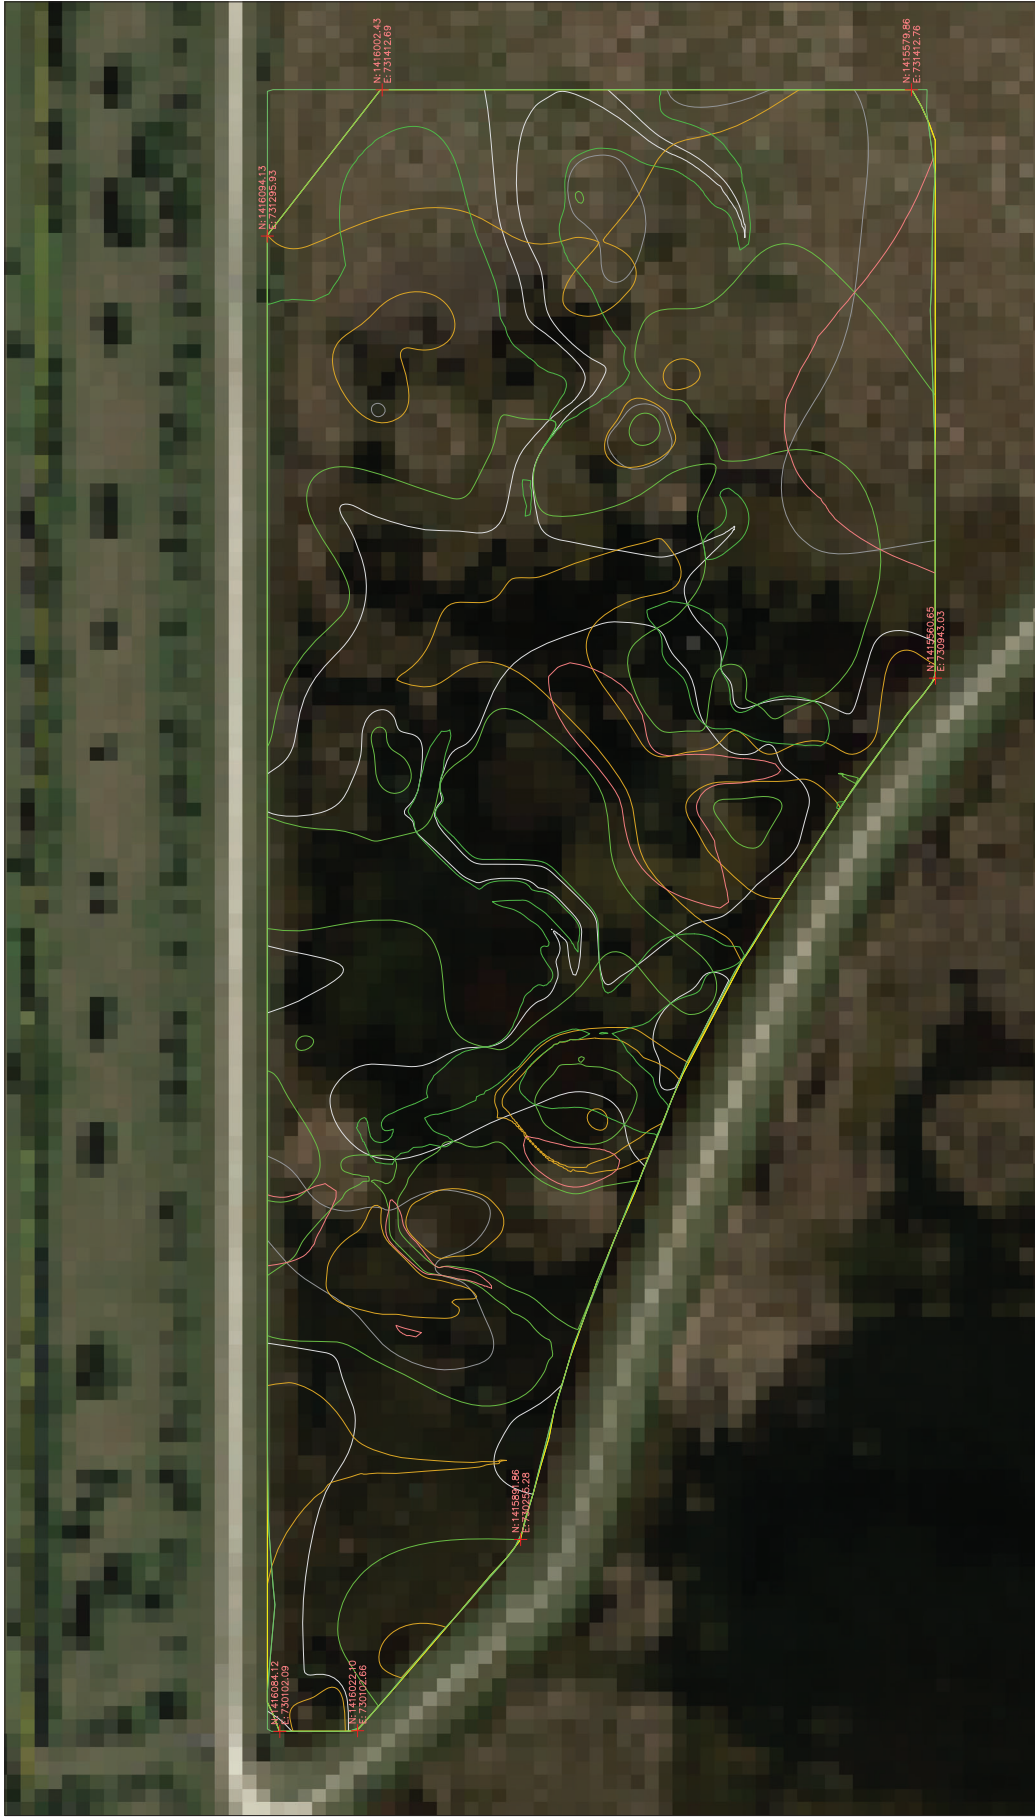
TOP MUCK CONTOURS OVERLAYED ON
HARD BOTTOM CONTOURS

Name	Cut Factor	Fill Factor	2d Area	Cut	Fill	Net
VOLUME	1.000	1.000	495757.79 Sq. Ft.	653.69 Cu. Yd.	7224.76 Cu. Yd.	6571.07 Cu. Yd. <Fill>
Totals			495757.79 Sq. Ft.	653.69 Cu. Yd.	7224.76 Cu. Yd.	6571.07 Cu. Yd. <Fill>

Data were collected from a total of 119 points in Cell 4. Muck thickness ranged from 0.05 to 1.4 feet thick, with an average thickness of 0.32 feet. An algal mat was apparent on the bottom in four locations and was not detectable with the probe. The presence of the algal mat could only be determined in areas where the water was relatively shallow and clear to identify the presence by sight. A summary of the survey data is provided in Table 3. The locations of the survey points, and maps summarizing the relative thickness of the muck are provided as Attachment 3. Based on the collected data, a total of 6,571 cubic yards of muck is present in the open water area in the western portion of Cell 4.

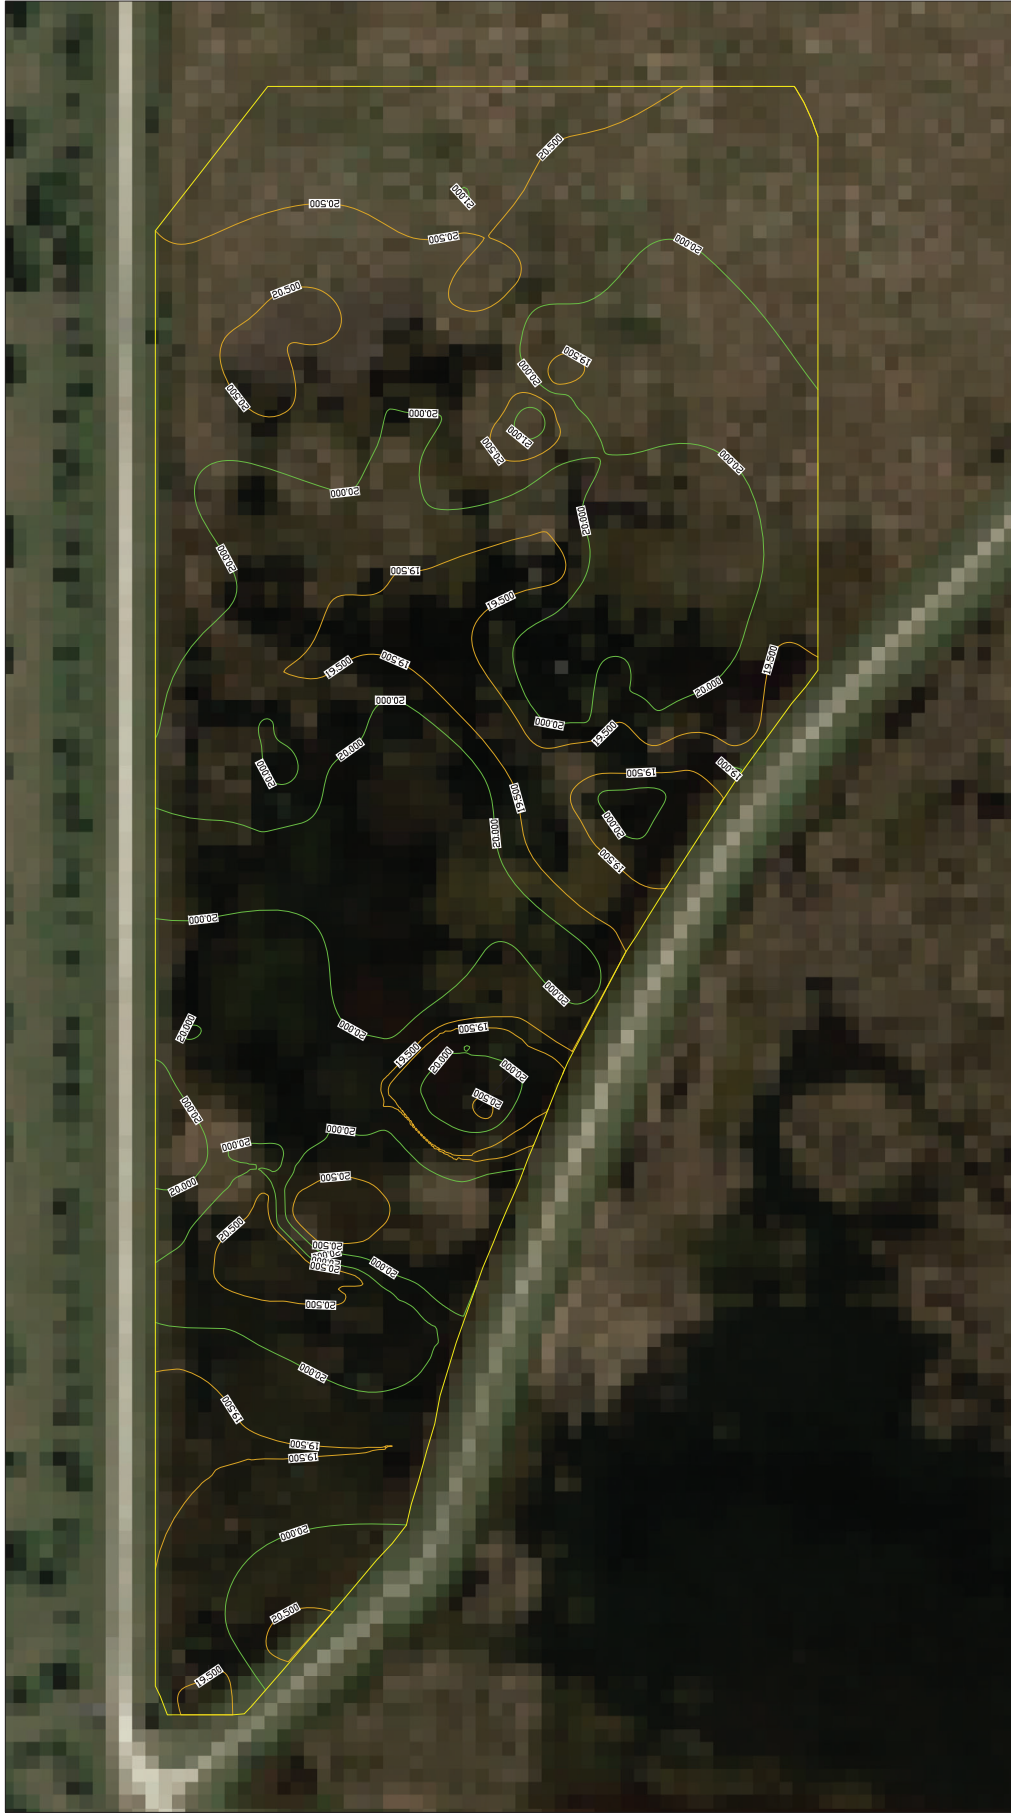
HARD BOTTOM CONTOUR MAP IN FEET
(NAVD88)

NOTE: MUCK PROBE SURVEY
PERFORMED BY OCEANSIDE
SOLUTIONS LLC ON 27, APRIL
2021

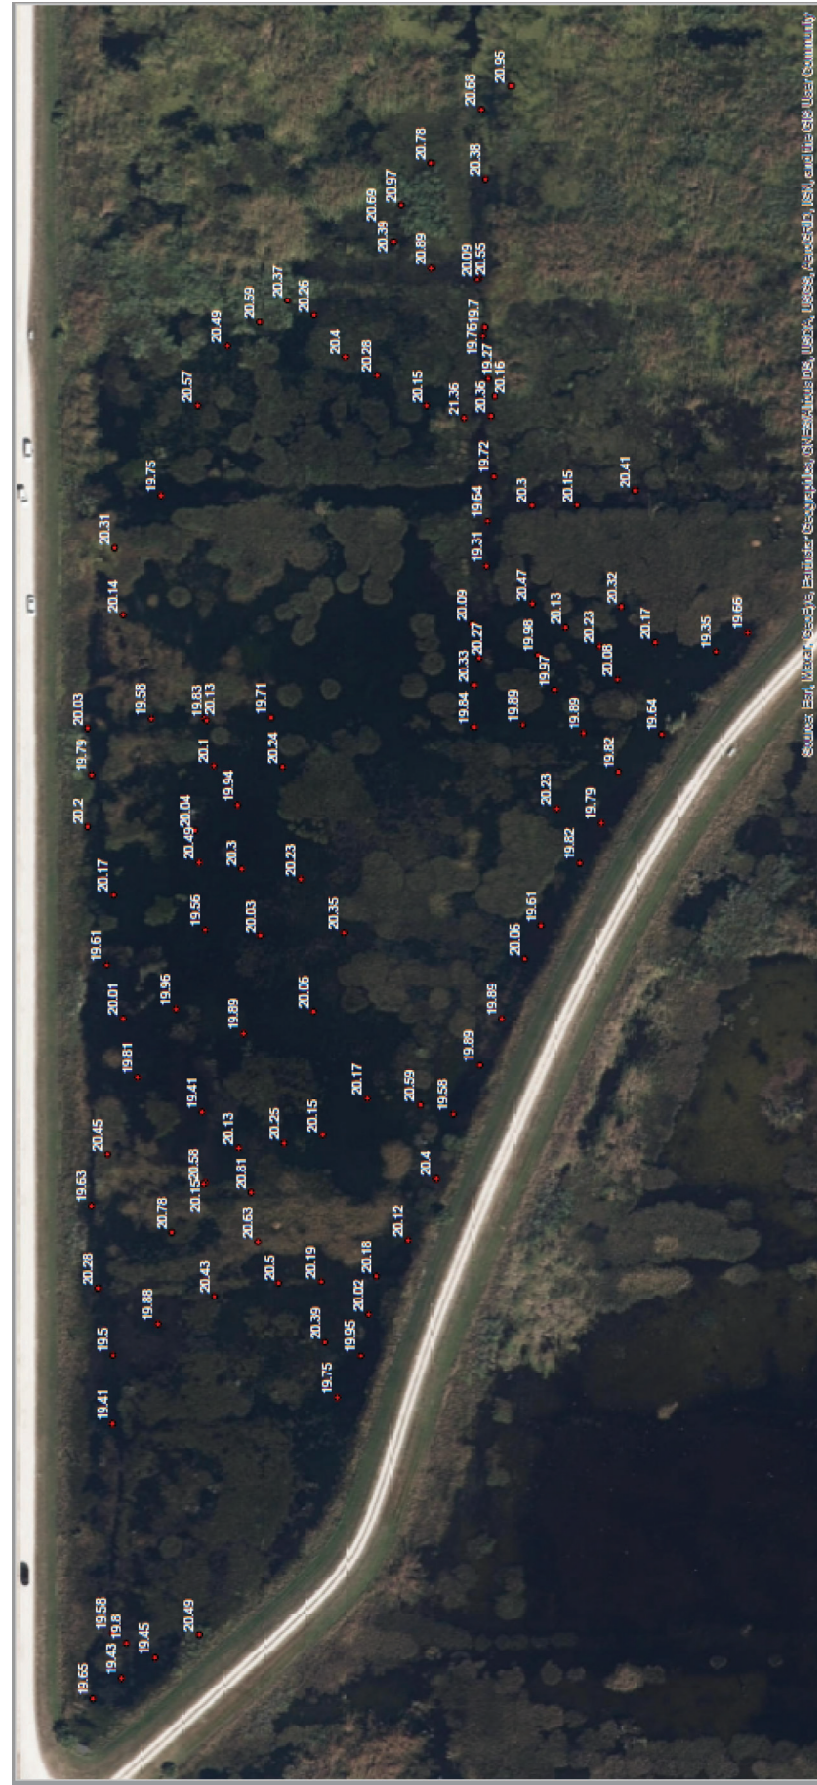
HARD BOTTOM POINT ELEVATIONS IN FEET
(NAVD88)

NOTE: MUCK PROBE SURVEY
PERFORMED BY OCEANSIDE
SOLUTIONS LLC ON 27, APRIL 2021

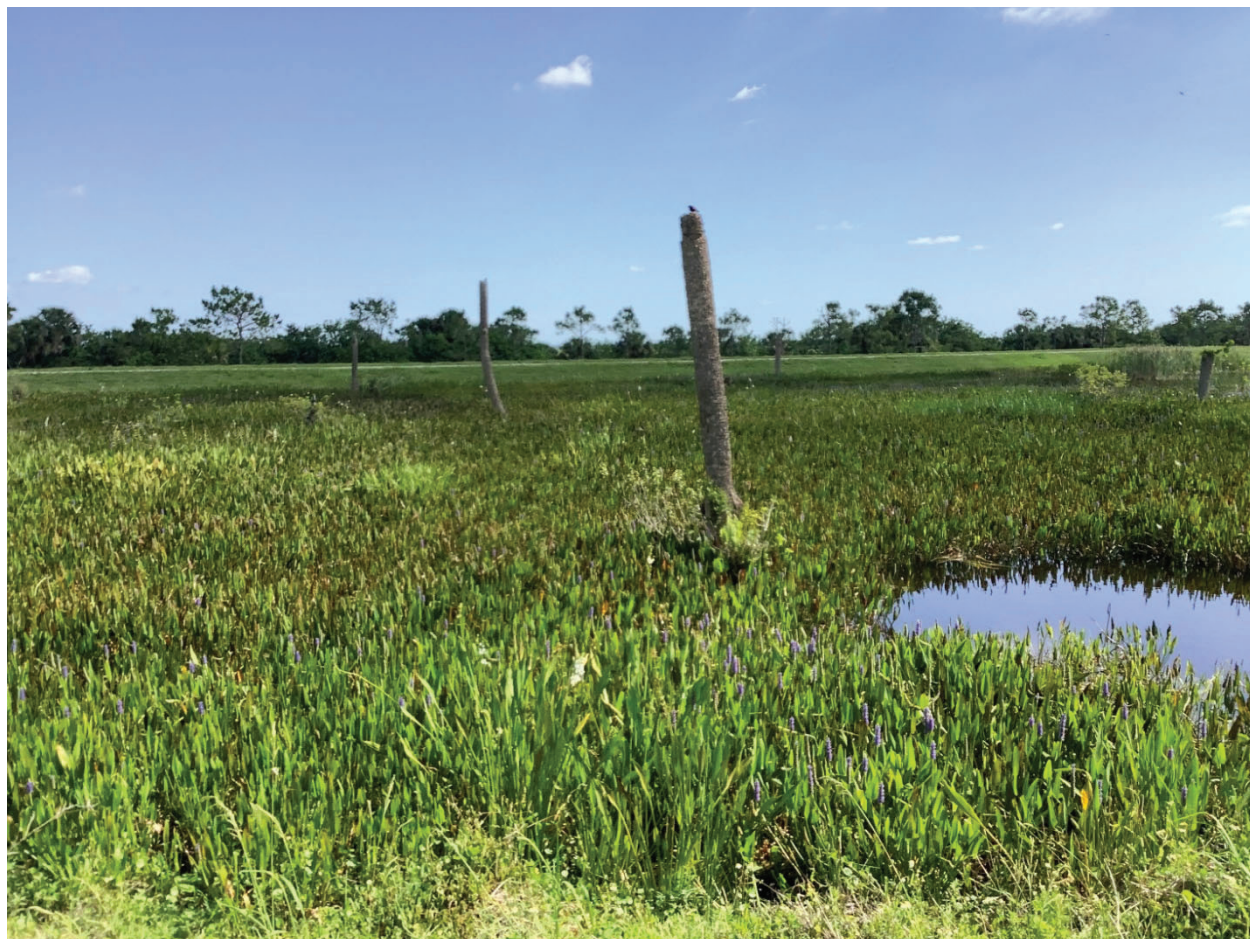
Pickerelweed and duck potato in equal distribution at Cell 4, Photo Station 2; facing north.

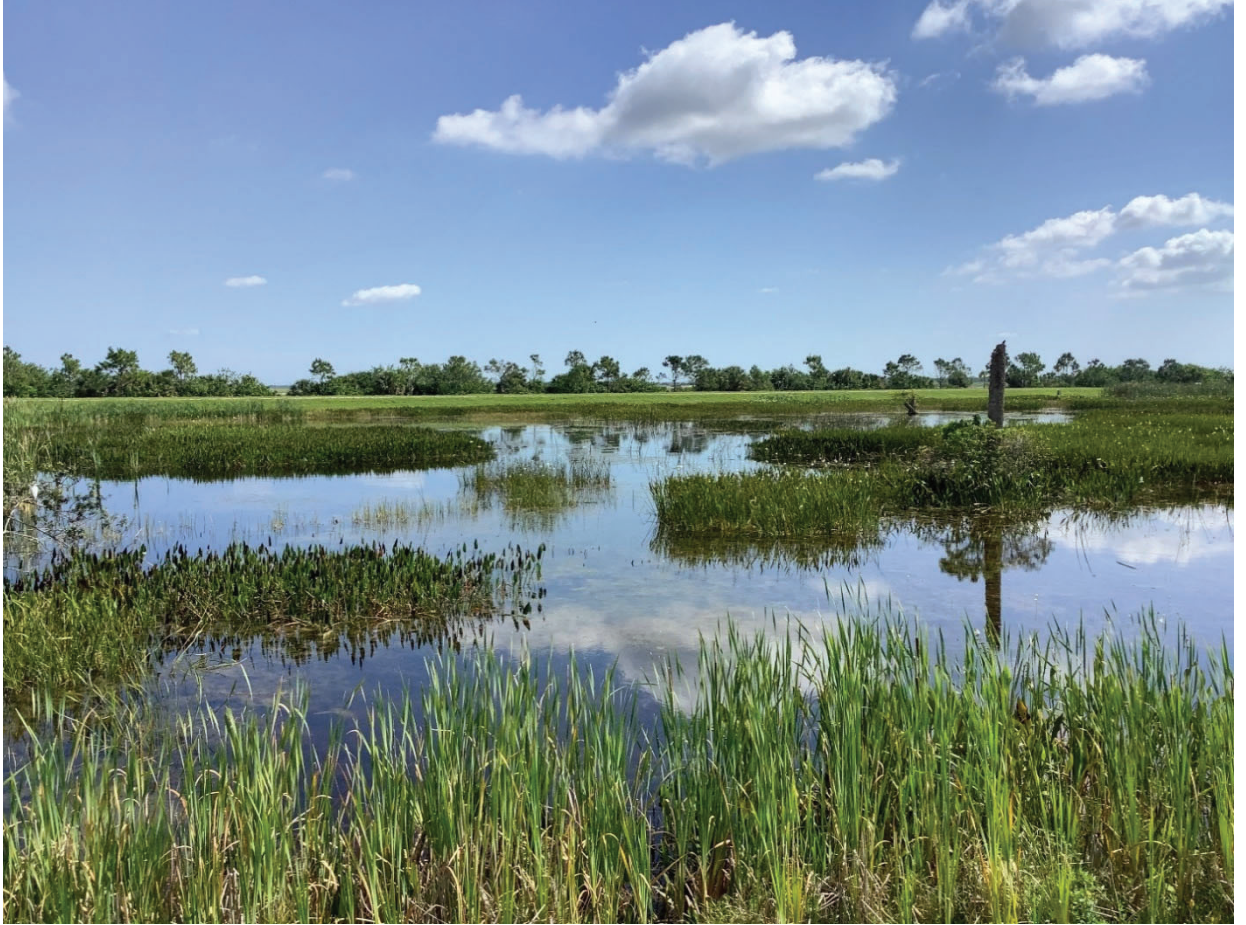
Open water and algal mats at Cell 4, Photo Station 3; facing northwest.

- Adopt a mechanical removal plan for excess filamentous algae, cattails, dead vegetation, and underlying organic material. This may include cutting of plant material and should include removal and disposal of all cut or observed floating or sinking detritus;

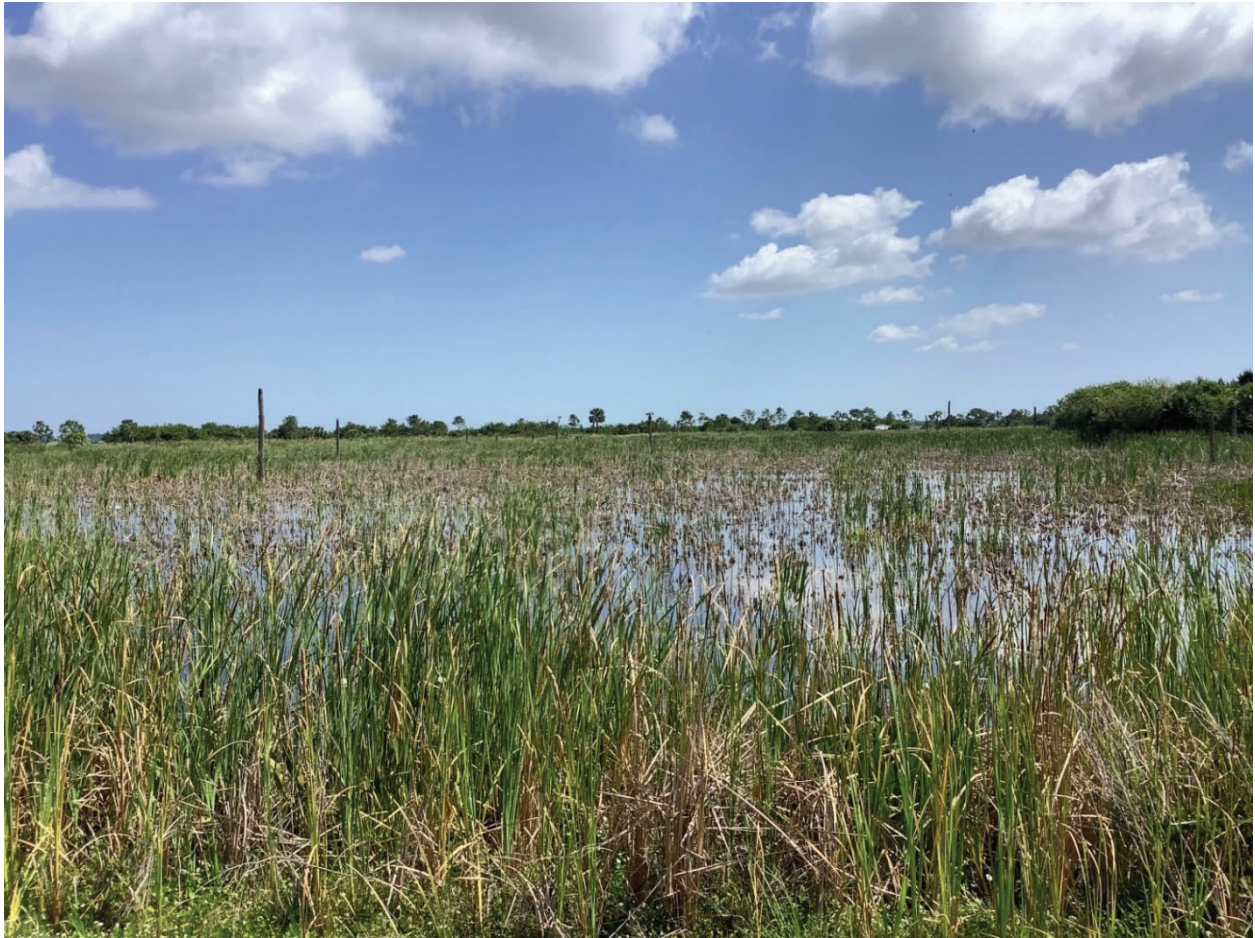
The assumption entering the project was the spraying of the cattails and leaving them in the system to decay was the root cause of the effluent water quality exceedances at WEP-1. The spray event occurred on May 11, 2020.

Living and dead cattails (from the spraying event) at Cell 4, Photo Station 5; facing northwest.

- Cease spraying of herbicide on cattail stands;
- Remove dead, decaying cattail stands;
- Herbicide spray monotypic areas of torpedo grass, allow to die back, then remove dead vegetation and underlying organic material;

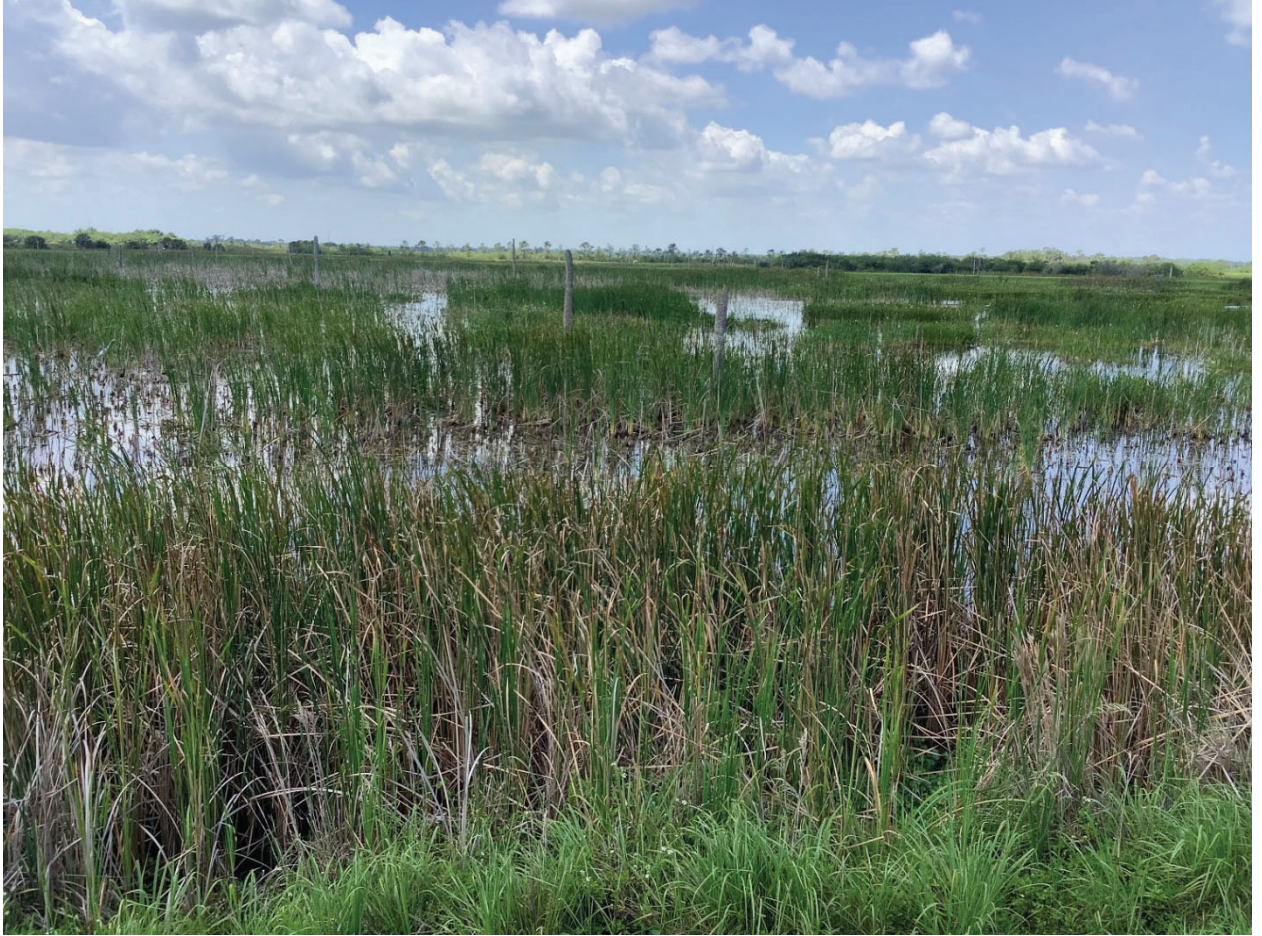
Living and dead cattails (from the spraying event) at Cell 4, Photo Station 9;
facing south.

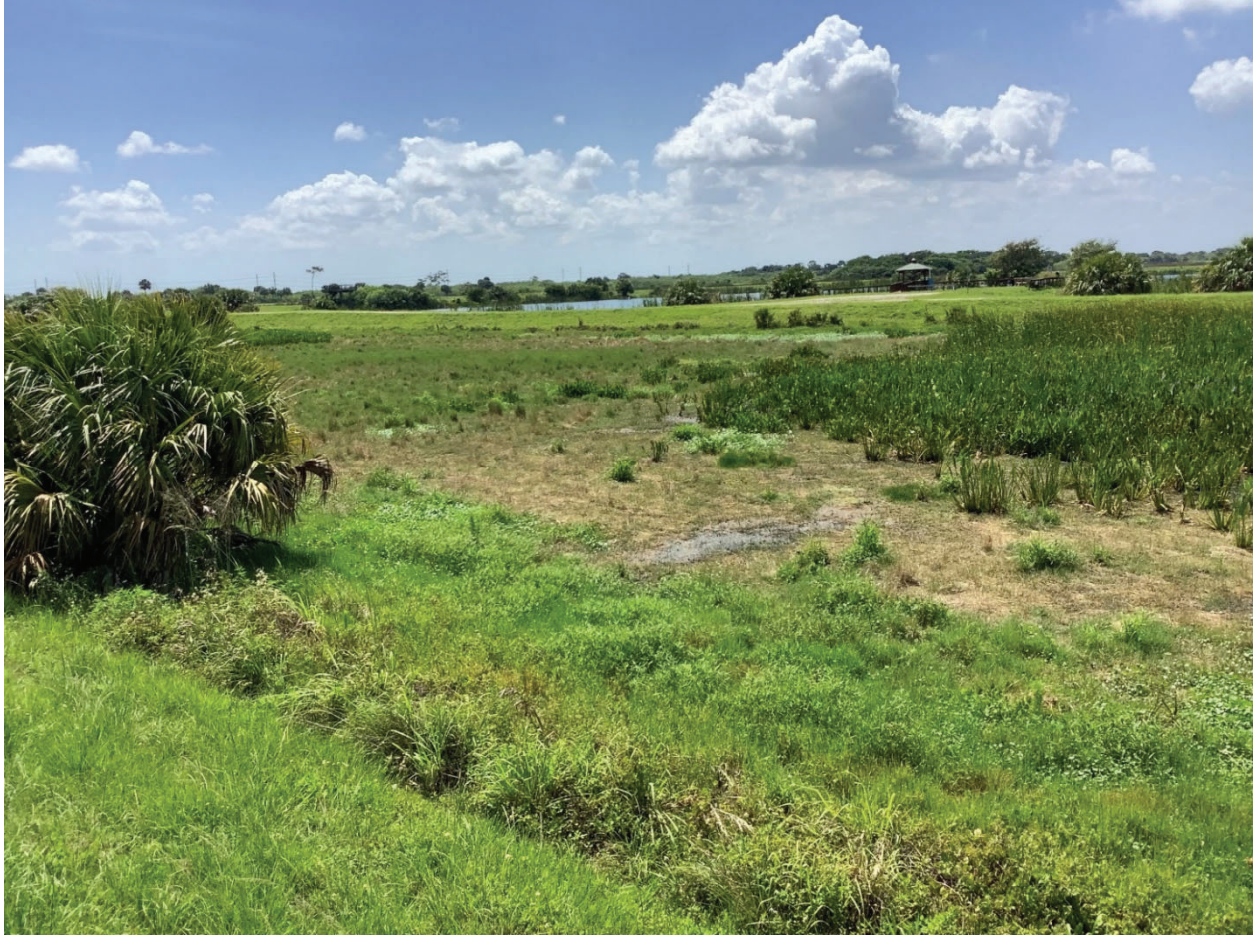
Invasive torpedo grass at Cell 4, Photo Station 11; facing south.

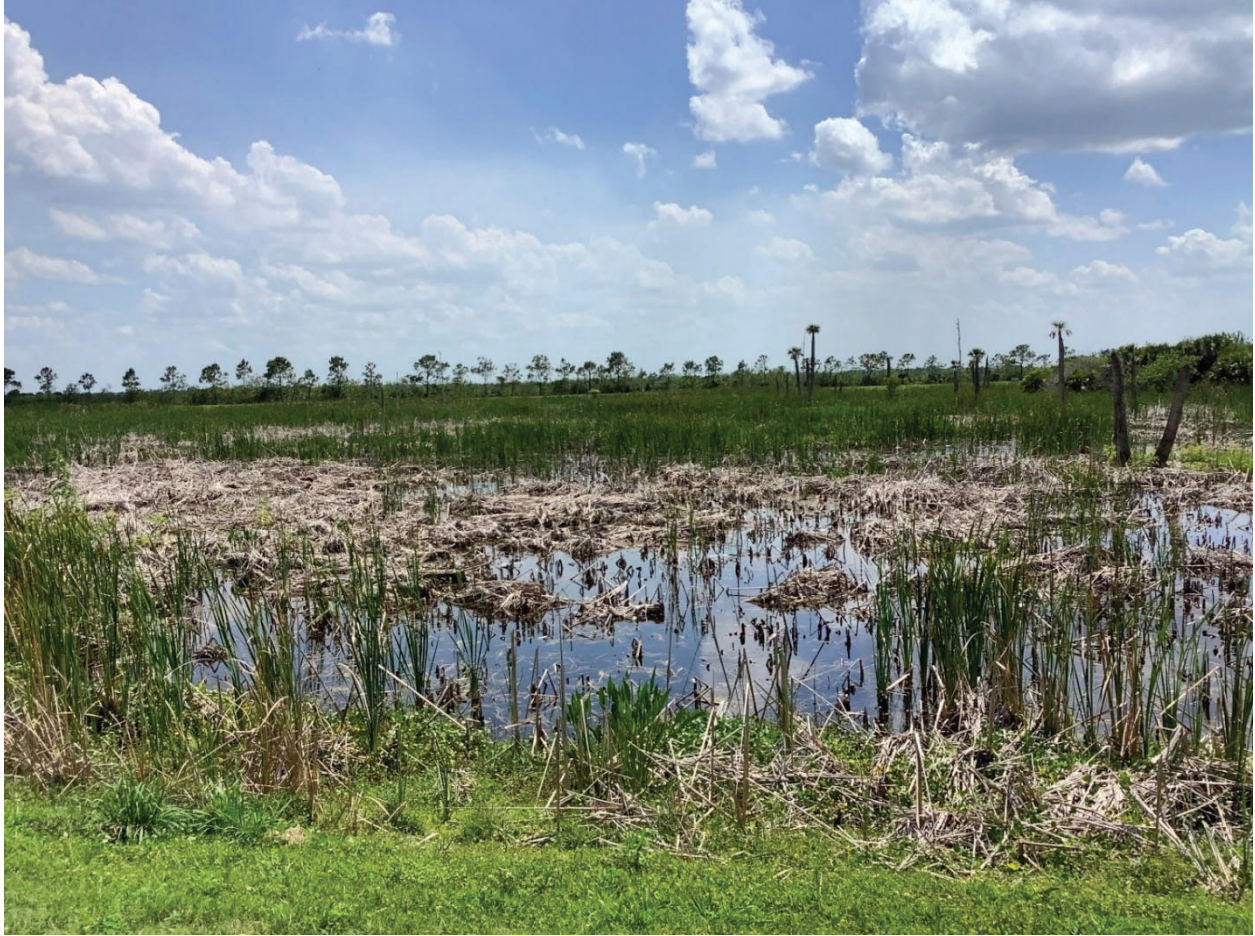
Dead and decaying cattails at Cell 3, Photo Station 24; facing south.
