## PELICAN CREEK OUTFALL/OLD CAUSEWAY OUTFALL

March 8, 2023

BREVARD COUNTY ROAD AND BRIDGE OUTFALL MAINTENANCE TIMELINE

## PELICAN CREEK OUTFALL/OLD CAUSEWAY OUTFALL MULCHING

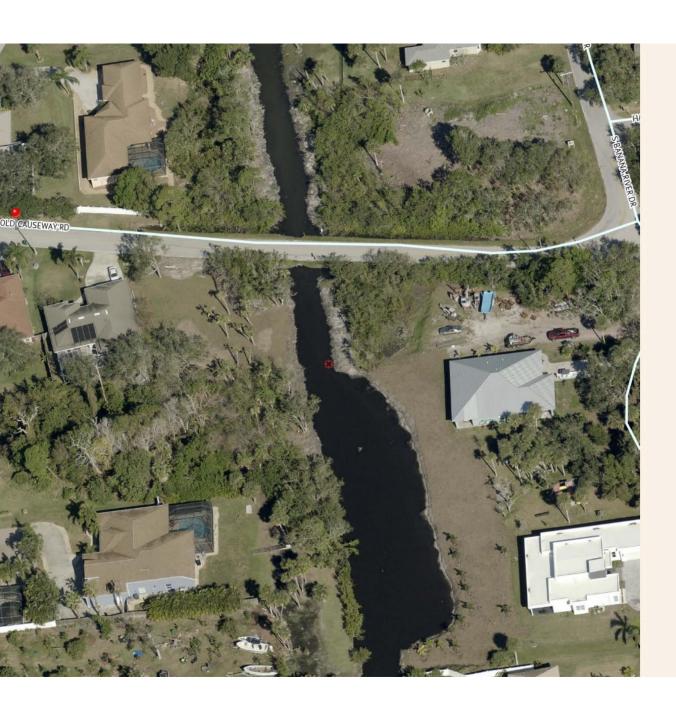
## AERIAL PHOTO OF PELICAN CREEK OUTFALL (YELLOW) AND OLD CAUSEWAY OUTFALL (ORANGE) PRIOR TO PUBLIC WORKS MAINTENANCE ACTIVITY.

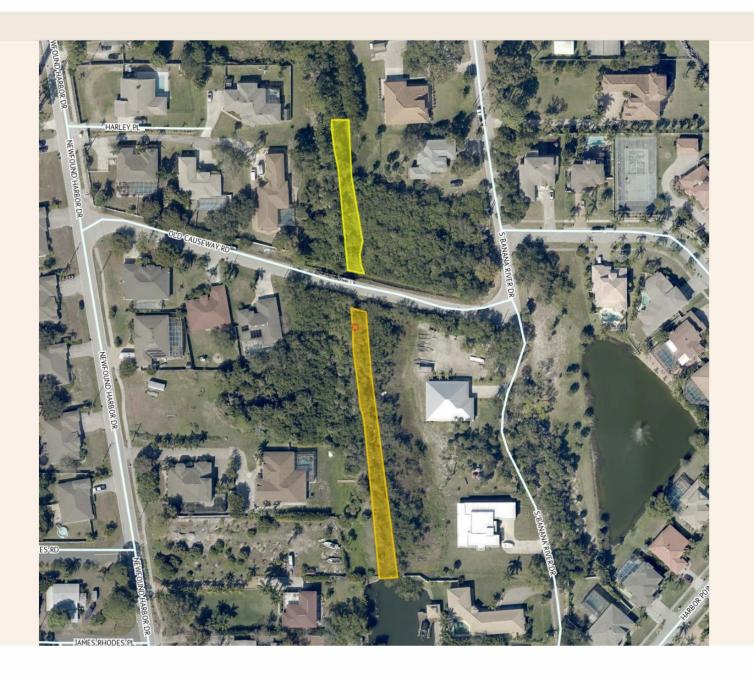
AERIAL PHOTO OF PELICAN CREEK
OUTFALL (YELLOW) AND OLD
CAUSEWAY OUTFALL (ORANGE)
AFTER PUBLIC WORKS
MAINTENANCE ACTIVITY AND
HOMEOWNER EXCAVATION OF OLD
CAUSEWAY OUTFALL.

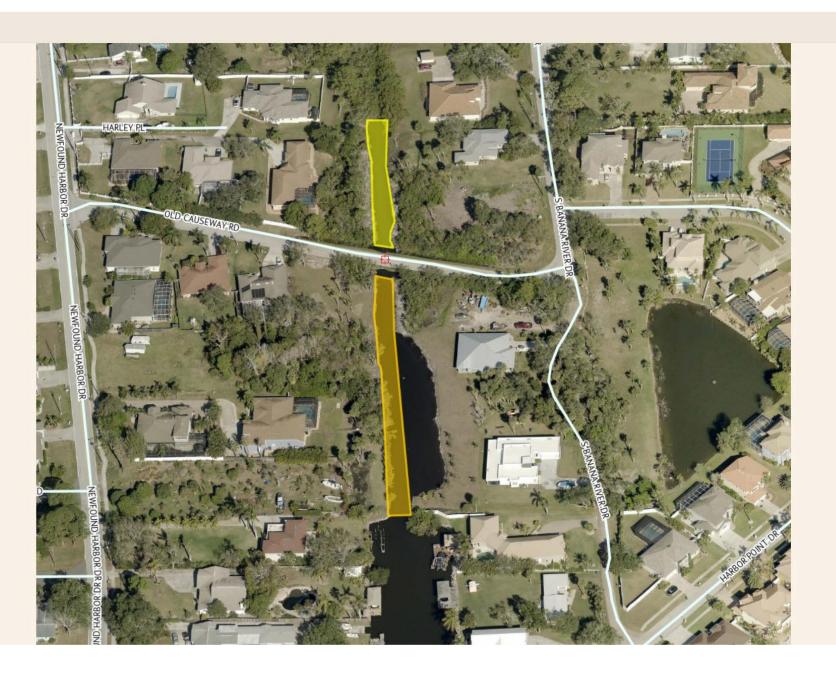
OLD CAUSEWAY RD LOOKING NORTH AT PELICAN CREEK OUTFALL (YELLOW) COUNTY'S MAINTENANCE ACTIVITY INCLUDED REMOVAL OF MULCHED VEGETATION AND APPROXIMATELY TWO (2) INCHES OF MUCK FROM THE OUTFALL AND LAID ON THE TOP OF BANK. OUTFALL CLEANING TAPERED OFF TO THE NORTH WITH MINIMAL SPOIL ON BANKS.

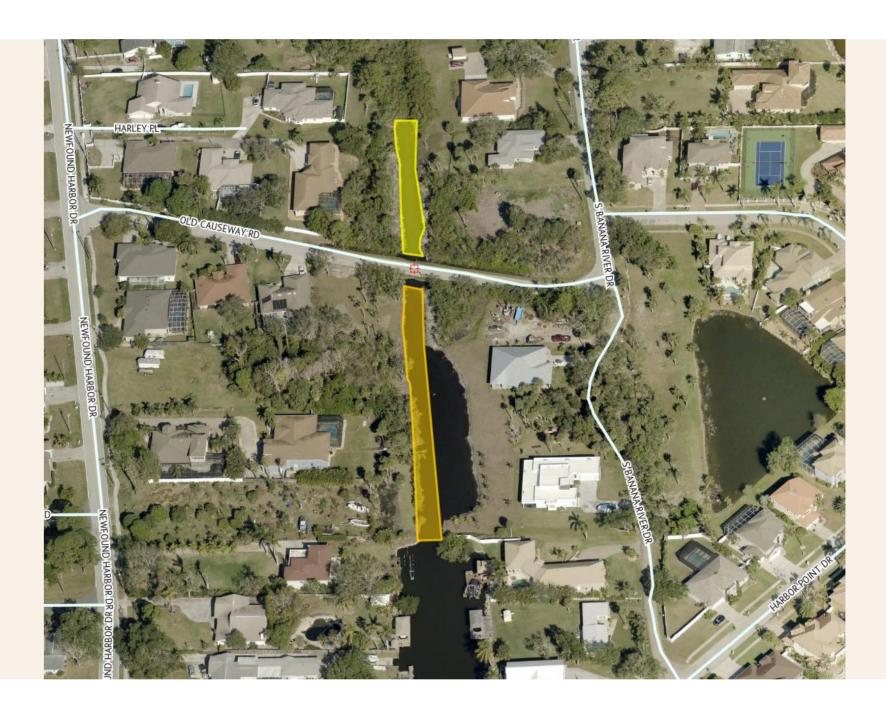
OLD CAUSEWAY RD LOOKING SOUTH AT OLD CAUSEWAY OUTFALL (ORANGE) NOTE: COUNTY'S MAINTENANCE ACTIVITY INCLUDED THE REMOVAL OF MULCHED VEGETATION AND ABOUT SIX (6) TO EIGHT (8) INCHES OF MUCK AT THE PIPE CROSSING, THEN TAPERING DOWN TO ABOUT 2 INCHES OF MUCK AT THE SOUTH PROJECT LIMITS. REMNANTS OF THE DEBRIS REMOVAL CAN BE SEEN ON THE LEFT (EAST) SIDE OF THE PHOTO FOR A SHORT DISTANCE DUE TO THE PROPERTY OWNER DREDGING ACTIVITY. TO THE RIGHT (WEST), THE PROPERTY OWNER INSTALLED SOD. TO THE SOUTHEAST, THE PROPERTY OWNER HIRED A CONTRACTOR TO DO SIGNIFICANT DREDGING AND EXCAVATION OF THE OUTFALL.

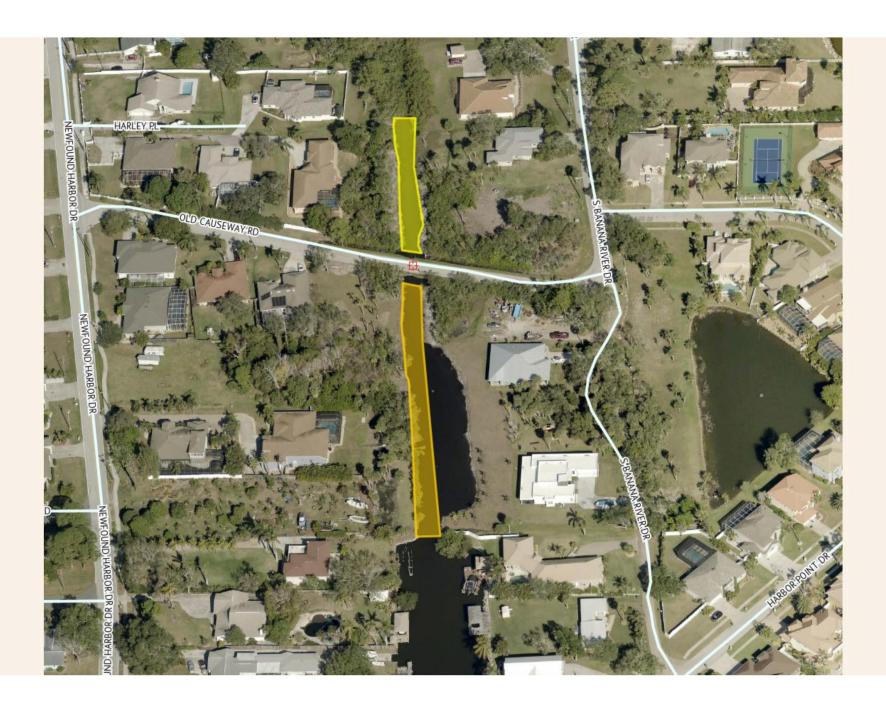
OLD CAUSEWAY OUTFALL LOOKING SOUTH AFTER PROPERTY OWNER STARTED HIS DREDGING-EXCAVATION OPERATION OUTSIDE THE WIDTH OF THE ORIGINAL OUTFALL.

OLD CAUSEWAY OUTFALL LOOKING SOUTH NEAR THE PROPERTY OWNER'S DREDGING-EXCAVATION OPERATION.

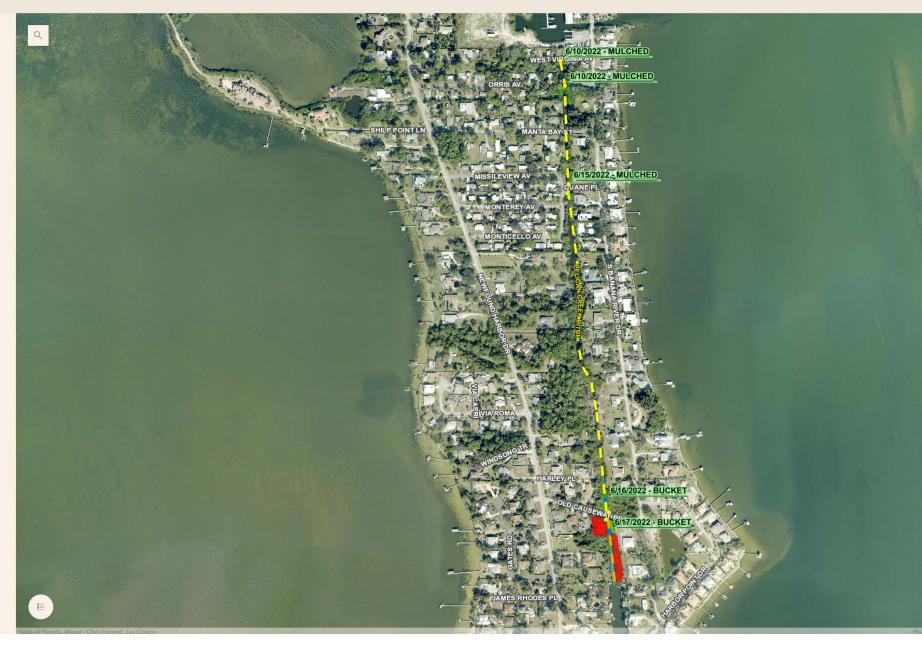
- THE OPERATOR STARTED DRAINAGE MAINTENANCE ON THE
- NORTH SIDE OF OLD CAUSEWAY RD WITH THE KAISER (WALKING
- EXCAVATOR) (SEE PHOTO BELOW).

WALKING EXCAVATOR WITH MULCHING ATTACHMENT (KAISER)

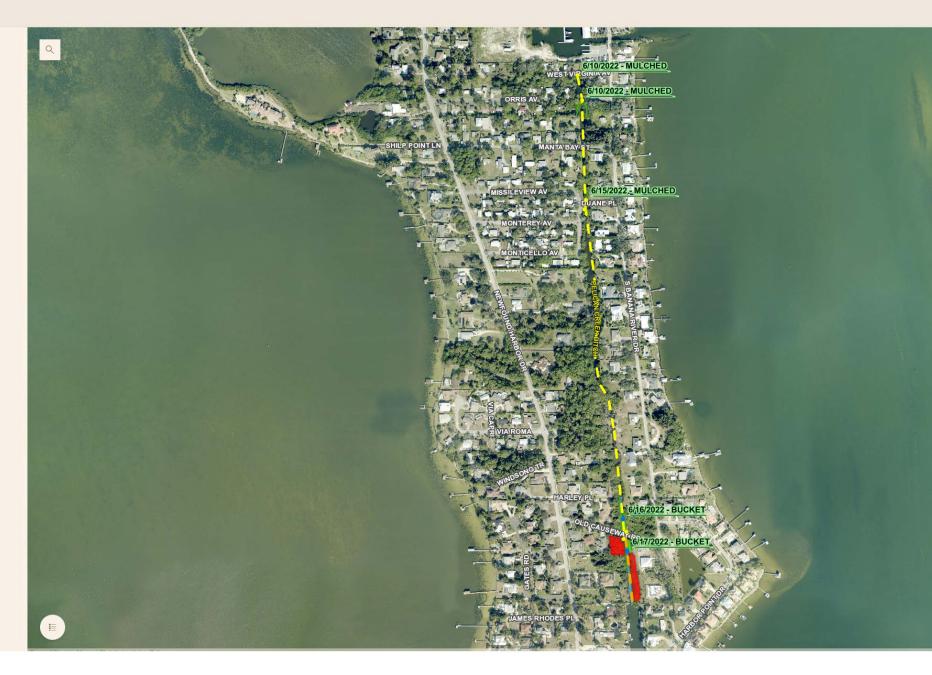
THURSDAY 6/9/22 - KAISER ENTERED PELICAN CREEK OUTFALL NORTH OF OLD CAUSEWAY RD. REMOVED VEGETATION INSIDE OUTFALL AND STOPPED 240'± NORTH OF OLD CAUSEWAY RD. ALSO MULCHED 10' ± ALONG THE EAST AND WEST BANK WITHIN THE 240'. MAINTENANCE ACTIVITY TAPERED OFF TO THE NORTH WITH MINIMAL SPOIL DEPOSITS ON THE BANK.

OLD CAUSEWAY RD - PELICAN CREEK OUTFALL LOOKING NORTH BEFORE MAINTENANCE - UNKNOWN DATE

OLD CAUSEWAY RD - PELICAN CREEK OUTFALL LOOKING NORTH DURING MAINTENANCE (JUNE 2022). ACTIVITY TAPERED TO THE NORTH WITH MINIMAL SPOIL DEPOSITS ON THE BANK

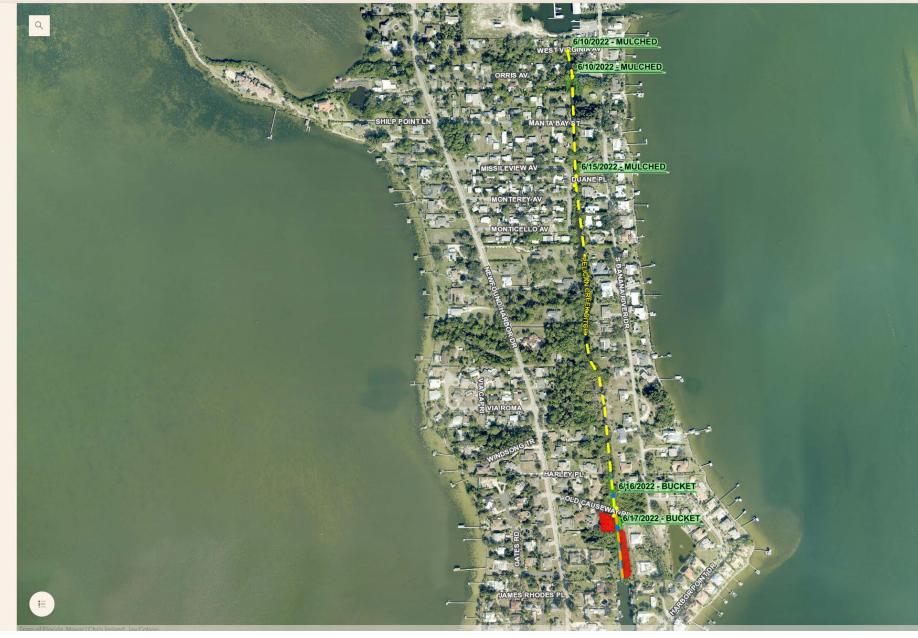
FRIDAY 6/10/22 THE KAISER ENTERED AT WEST VIRGINIA AVE HEADING SOUTH AND MULCHED ABOUT 25' ON THE EAST, NORTH, AND WEST SIDE OF PELICAN CREEK OUTFALL - VERY LIMITED TRIMMING AS CAN BE SEEN IN THE PICTURE BELOW.

WEST VIRGINIA AVE PELICAN CREEK OUTFALL LOOKING SOUTH

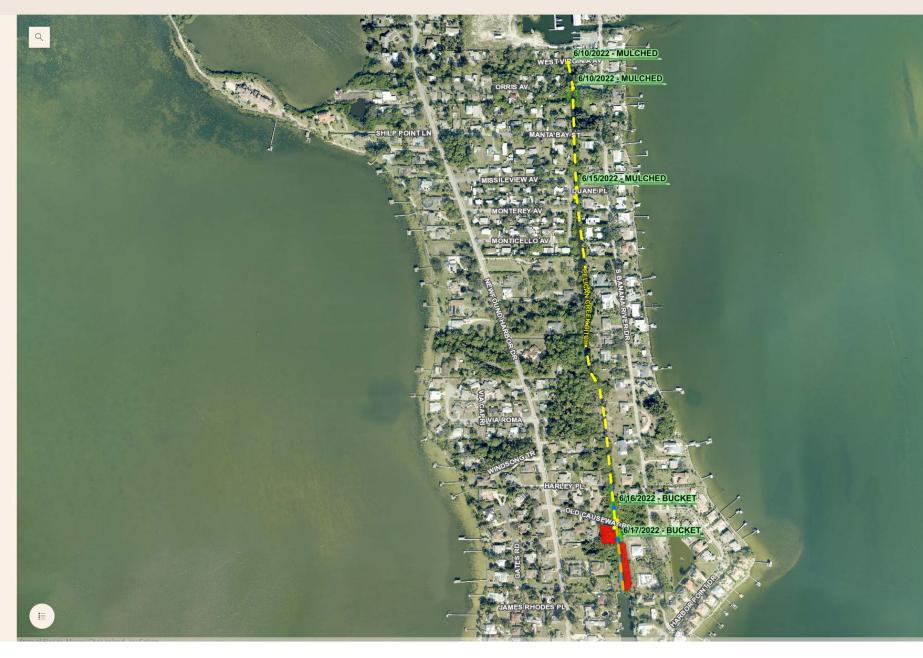
FRIDAY 6/10/22 - KAISER ENTERED AT ORRIS AVE AND
PERFORMED LIMITED MULCHING OF VEGETATION ALONG EAST
AND WEST BANK - VERY LIMITED TRIMMING AS CAN BE SEEN IN
THE PICTURE BELOW

PELICAN CREEK OUTFALL LOOKING SOUTH FROM ORRIS AVE

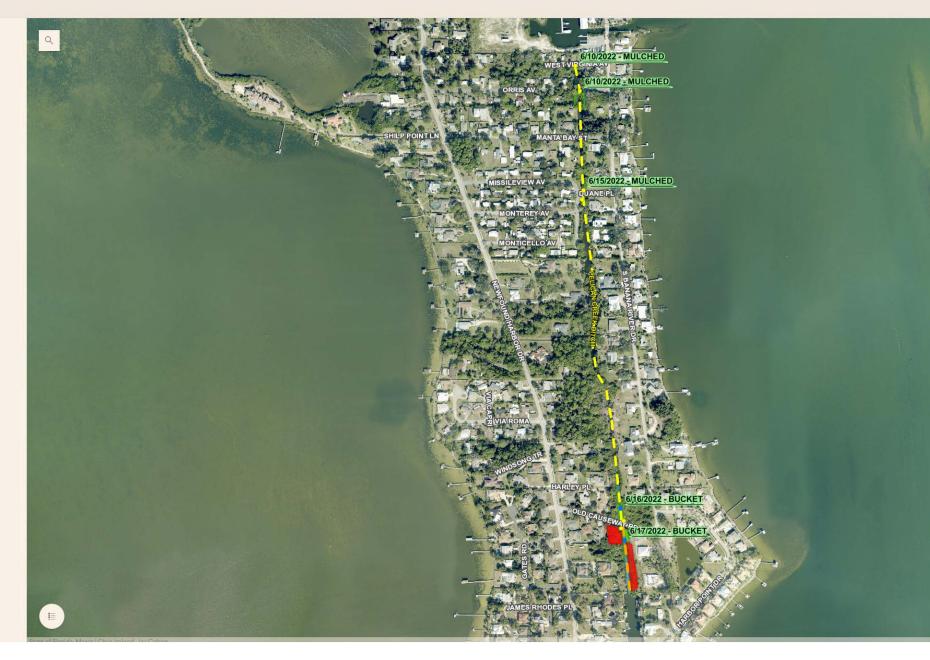
TUESDAY 6/14/22 - FPL RAISED THE POWERLINES AND KAISER ENTERED THE OLD CAUSEWAY OUTFALL AND MULCHED VEGETATION INSIDE THE OUTFALL FROM OLD CAUSEWAY RD, SOUTH 400'±. ALSO MULCHED 10' ± ALONG THE EAST AND WEST BANK. REMOVAL OF MULCHED VEGETATION INSIDE THE OUTFALL AND APPROXIMATELY TWO (2) INCHES OF MUCK WERE LAID ON THE TOP OF THE BANK

- OLD CAUSEWAY RD OLD CAUSEWAY OUTFALL LOOKING SOUTH BEFORE
- MAINTENANCE ACTIVITY UNKNOWN DATE

OLD CAUSEWAY RD - OLD CAUSEWAY OUTFALL LOOKING SOUTH (JUNE 2022)

COUNTY MAINTENANCE ACTIVITY INCLUDED MULCHED VEGETATION INSIDE THE OUTFALL FROM OLD CAUSEWAY RD, SOUTH 400'±. ALSO MULCHED 10' ± ALONG THE EAST AND WEST BANK. REMOVAL OF MULCHED VEGETATION INSIDE THE OUTFALL AND APPROXIMATELY TWO (2) INCHES OF MUCK WERE LAID ON THE TOP OF THE BANK

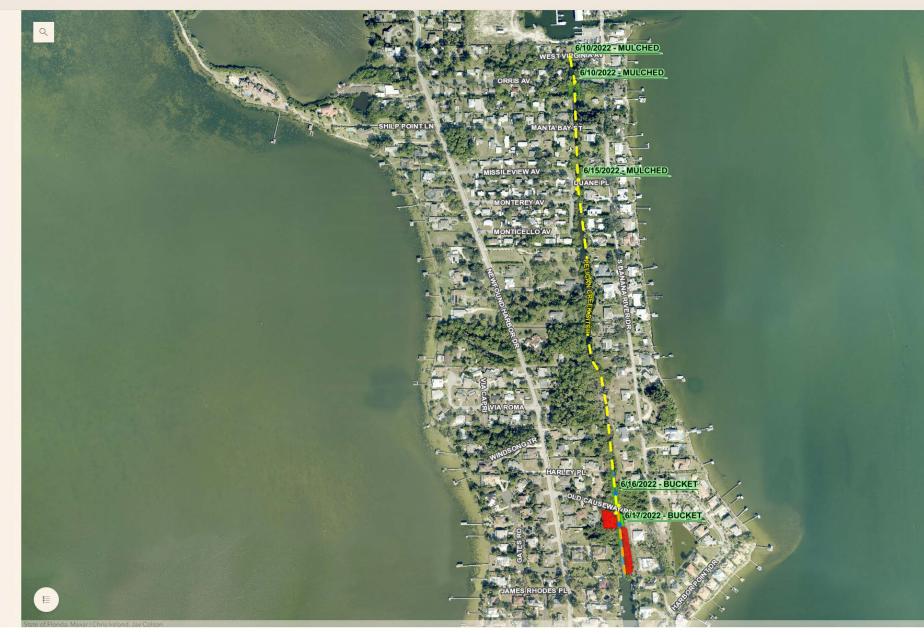
WEDNESDAY 6/15/22- KAISER ENTERS DUANE PLACE HEADING NORTH 40'±. OPERATOR MULCHED VEGETATION FROM PELICAN CREEK OUTFALL - VERY LIMITED TRIMMING AS CAN BE SEEN IN THE PICTURE BELOW

PELICAN CREEK DITCH LOOKING NORTH FROM DUANE PL

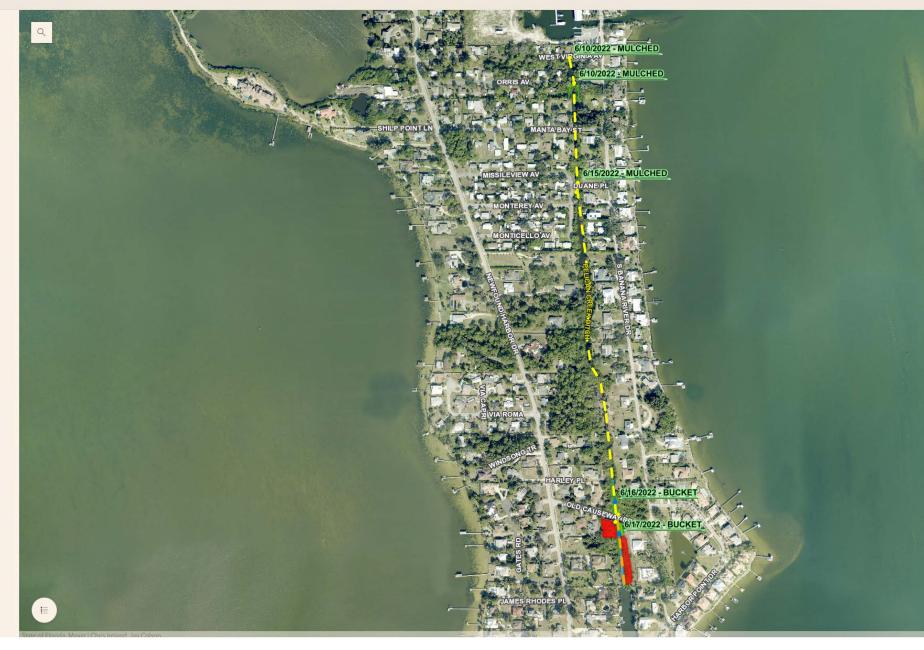
WEDNESDAY 6/15/22- KAISER ENTERS DUANE PLACE HEADING SOUTH 24'±. OPERATOR MULCHED VEGETATION FROM PELICAN CREEK OUTFALL - VERY LIMITED TRIMMING AS CAN BE SEEN IN THE PICTURE BELOW. DUE TO OUTFALL DEPTH, THE OPERATION COULD NOT CONTINUE ANY FURTHER SOUTH.

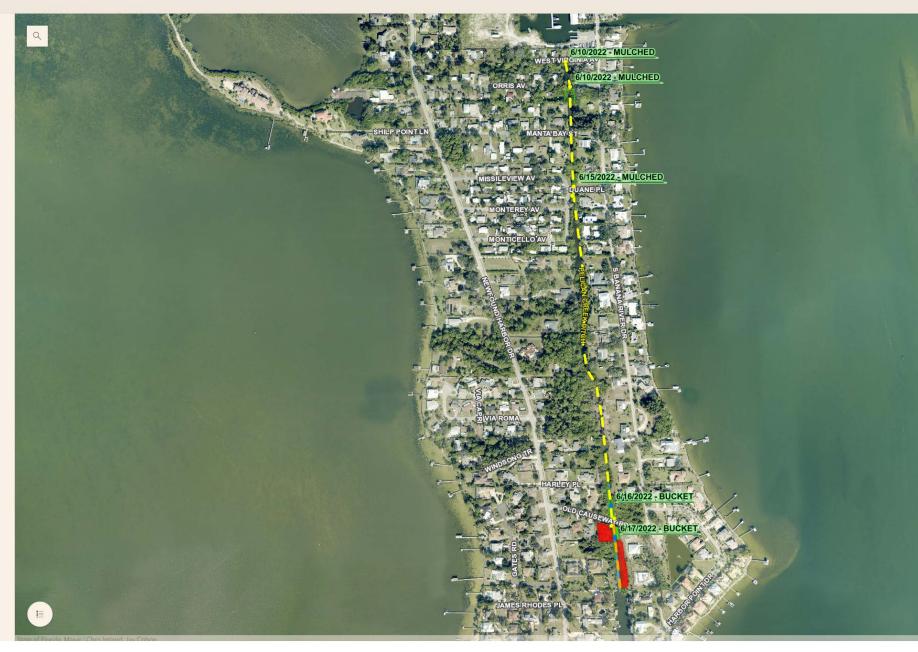
PELICAN CREEK OUTFALL LOOKING NORTH FROM OLD CAUSEWAY RD

6/17/22 - KAISER RE-ENTERED AT OLD CAUSEWAY ROAD HEADING SOUTH AND REMOVING VEGETATION PREVIOUSLY MULCHED INSIDE OLD CAUSEWAY OUTFALL.

OLD CAUSEWAY OUTFALL LOOKING SOUTH (AUGUST 2022) NEW SOD HAS BEEN INSTALLED AND BOAT DECK CONSTRUCTED BY THE PROPERTY OWNER.

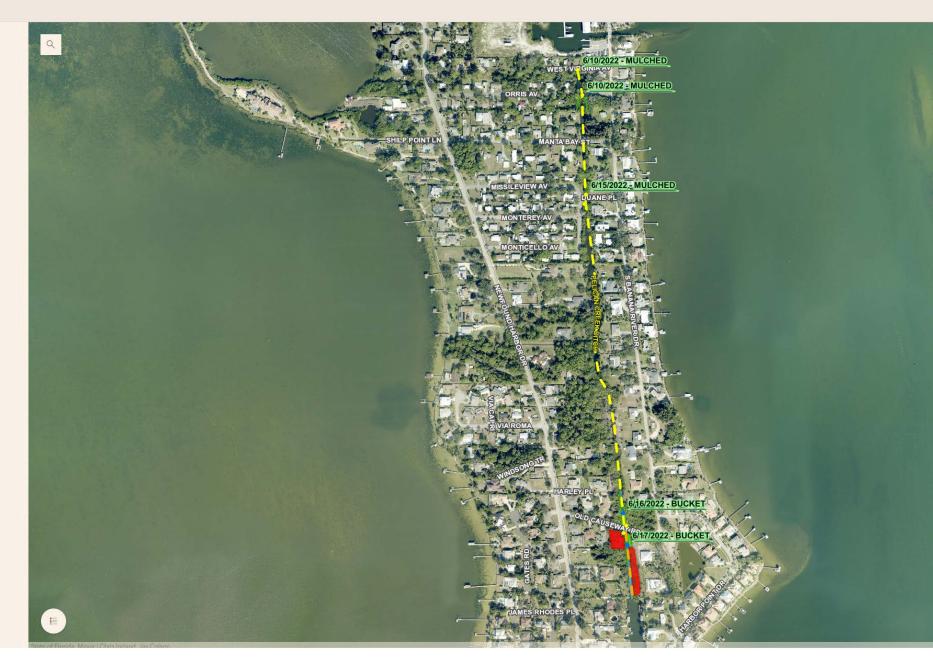
OLD CAUSEWAY OUTFALL LOOKING SOUTH FROM OLD CAUSEWAY RD AFTER PROPERTY OWNER DREDGED AND EXCAVATED THE OUTFALL.

RED = AREA ALTERED BY HOMEOWNER

YELLOW = PELICAN CREEK OUTFALL

ORANGE = OLD CAUSEWAY OUTFALL

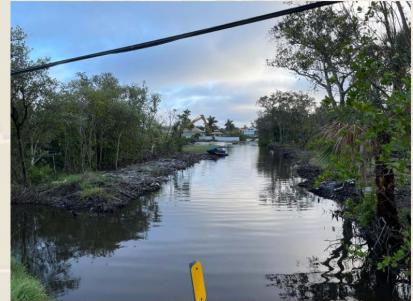
Old Causeway Outfall - Homeowner Excavator
