SOUTH CENTRAL WASTEWATER TREATMENT FACILITY HEADWORKS ODOR CONTROL AND STRUCTURAL ASSESSMENTS TECHNICAL MEMORANDUM

Brevard County, Florida

B&V PROJECT NO. 421429

17 APRIL 2026

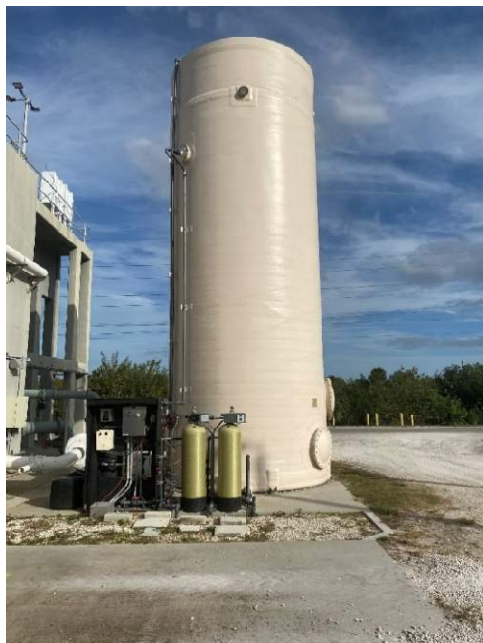
Figure 2-1 Existing Odor Control Unit at Headworks

An existing biotrickling filter shown on Figure 2-1 is currently used to mitigate odors at the headworks. Table 2-1 summarizes the key features of the existing unit. The unit is monitored and operated by a third party.

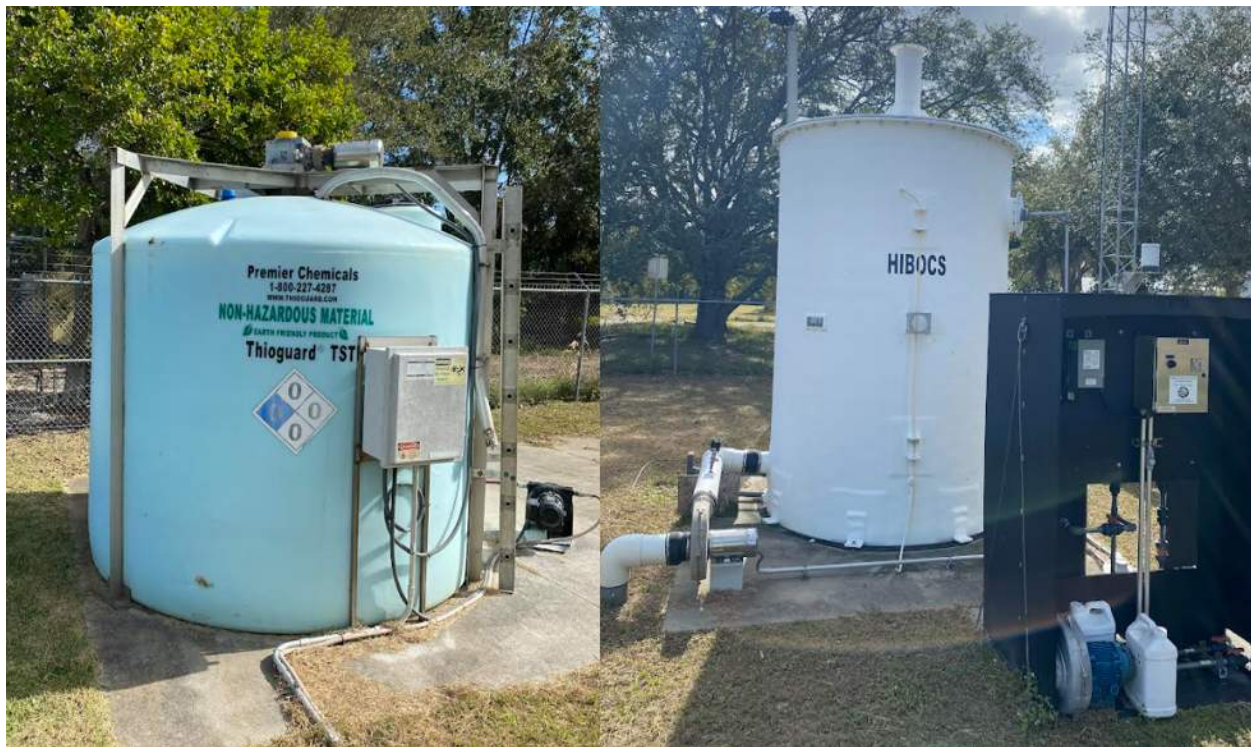
Figure 2-2 Thioguard Addition System (Left) and Biotrickling Filter (Right)

BCUSD injects magnesium hydroxide (Thioguard) into wastewater at three lift stations (W-15, T-16, T-07) to reduce odors in their collection system.

In addition to the Thioguard addition, the three lift stations are equipped with biotrickling filters to treat odors from the wet well headspace. BCUSD has not reported issues with the system's performance or maintenance. Figure 2-2 shows the odor control systems installed at each of the three lift stations.

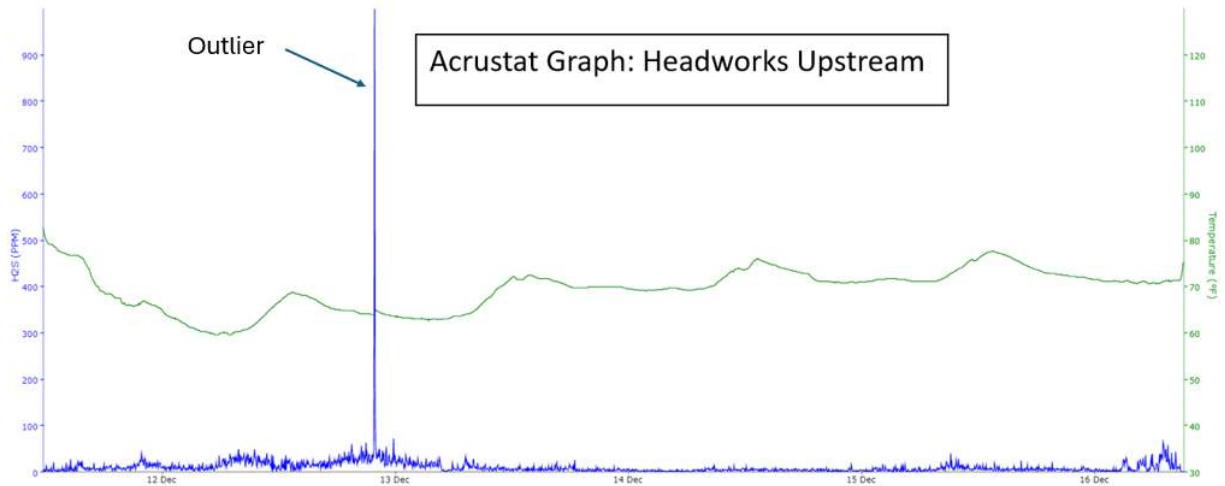
Figure 2-4 Upstream Acrustat Data

Locations	Avg H ₂ S (ppm)	Max H ₂ S (ppm)
Headworks (upstream end)	11	75 ²
Headworks (downstream end) ¹	178	1,100

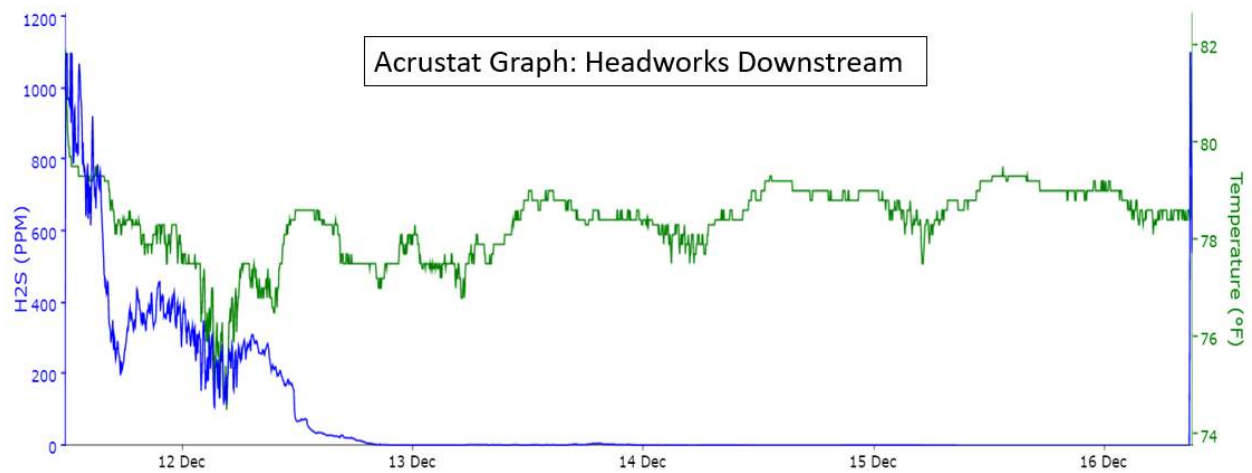
Figure 2-5 Downstream Acrustat Data

As shown in the table, the measured H₂S concentration was much higher in the downstream portion of the headworks, where turbulence and, accordingly, H₂S volatilization are greater. The turbulence in the downstream portion of the headworks resulted in average H₂S higher than 100 ppm. As a result, the downstream area also exhibits the greatest corrosion. Note that H₂S levels in the downstream channel dropped after the first 2 days due to FOG build up on the sensor. This can be seen on the data shown on Figure 2-5 (blue line).

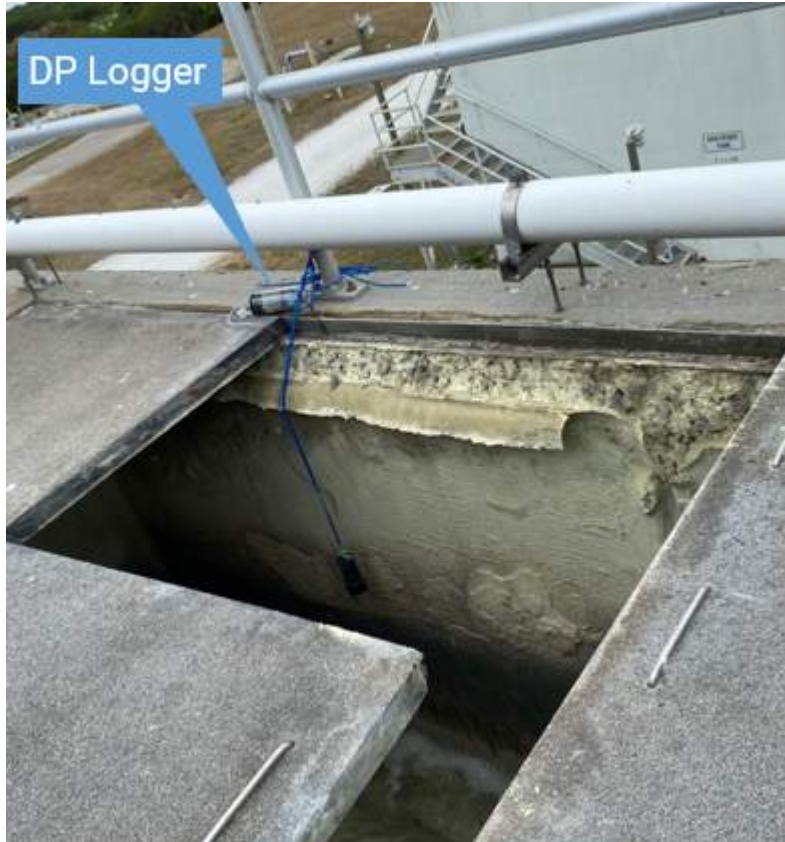
Figure 2-6 DP Datalogger at Headworks

An Acrulog was installed on the downstream end of the headworks channel to monitor differential pressure (DP), as shown on Figure 2-6. Table 2-5 summarizes minimum, average, and maximum pressures.

As shown in the table, positive pressure – which could result in foul air pushed out of the headworks – was recorded at this location. Note that odor control designs typically target a negative pressure of - 0.1 inch water column (WC) to ensure that odors are effectively collected and to minimize the potential for fugitive (escaping) odors. The values recorded indicate that balancing of the foul air collection system, at minimum, may be required to improve odor collection and headworks ventilation.

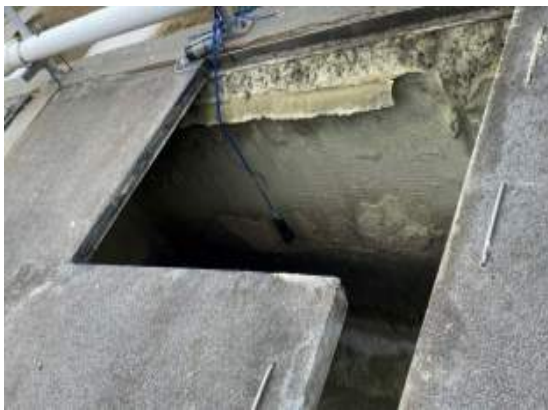
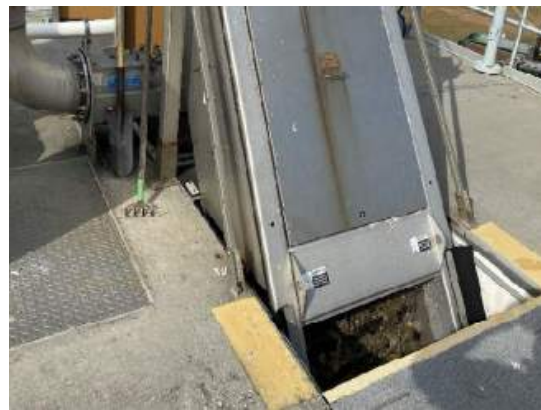
Figure 2-7 Downstream Channel (Left), Opening at Bar Screen (Right)

- Fugitive odors escaping from openings near the bar screens. Efficient operation of the odor control system relies on effective capture of odorous air. Gaps near the bar screens need to be covered to make odorous air ventilation more efficient.
- Corrosion is extensive on the inner channel walls, depicted on Figure 2-7 **Error! Reference source not found.**

Recommended Improvement	Description
Provide gasketing at openings	This is a simple and inexpensive option to minimize openings at headworks. Cost will vary depending on the size, but ranges between \$5-15 /sf.
Test and balance foul air collection	This effort will determine if the air is being collected from individual areas of the headworks as designed – and could identify the reason for positive pressure measured during the field program. The estimated cost is less than \$10,000.
Investigate landfill leachate impacts on H ₂ S generation	This effort would require monitoring of leachate discharge times, leachate characterization and monitoring of impacts at the headworks. If a relationship is identified between H ₂ S and leachate discharges, mitigation efforts could focus on this waste stream and/or the sewer shed where it discharges. The cost will depend on the scope.
Thioguard vendor coordination to assess a new dosage location	Work with Thioguard vendor to identify a new dosing location with the objective to control odors at the headworks as the existing systems focus is on collection system odor control. The O&M cost for a new dosing system is preliminarily estimated to be \$100,000 per year.

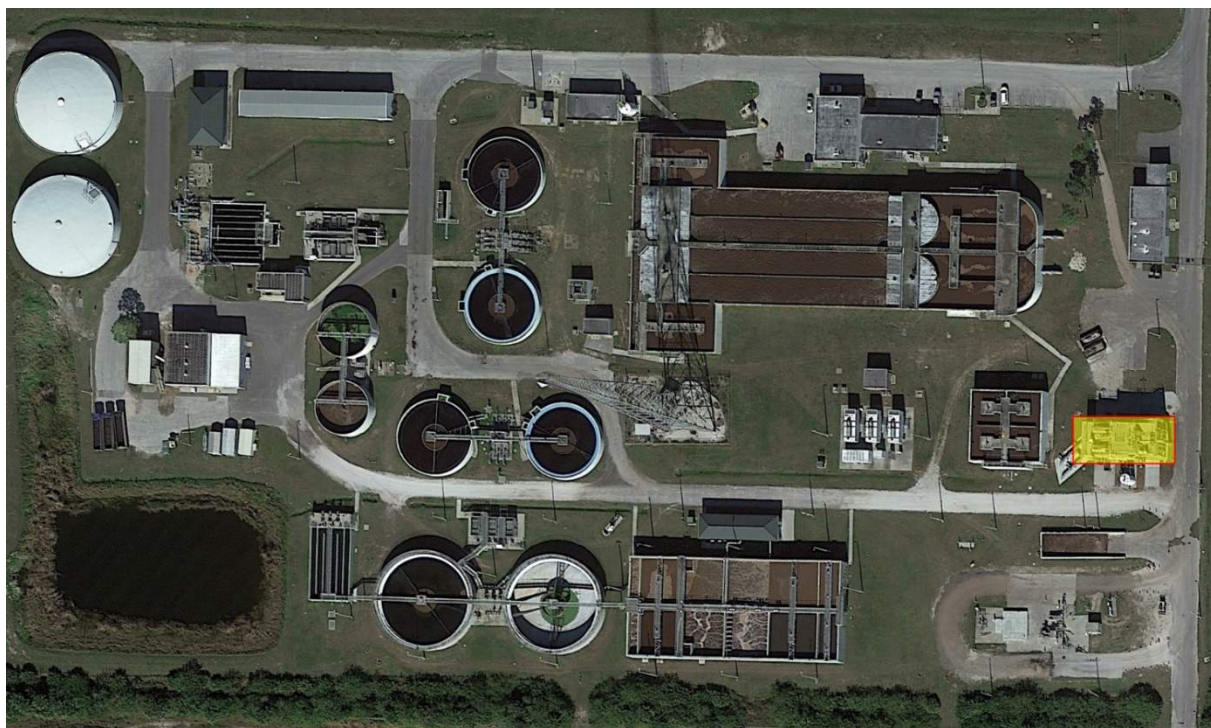
Figure 3-1 Aerial View

Figure 3-1 presents the aerial view, highlighting the headworks location with a yellow rectangle.

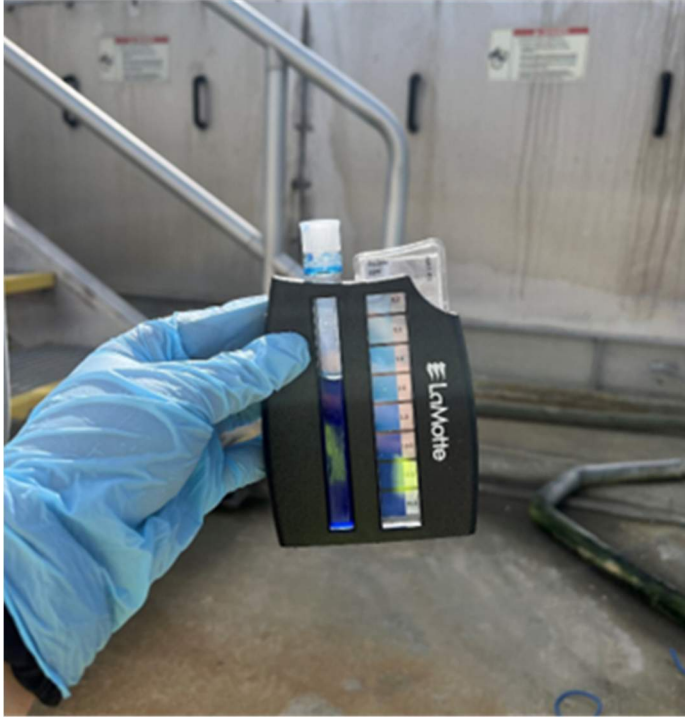
Figure 3-3 **Photo 1 - Wastewater Sulfides and pH**

Based on the odor control investigation conducted on December 10, 2024, extremely high sulfides were encountered throughout the headworks structure; refer to Figure 3-3. Hydrogen Sulfides are categorized by the American Concrete Institute (ACI) as a Group 3A – “Slow Corrosion” corrosive chemical.

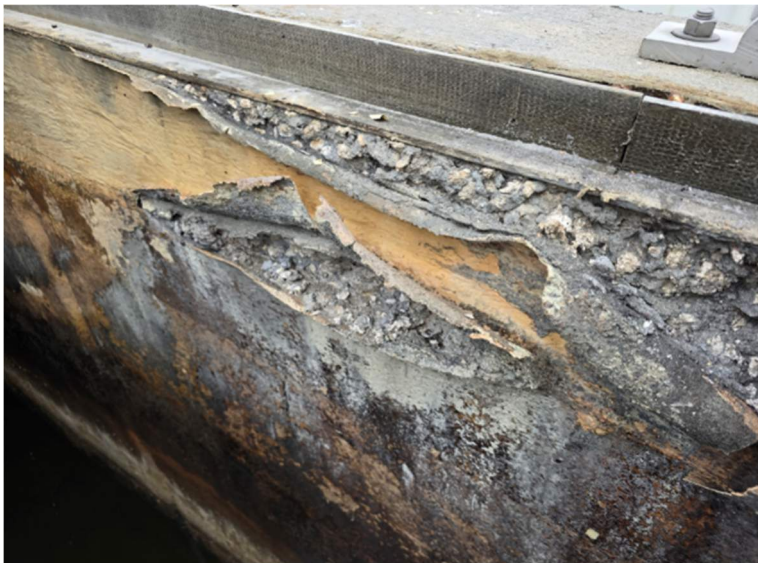
Figure 3-4 **Photo 2 - Lining System Failure**

Photos from the site visit reveal that the existing lining system in the end chamber of the headworks structure has failed. The lining appears discolored and is peeling away from the concrete wall and exposing the concrete surfaces against aggressive chemicals. Refer to the photos in Figure 3-4, Figure 3-5, Figure 3-7, Figure 3-8, Figure 3-9, and Figure 3-10. Figure 3-6 shows the lining within the bar screen chamber; the lining appears in better shape and is intact.

The deterioration to the walls of the pre-treatment structure is likely due to a lining failure which resulted in exposure to H₂S and sulfuric acid to the concrete structure. Partial or localized repairs of the existing lining are not recommended, as the lining could obscure degraded or otherwise weakened concrete. Preparation methods exist which would qualify remaining material as tightly adherent but would not address contamination of the underlying concrete. Due to the accelerated nature of the initial failure, full removal and replacement of lining is recommended after the necessary concrete repairs are completed.

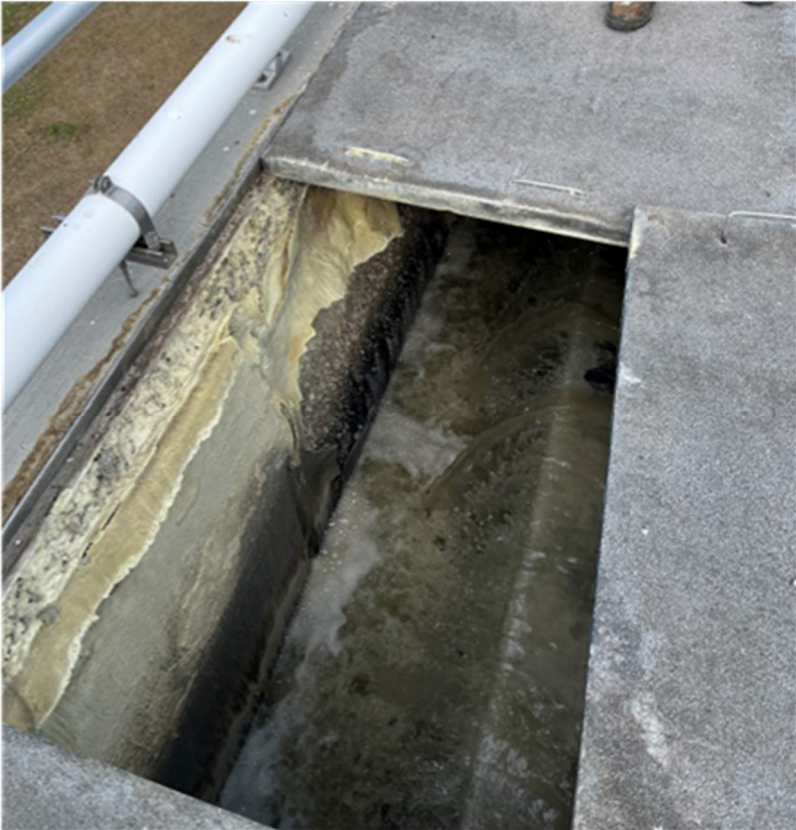
Figure 3-5 Photo 3 - Lining Failure at Weir Chamber

Lining systems for sulfate and sulfide resistance are required for structures with high sulfates and sulfide exposures (per ACI 350). These systems help prevent the anerobic bacteria that create H_2SO_4 (Sulfuric Acid) affecting concrete that is exposed to air and moisture. When there is a holiday (a hole, a rip, or tear) in the lining system, it provides a haven for the bacteria to sit and grow. As the bacteria thrives in this environment, bubbles form in the coating as the bacteria creates backfill and pushes the lining out. This appears to be what has happened to the lining in Figure 3-4, Figure 3-5, Figure 3-7, Figure 3-8, Figure 3-9, and Figure 3-10.

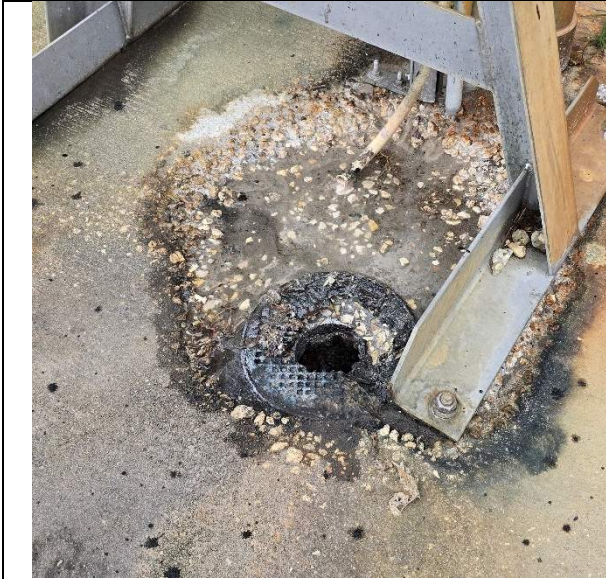
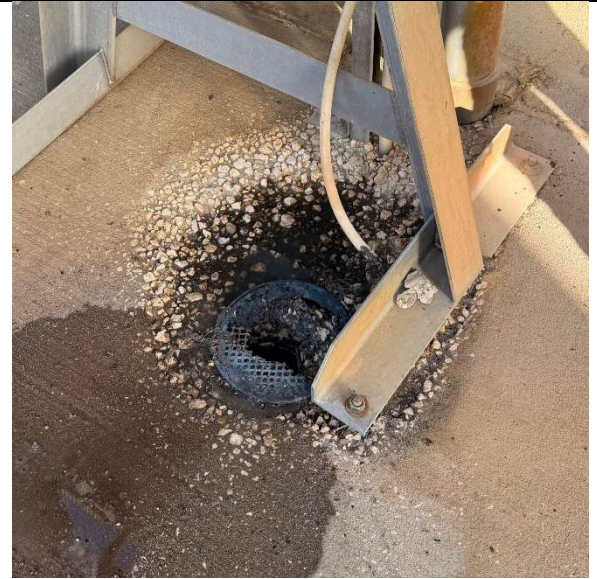
2. Figure 12 and Figure 12A show the corrosion of a steel drain cap plate at the south dumpster. The corrosion of the steel cap has increased as shown in Figure 12A.

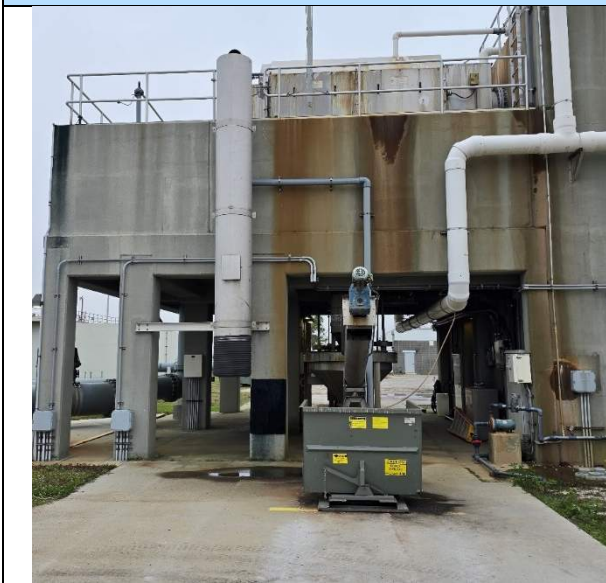
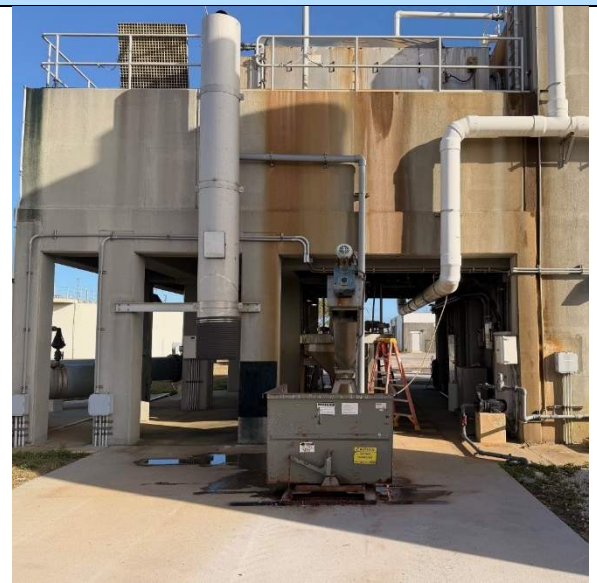
1. The Pretreatment Structure was built in 2020. The structure consists of cast in place concrete walls, slabs, columns, and beams. The roof consists of concrete beams and what appears to be concrete panels acting as hatches. The exterior of the building exhibits some cracking and discoloration, see Figure 13 and Figure 13A.

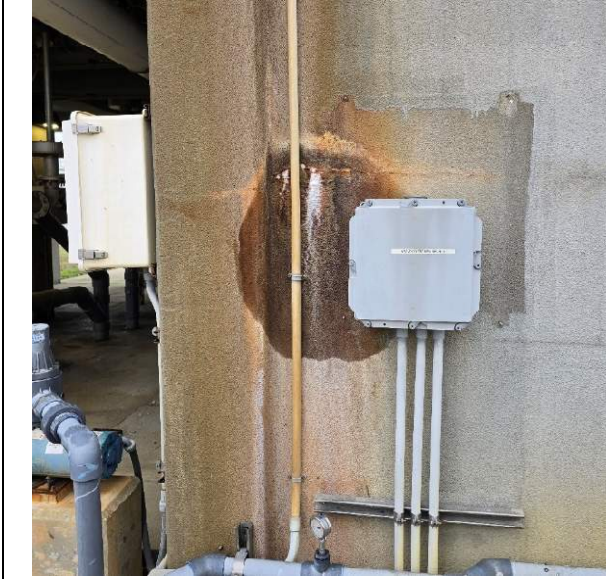
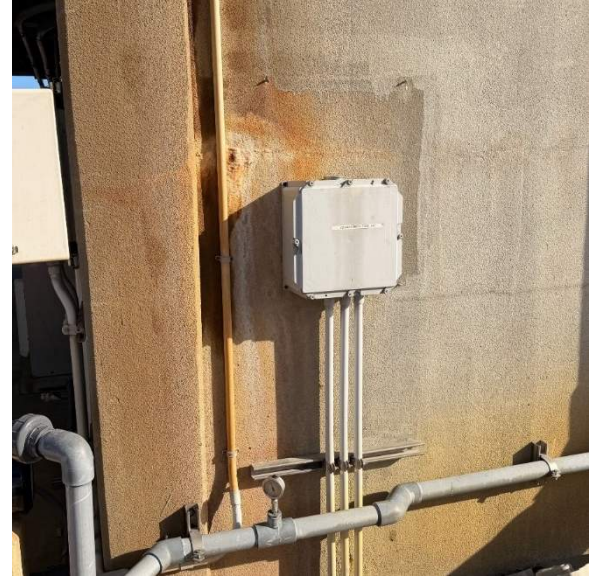
An operator with the county also noted that the crack shown in Figure 14 and Figure 14A is continuing to leak on high temperature days. This crack is located on the wall supporting the South Grit Removal Unit. This indicates that there is an active crack within the chamber. At this time, we do not have any photographs of that interior area, but it is assumed that it would have damage due to sulfides and lining failure as well.

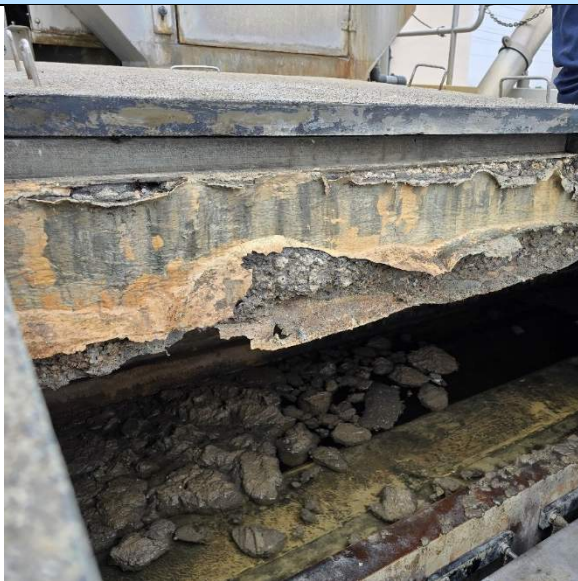
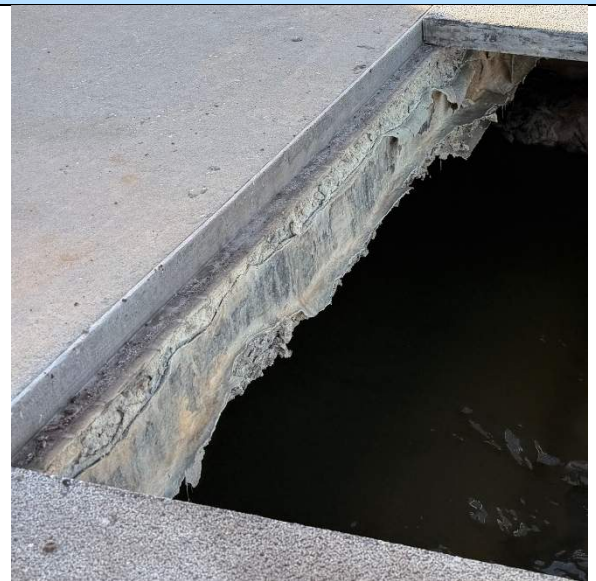
It was also observed that the concrete beams supporting the concrete panels over the North and South Flow Split chambers appear to be in poor shape. At this time no reinforcement can be observed; however, based on the surrounding conditions, it is likely that the reinforcement in the concrete beams may also be subject to the harsh conditions (See Figure 17 & 17A).

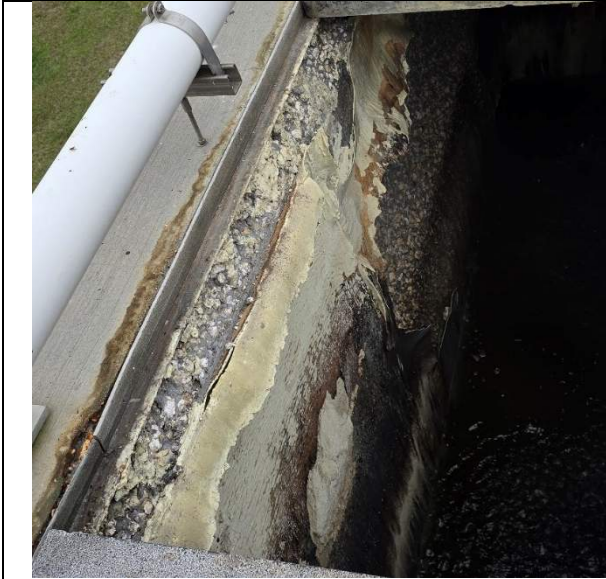
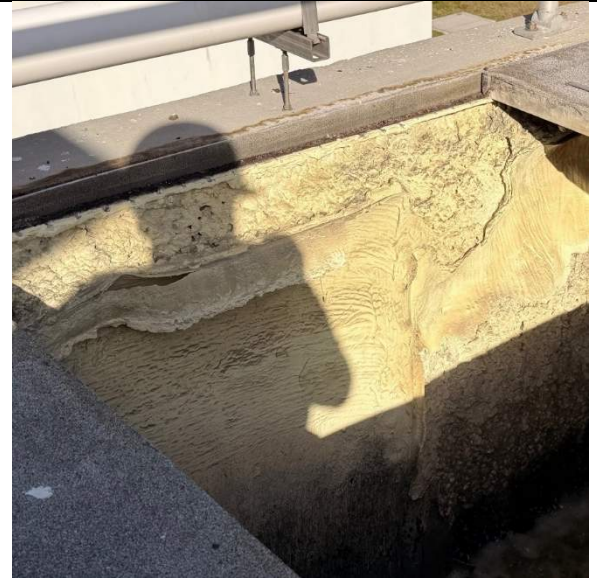
Figure 18

During the examination of the existing structure that occurred on February 17, 2026, it was observed that reinforcement could be seen for the concrete walls of the North Flow Split Chamber (PS-10). It was also noted by the Lead Operator that the concrete consistency at the top of the wall was very soft (see Figure 18A & Figure 19).

5. In Figure 18, the concrete towards the top of the wall can be seen to appear as a foam/slurry. The aggregate in the concrete appears to be missing.
6. In Figure 19, it was observed that the vertical reinforcement was broadcasting through the thin layer of concrete cover. The concrete clear cover, as indicated in the drawings, was designed as 2" from face of the wall.

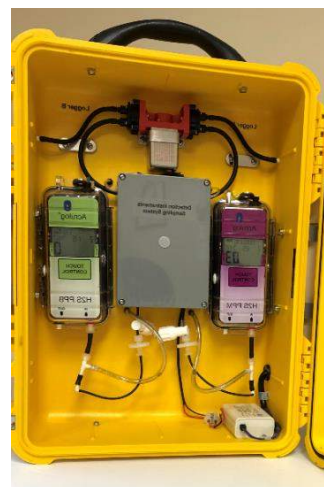
Figure 2-2 LRSS-2 System with AcruLogs

A 0-1,000 ppm unit will be used to measure inlet concentrations of the odor control system and a 0-200 ppm unit will be used for outlet measurements. Note that selection of a 0-200 ppm unit for the outlet is unusual but reflects reported concentrations as high as 45 ppm at the outlet. The units will be housed in an LRSS-2 system, which includes external moisture removal traps and a dual-headed pump to ensure that the sampled airstreams are delivered to the AcruLogs at the proper flow rate and pressure.

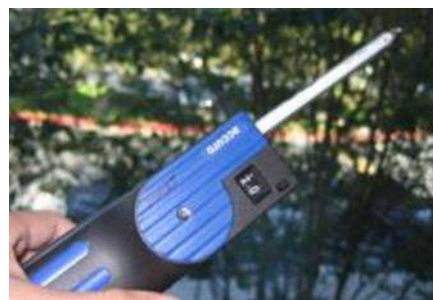
Figure 2-3 Dräger Tube and Pump

Methyl mercaptan will be measured using colorimetric tubes manufactured by Dräger that provide a measurement ranger of 0.1 to 15 ppm and an Accuro bellows pump designed to be used with the tubes. Measurements should be performed, at minimum, at the headworks odor control system inlet and outlet.

To use the tubes, the tube ends are broken first off, and the tube is then inserted in a bellows pump (refer to Figure 2-3), with the arrow on the tube pointing toward the pump. The bellows pump is compressed to take a measurement, with the number of compressions required shown on the tube.

The tube will change color if the sampled odorant is present, with the color change/concentrations shown on the tube gradations.
