Environmental Report  
22Z00004  
Storsafe

**Proj: Brevard Storage – Brevard County, Florida**  
**Sections 23 Township 25 South, Range 36 East**  
**(BTC File #597-24)**  
**Re: Environmental Assessment Report**

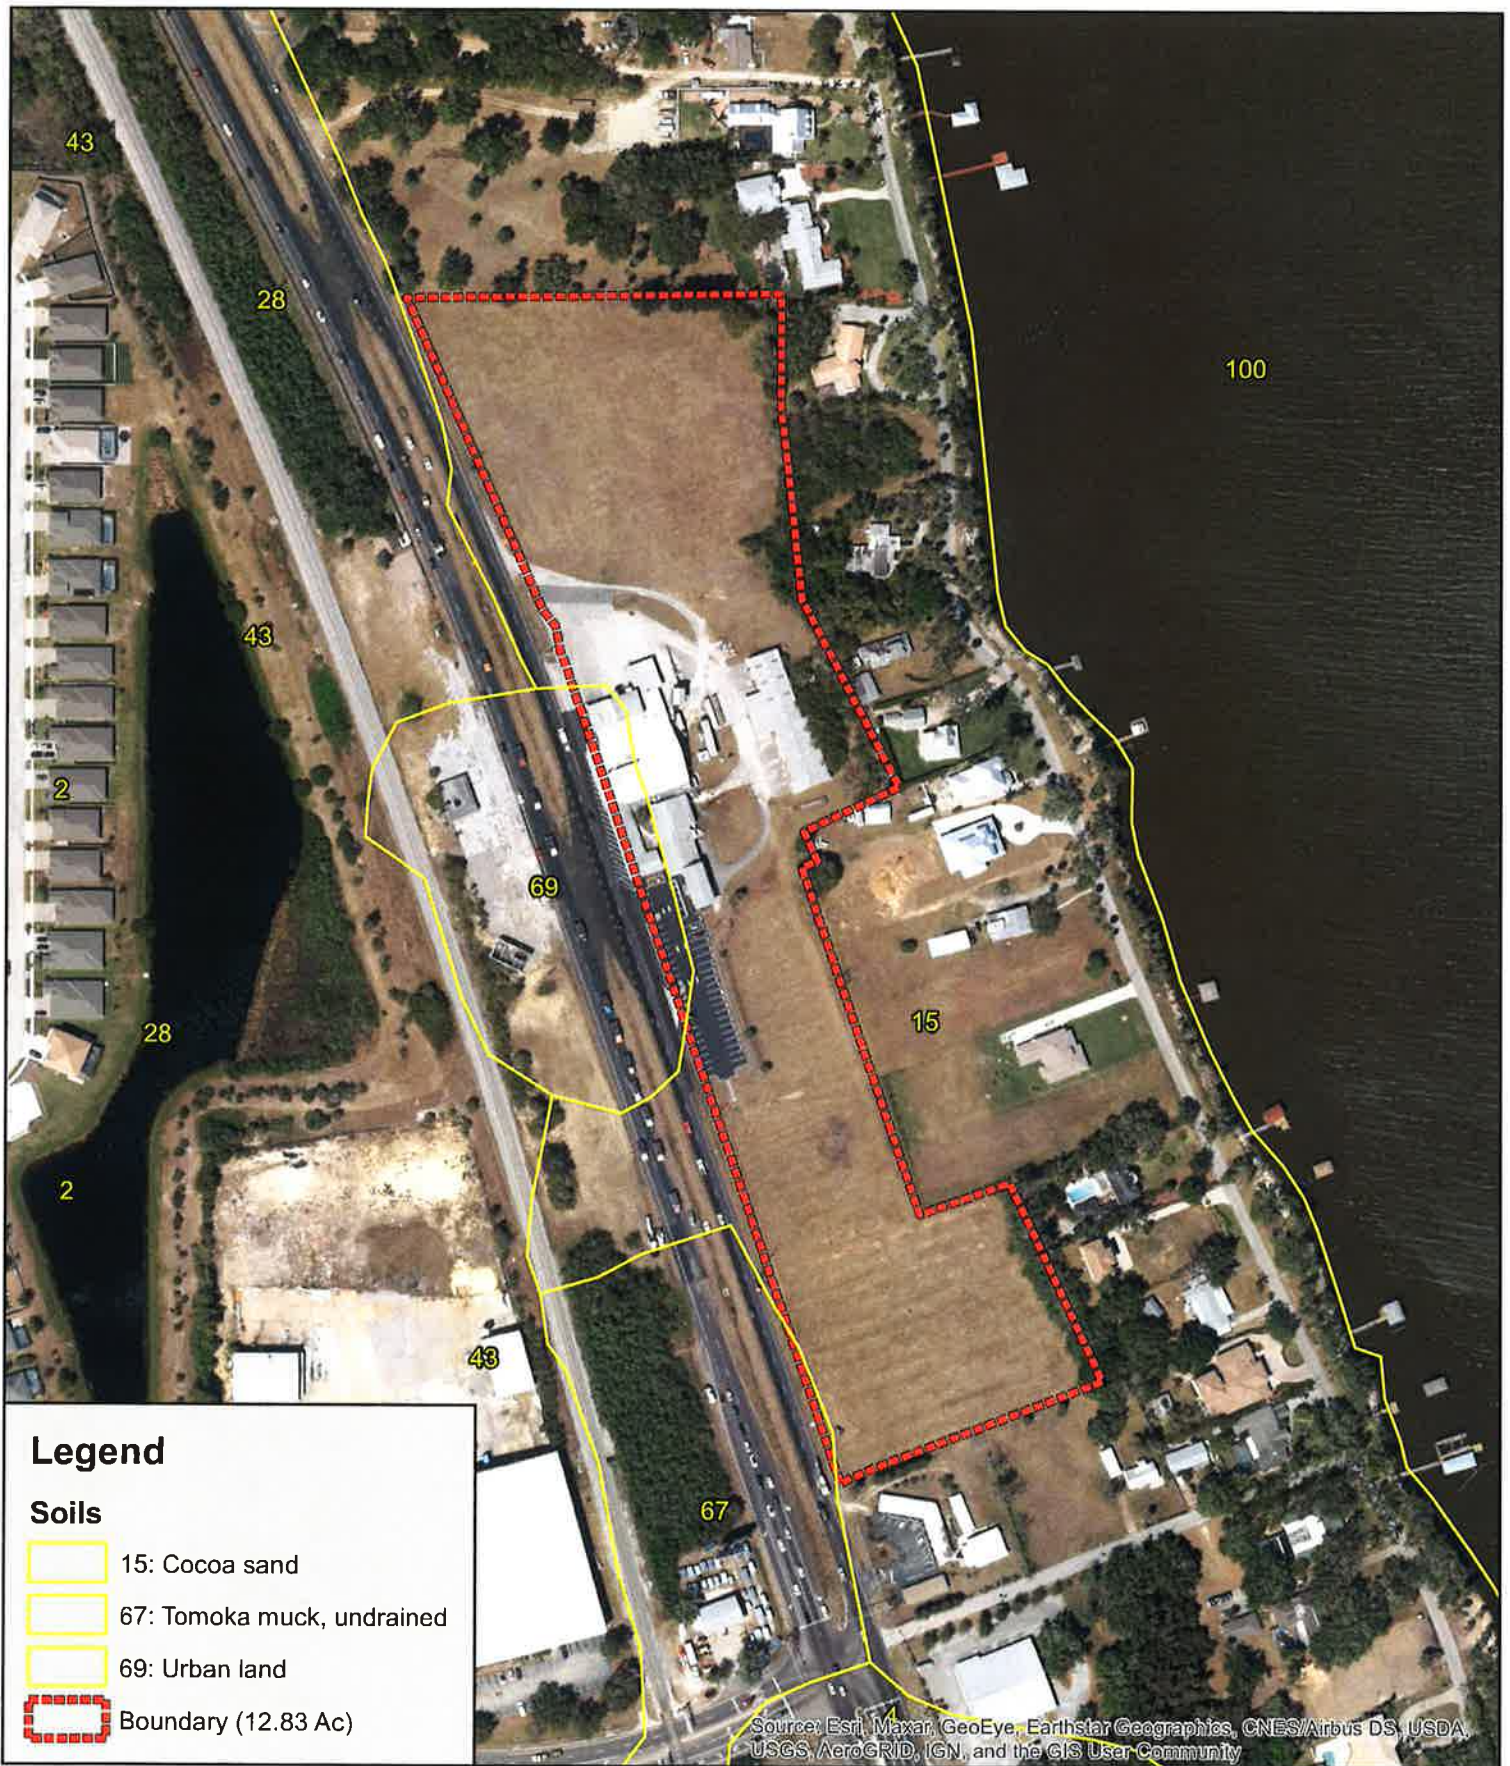
The subject site currently supports two (2) land use types/vegetative communities (Figure 5). These land use types/vegetative communities were identified utilizing the Florida Land Use, Cover and Forms Classification System, Level III (FLUCFCS, FDOT, January 1999). The on-site upland land use types/vegetative communities are classified as Industrial (150) and Open

Land (190). No wetland/surface water land use types were found on site. The following provides a brief description of the on-site land use types/vegetative communities:

The property contains an abandoned warehouse with a store and a parking lot that is most consistent with the Industrial (150) FLUCFCS code. Vegetative species identified include Brazilian pepper (*Schinus terebinthifolia*), lantana (*Lantana strigocamara*), Spanish needles (*Bidens alba*), Mexican clover (*Richardia brasiliensis*), switchgrass (*Panicum virgatum*), and bahiagrass (*Paspalum notatum* var. *notatum*).

Surrounding the warehouse on either side are fields with no structures being most consistent with the Open Land (190) FLUCFCS code. Vegetative species identified include live oak (*Quercus virginiana*), cabbage palm (*Sabal palmetto*), slash pine (*Pinus elliottii*), Australian pine (*Casuarina equisetifolia*), golden bamboo (*Phyllostachys aurea*), carrotwood (*Cupaniopsis anacardioides*), chinaberry tree (*Melia azedarach*), golden raintree (*Koelreuteria paniculata*), white lead tree (*Leucaena leucocephala*), saw palmetto (*Serenoa repens*), Mexican clover (*Richardia brasiliensis*), and bahiagrass (*Paspalum notatum* var. *notatum*).

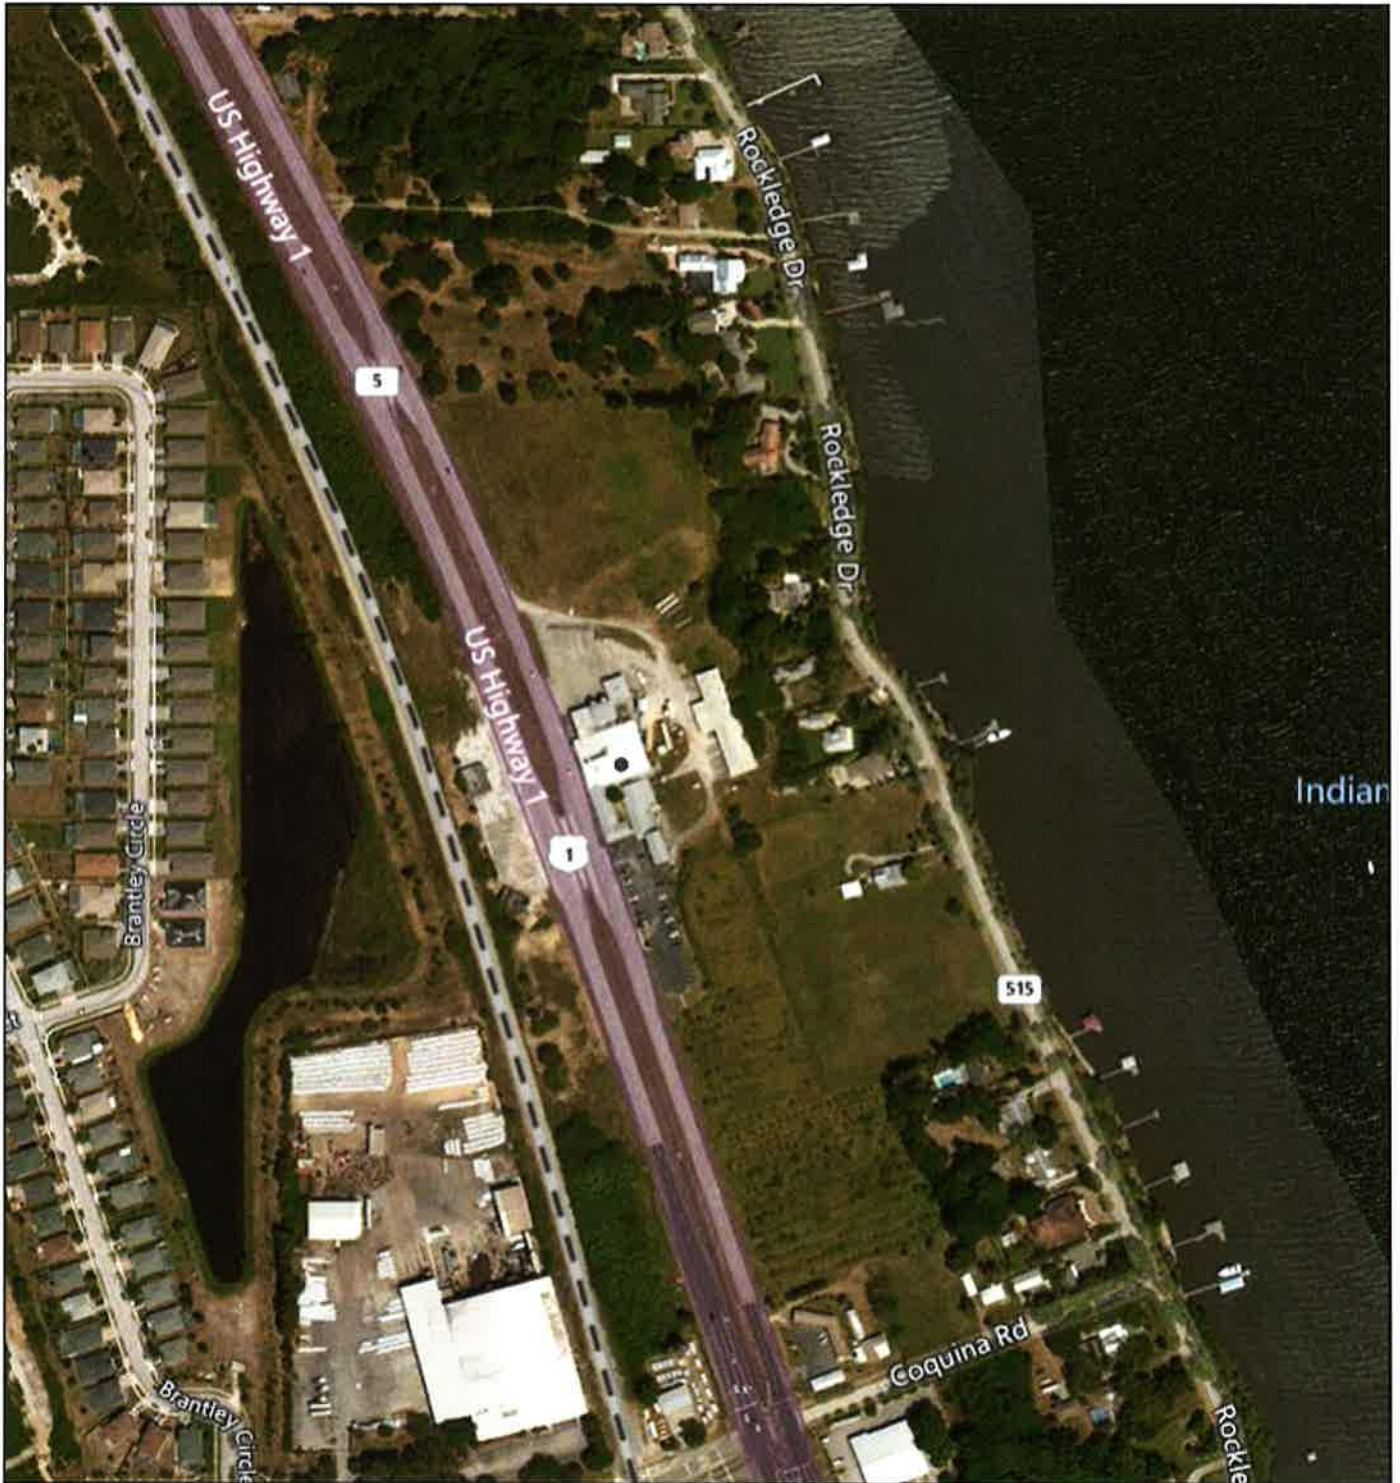
# EagleWatch Map

In addition to the on-site evaluation for listed species, BTC conducted a review of FFWCC's database and Audubon's Eagle Watch program database for recorded Bald Eagle nests within the surrounding 660 feet of the subject site. This review revealed no Bald Eagle nests, through the 2020-2021 nesting season, located within one (1) mile of the subject site (see attached Bald Eagle Nest Data). Therefore, there will be no development constraints regarding Bald Eagle nests unless a new nest is found.
