Environmental Impact Report

495 W Merritt Ave Merritt Island

FEC Job #22-164

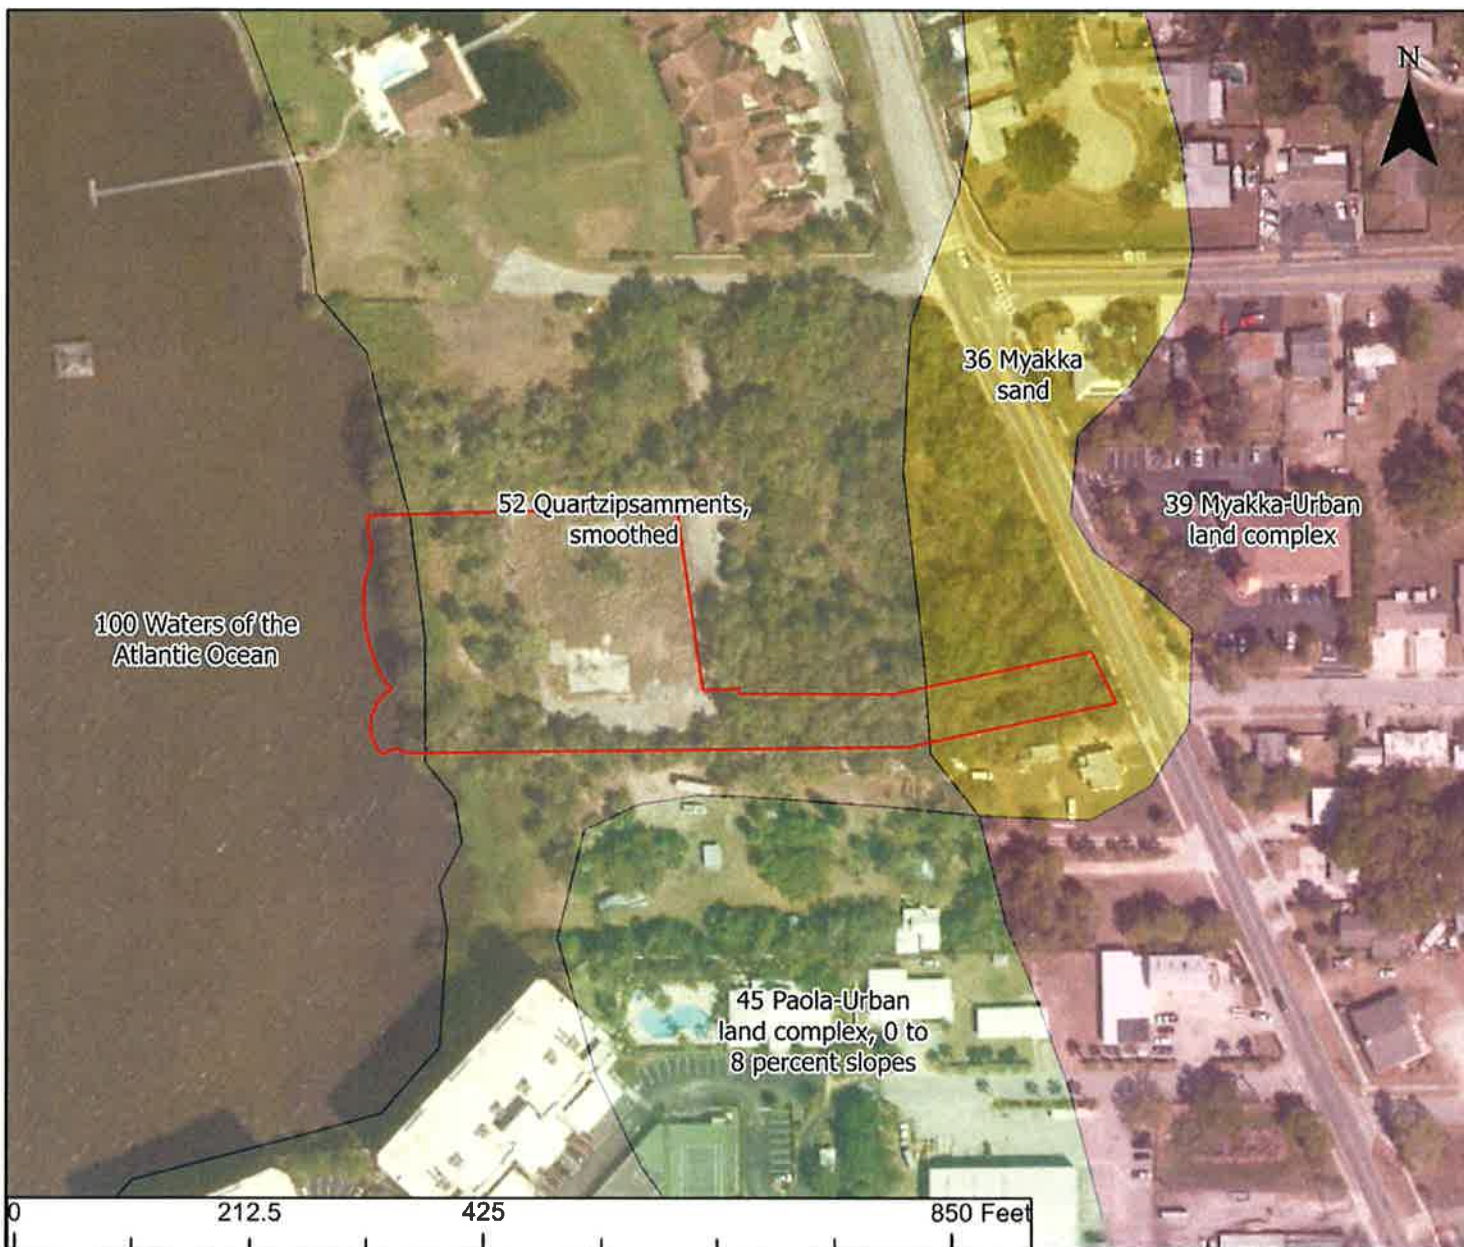
SOILS

According to the U.S. Department of Agriculture Natural Resources Conservation Service (NRCS) the property contains 2 major soil types more specifically described as:

Soil 52, *Quartzipsammments, smoothed*, characterized as moderately well drained sand with a water table typically about 24-60 inches below the surface with no typical frequency of ponding or flooding.

Soil 36, *Myakka sand*, 0 to 2 percent slopes, characterized as poorly drained sand with a water table typically about 6-18 inches below the surface with no typical frequency of ponding or flooding.

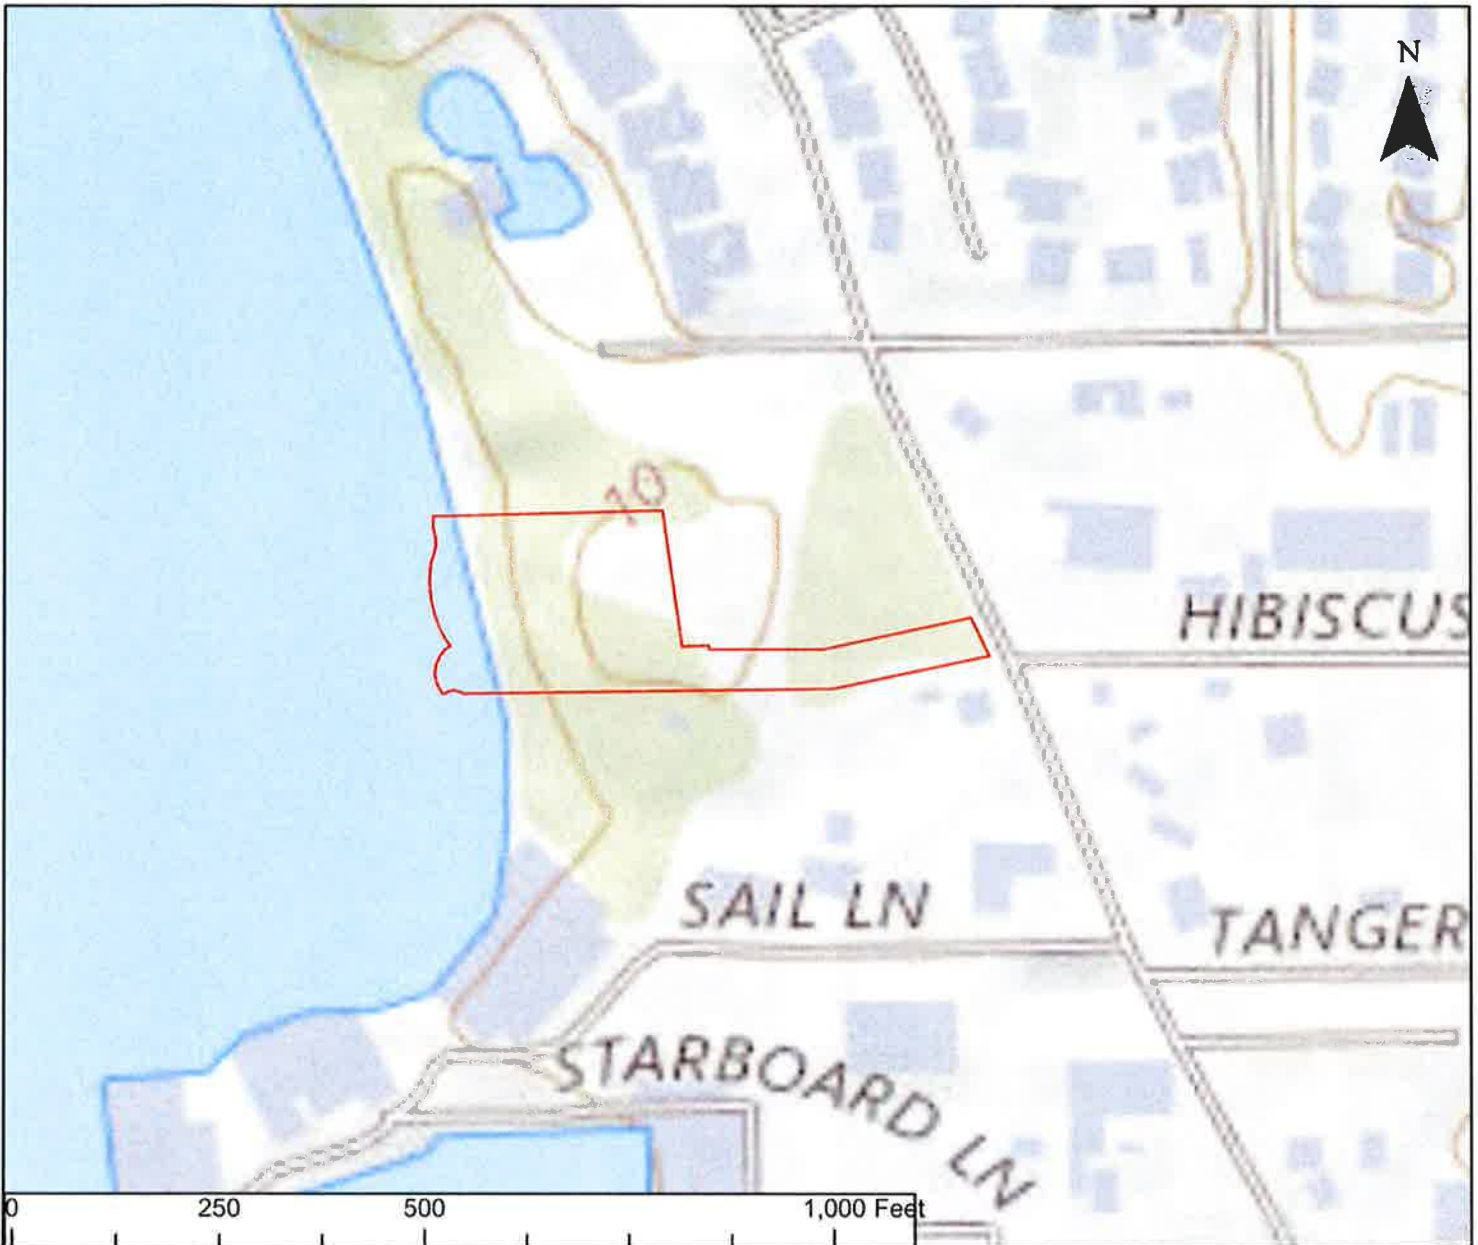
TOPO

This project is in hydrologic basin 21, the *Northern Indian River Lagoon* basin, and the United States Geological Survey (USGS) Topographic Map in the Appendix shows the area as generally flat with stormwater runoff sheet flowing towards the Indian River. Using the North American Vertical Datum of 1983 (NAD83) the natural ground grade is approximately elevation 10 and according to the Flood Hazard Map in the Appendix, this area is largely not in a flood plain and as such is considered Flood Zone X, however the waterfront portion is partially in flood zone AE-5.

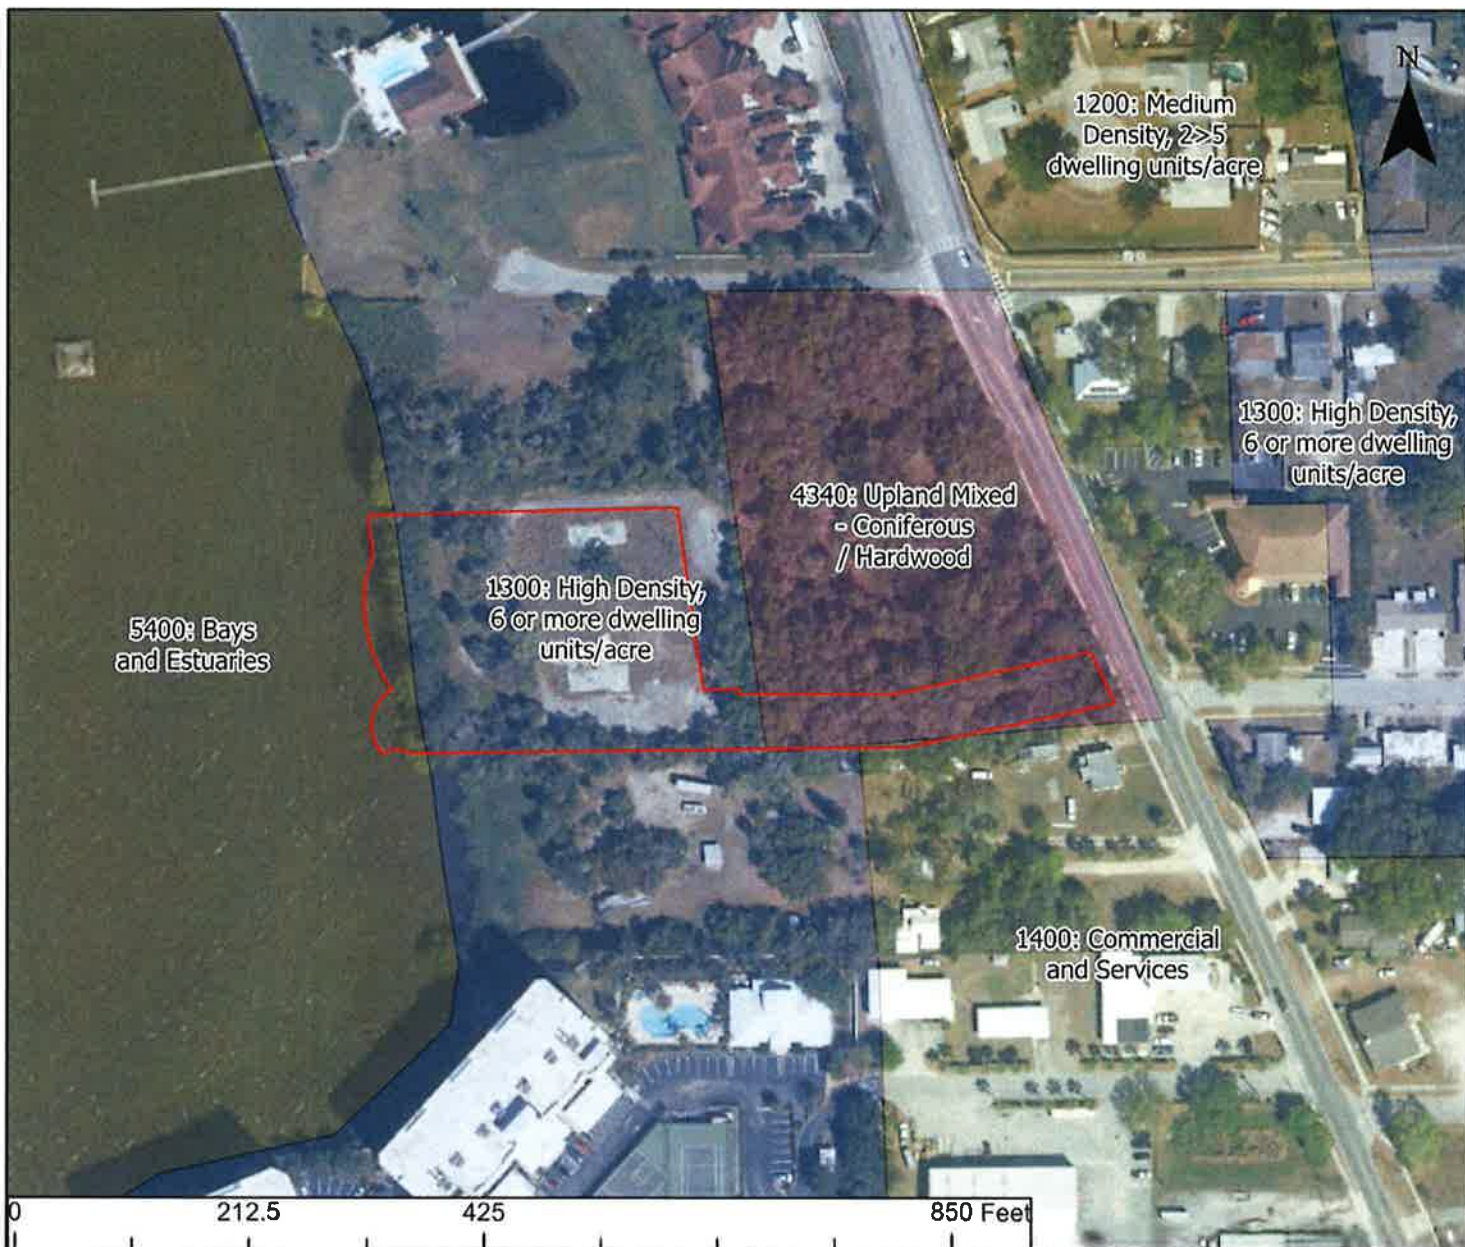
As noted in the introduction the property is one parcel totaling approximately 2.12 acres of vacant partially cleared land. The flora of the property has already been impacted by historic clearing, however the site exhibits remnant Hardwood/Conifer mixed habitat characteristics (FLUCCS 4340). Please see the Aerial LULC Map and Site Photos in the Appendix.

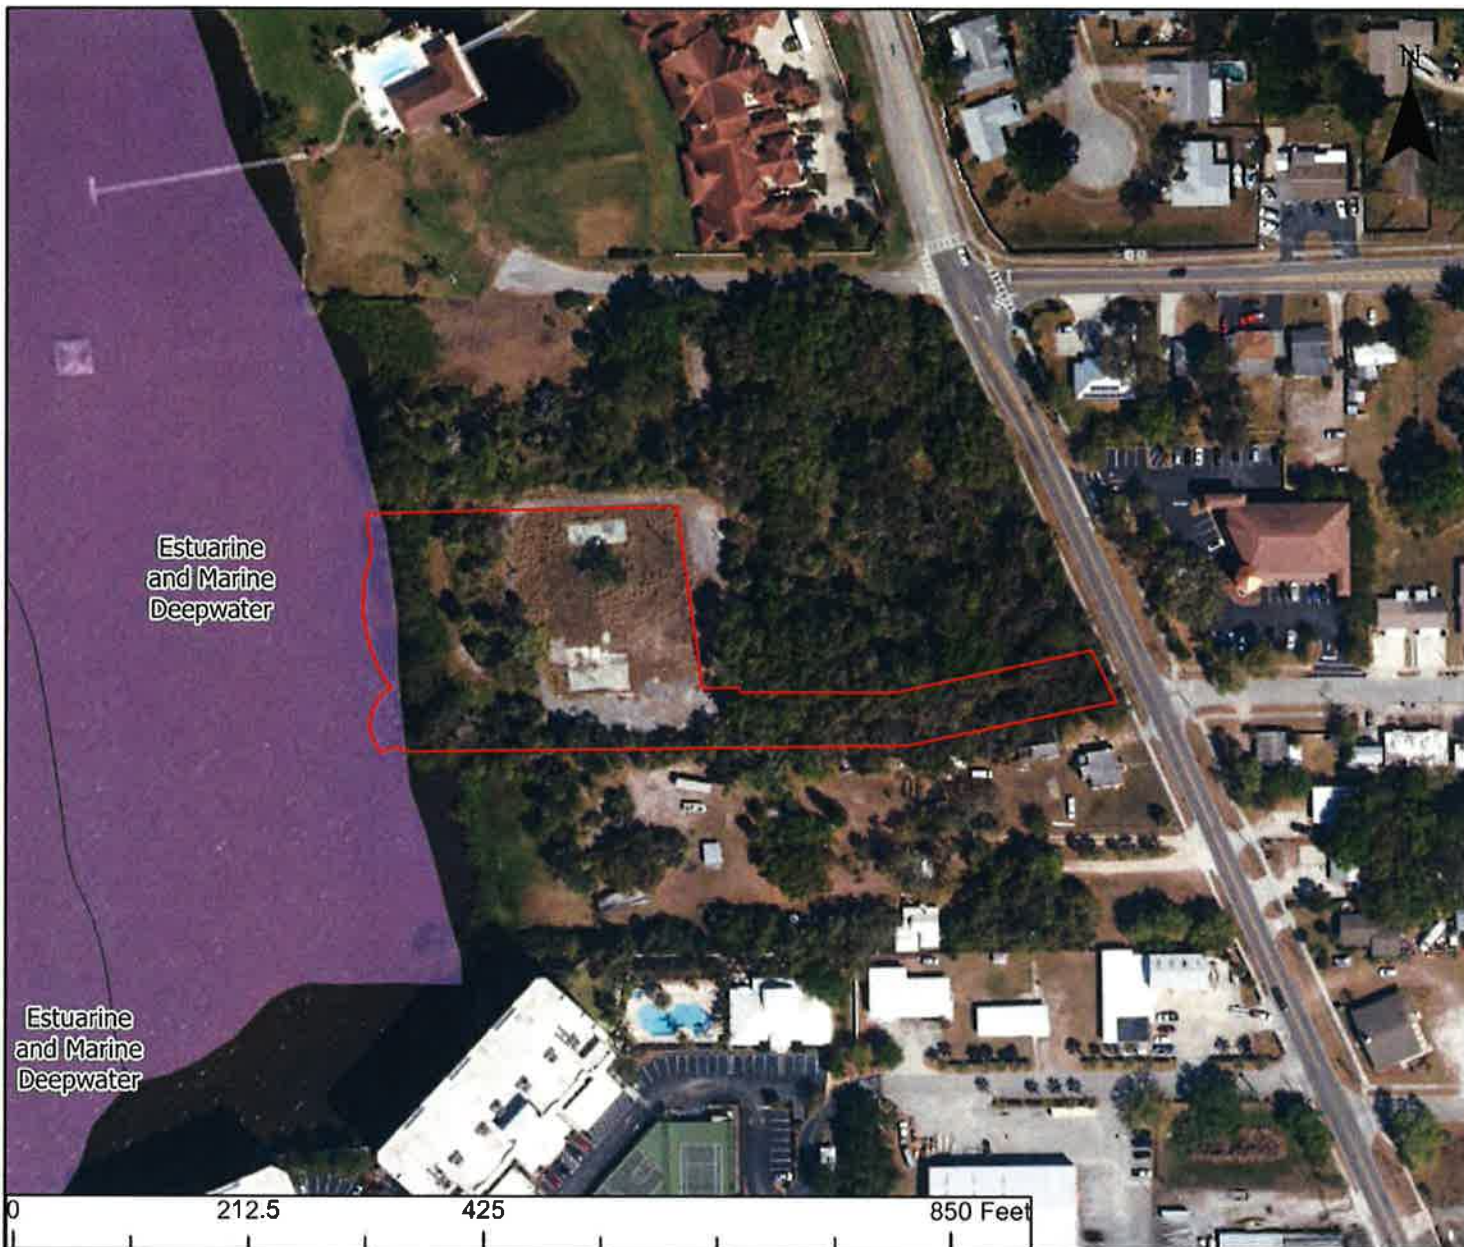
NWI

Based on topography and aerial interpolation in conjunction with the soils survey publication and given the proximity to the Indian River, wetlands were not suspected, and this was confirmed in the field. However, the area below the high-water line of the Indian River would be considered protected waters of the State.

Please see the National Wetland Inventory Map in the Appendix of this report.
