RE: Assessment of Jurisdictional Wetlands  
Within Six Parcels of Property  
Totaling 8.03-ACRES  
Located at 39XX Grissom Parkway, Cocoa, Florida  
Tax Identification Numbers:  
2400694, 2400695, 2400696, 2400697, 2400698 & 2400700

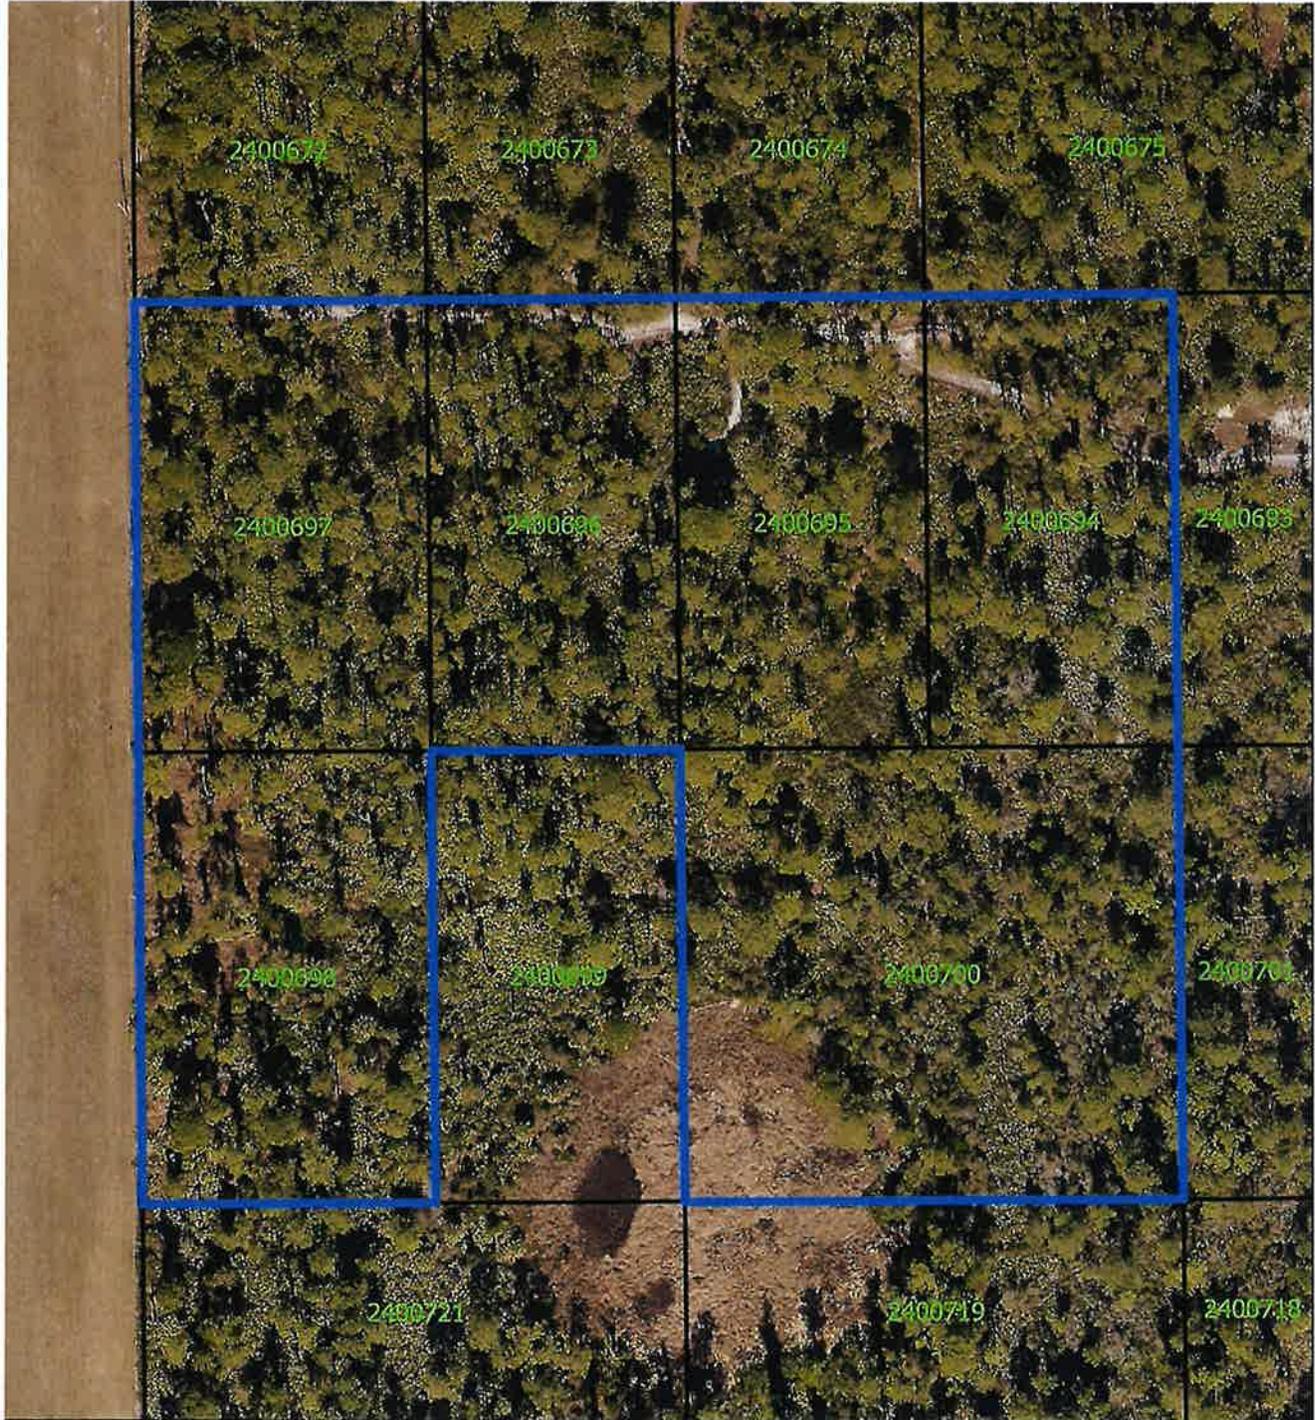
Figure 1: Map of Study Parcels with Tax Identification Numbers

The following is a summary of Toland Environmental Consulting's (TEC) determination of the presence or absence of federal and state jurisdictional wetlands within six adjacent parcels of properties located in Brevard County off Grissom Road in Cocoa, Florida. The six parcels have tax identification of 2400694, 2400695, 2400696, 2400697, 2400698 & 2400700 (Figure 1). The property is bounded to the north, east, and south by unimproved single-family residential lots and to the west by Grissom Parkway (Figure 2).

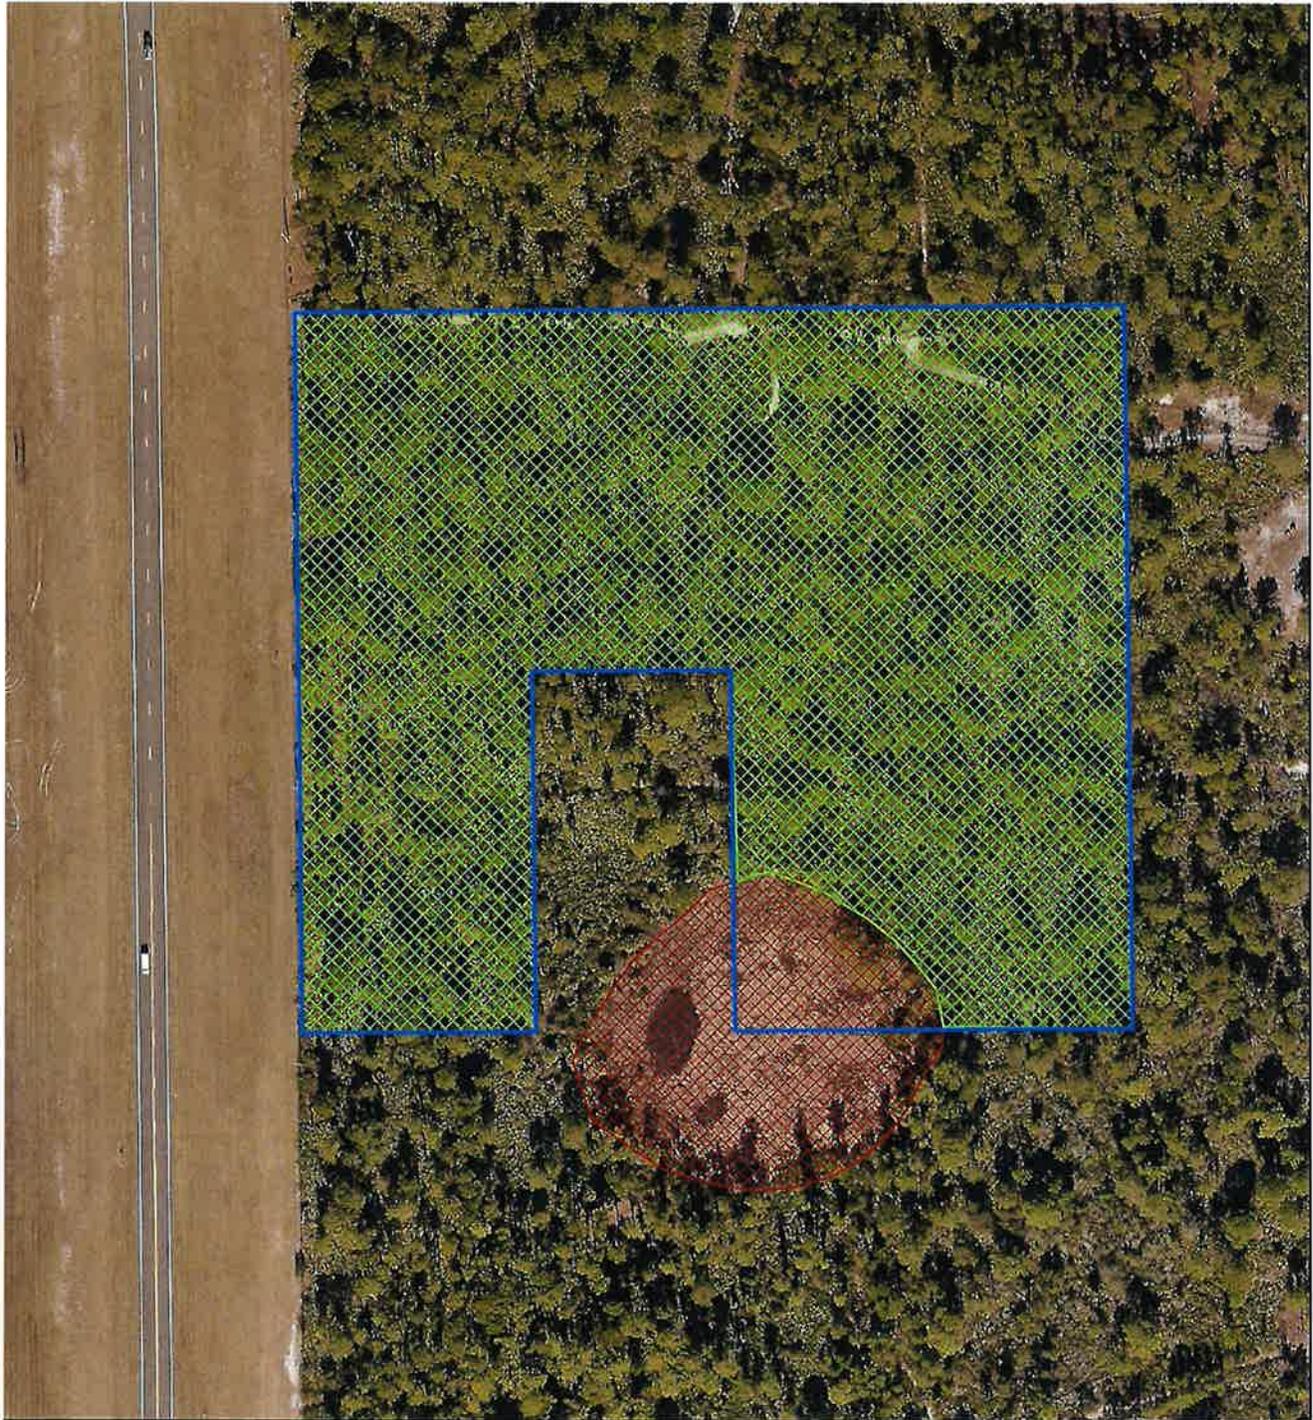
Figure 3: Natural Communities Cover Map

In addition, on October 31, 2022, TEC ground-truthed, delineated and described the natural communities present within the study area with reference to Florida's Cooperative Land Cover (CLC) classification system as maintained by FWC and last updated in September 2018 as well as by FDOT FLUCCS codes. In its current condition, the property would be classified as having 7.60 acres of CLC 1312-Scrubby Flatwoods (FLUCCS 4110-Pine Flatwoods), and 0.42 acres of 21211-Depression Marsh (FLUCCS 6410-Freshwater Marsh)(Figure 3).

Fire suppression has resulted in the canopy of the scrubby pine flatwoods to become dominated by sand pines (*Pinus clausa*), with lesser amounts of longleaf pines (*Pinus palustris*) and occasional Live oak (*Quercus virginiana*). The lack of fire has also resulted in a dense and overgrown mid-story and understory with rank saw palmetto (*Serenoa repens*), tall, dense sand live oak (*Quercus geminata*), intermittent dwarf live oak (*Quercus minima*), runner oak (*Quercus pumila*), and rusty lyonia (*Lyonia ferruginea*). The depression marsh shows damage from wild hogs with groundcover including chalky bluestem (*Andropogon capillipes*), redroot (*Lachnanthes caroliniana*), soft rush (*Juncus effusus*), and wax myrtle (*Myrica cerifera*) around the perimeter.

The NWI wetland inventory has mapped two potential wetland systems within the study parcels which they classify as a PEM1C (Palustrine, emergent, persistent, seasonally flooded). By contrast, the SJRWMD has mapped one potential freshwater marsh system (FLUCCS 6410) in the same area TEC field verified a depression marsh (Figure 5). TEC attributes the discrepancy between federal and state potential wetland maps to the federal map including a historical system that could have existed in the area mapped as having hydric soils and would have been visible in aerial images in the early seventies (Figures 6). By 1986, this system shows signs of succession into pine flatwoods (Figure 7). After the construction of Grissom Parkway, most of the wetland system was gone by 1993 and what remained was heavily altered by changes in regional drainage patterns brought on by the construction of the road (Figure 8). TEC reviewed the old wetland system to establish whether it still met the delineation criteria found within Chapter 62-340, Florida Administrative Code or Section 404 of the Clean Water Act (33U.S.C. 1344) to be jurisdictional for regulatory purposes. TEC's field review established that this system was no longer jurisdictional with an upland canopy, no signs of hydrology and soils that lacked the organic coating requirements to be classified as hydric. Accordingly, this area was excluded from TEC's jurisdictional wetland map (Figure 3).

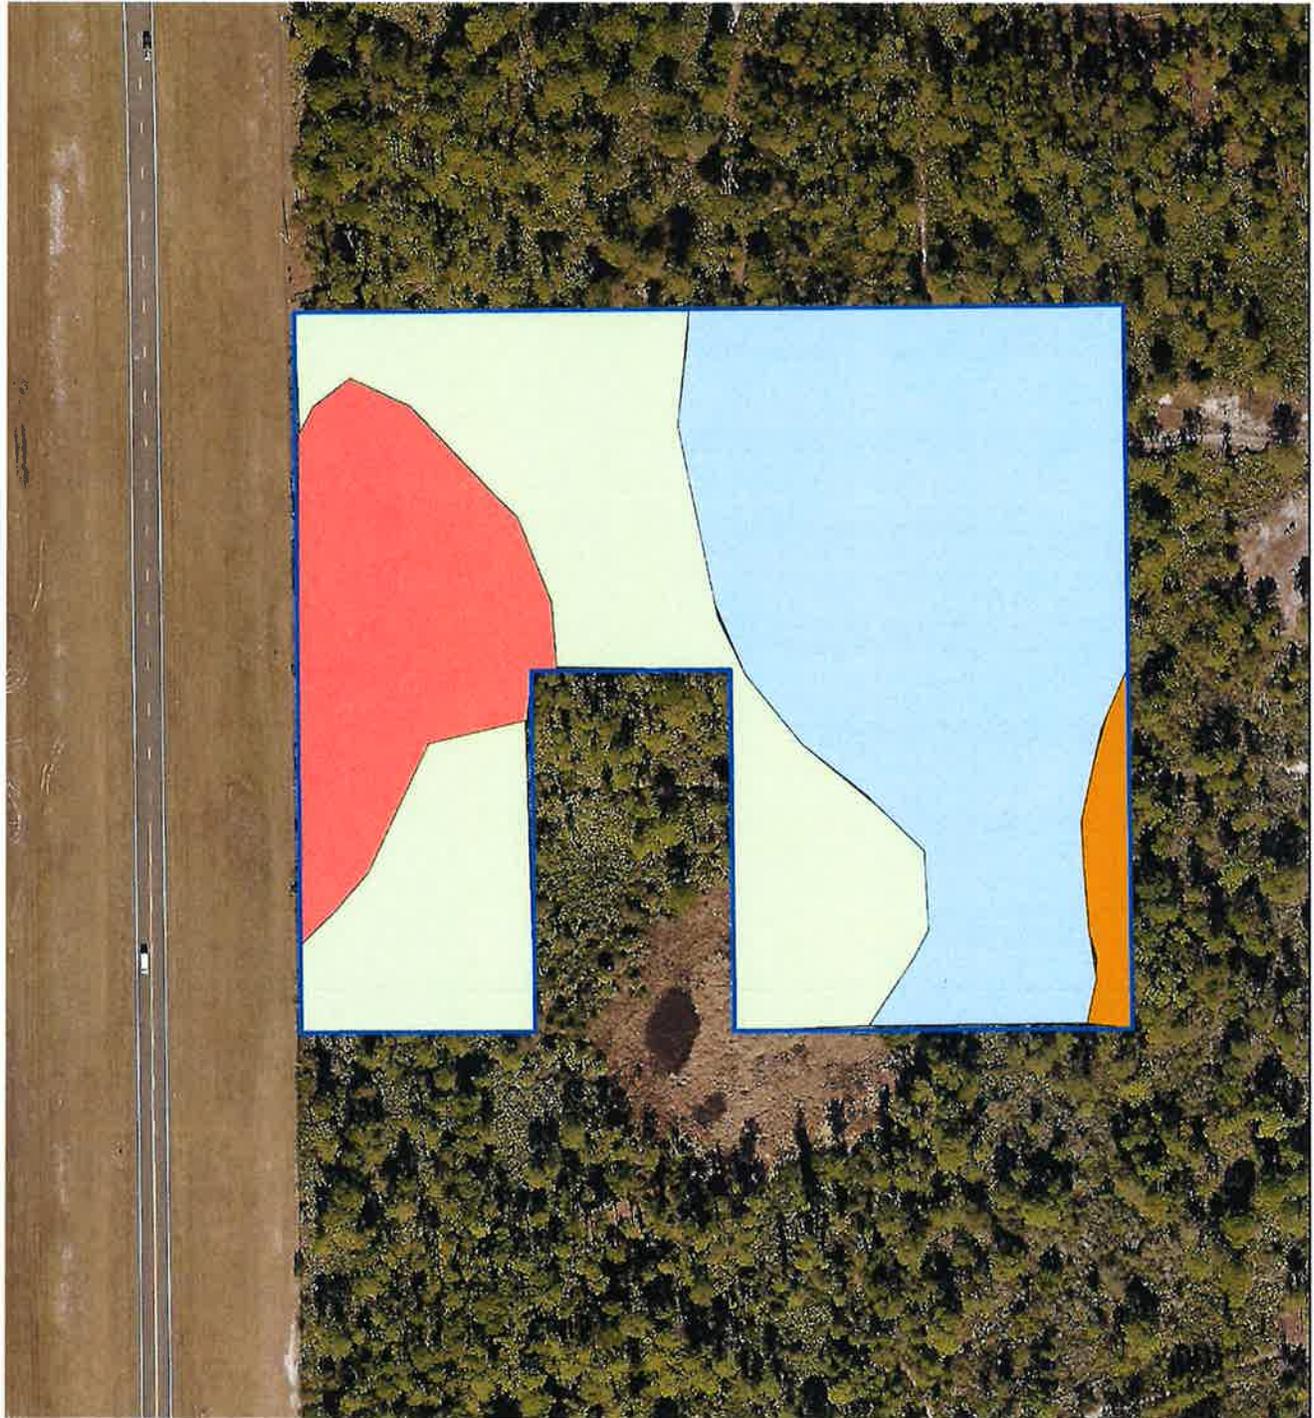
Figure 4: NRCS Soils Map

In order of relative abundance, the onsite soils are classified by NRCS as Immokalee sand, Myakka sand, Myakka sand, depressional, and Pomello sand (Figure 4). Of these soil series, Myakka sand, depressional is the only soil classified as hydric within the "Hydric Soils of Florida Handbook, fourth edition" prepared by Florida Association of Environmental Soil Scientist. Hydric soils are usually associated with wetlands while non-hydric soils are generally associated with upland habitats.

Within the scrubby flatwoods, TEC reviewed representative samples of the onsite soils and found they lacked the required features to be classified as hydric or indicative of having been formed under aerobic conditions by exhibiting signs of stripping, redox concentrations, or substantial organic accumulations within the first six inches of the soil profile. Soils within the depression marshes showed organic accumulations within the first six inches of the soil profile including mucky minerals (A7 indicator) and muck (A9 indicator) that demonstrated the soils formed under anaerobic conditions and would meet the criteria found within the Handbook and Florida's wetland delineation rules to be classified as hydric.
