Project Address: N. Courtenay Pkwy, Merritt Island, FL 32953  
Project Area:  $\pm 0.59$  acres  
Brevard Parcel ID: 24-36-02-00-269  
Brevard Tax ID: 2410506  
Parcel Description: PART OF W 1/2 OF NW 1/4 W OF RD AS DES IN ORB 252 PG 455

Subject: Letter of Determination for Wetlands and Protected Species for Brevard County Natural Resources Management Department

Dear Ms. Garagozlo;  
Ecospatial Analysts, Inc. conducted an environmental assessment and wetland determination on the above-referenced property ( $\pm 0.59$ -acres) on February 6, 2021. The property is a vacant parcel located in Merritt Island, Brevard Co., Florida (Figure 1). The parcel was bordered by North Courtenay Parkway to the east, vacant land to the north and west and commercial business to the south. A stormwater ditch and a utility corridor occurred between the parcel and N Courtenay Parkway. The parcel boundary is also shown on an aerial image in Figure 2 and a 7.5-minute USGS topological quad in Figure 3.

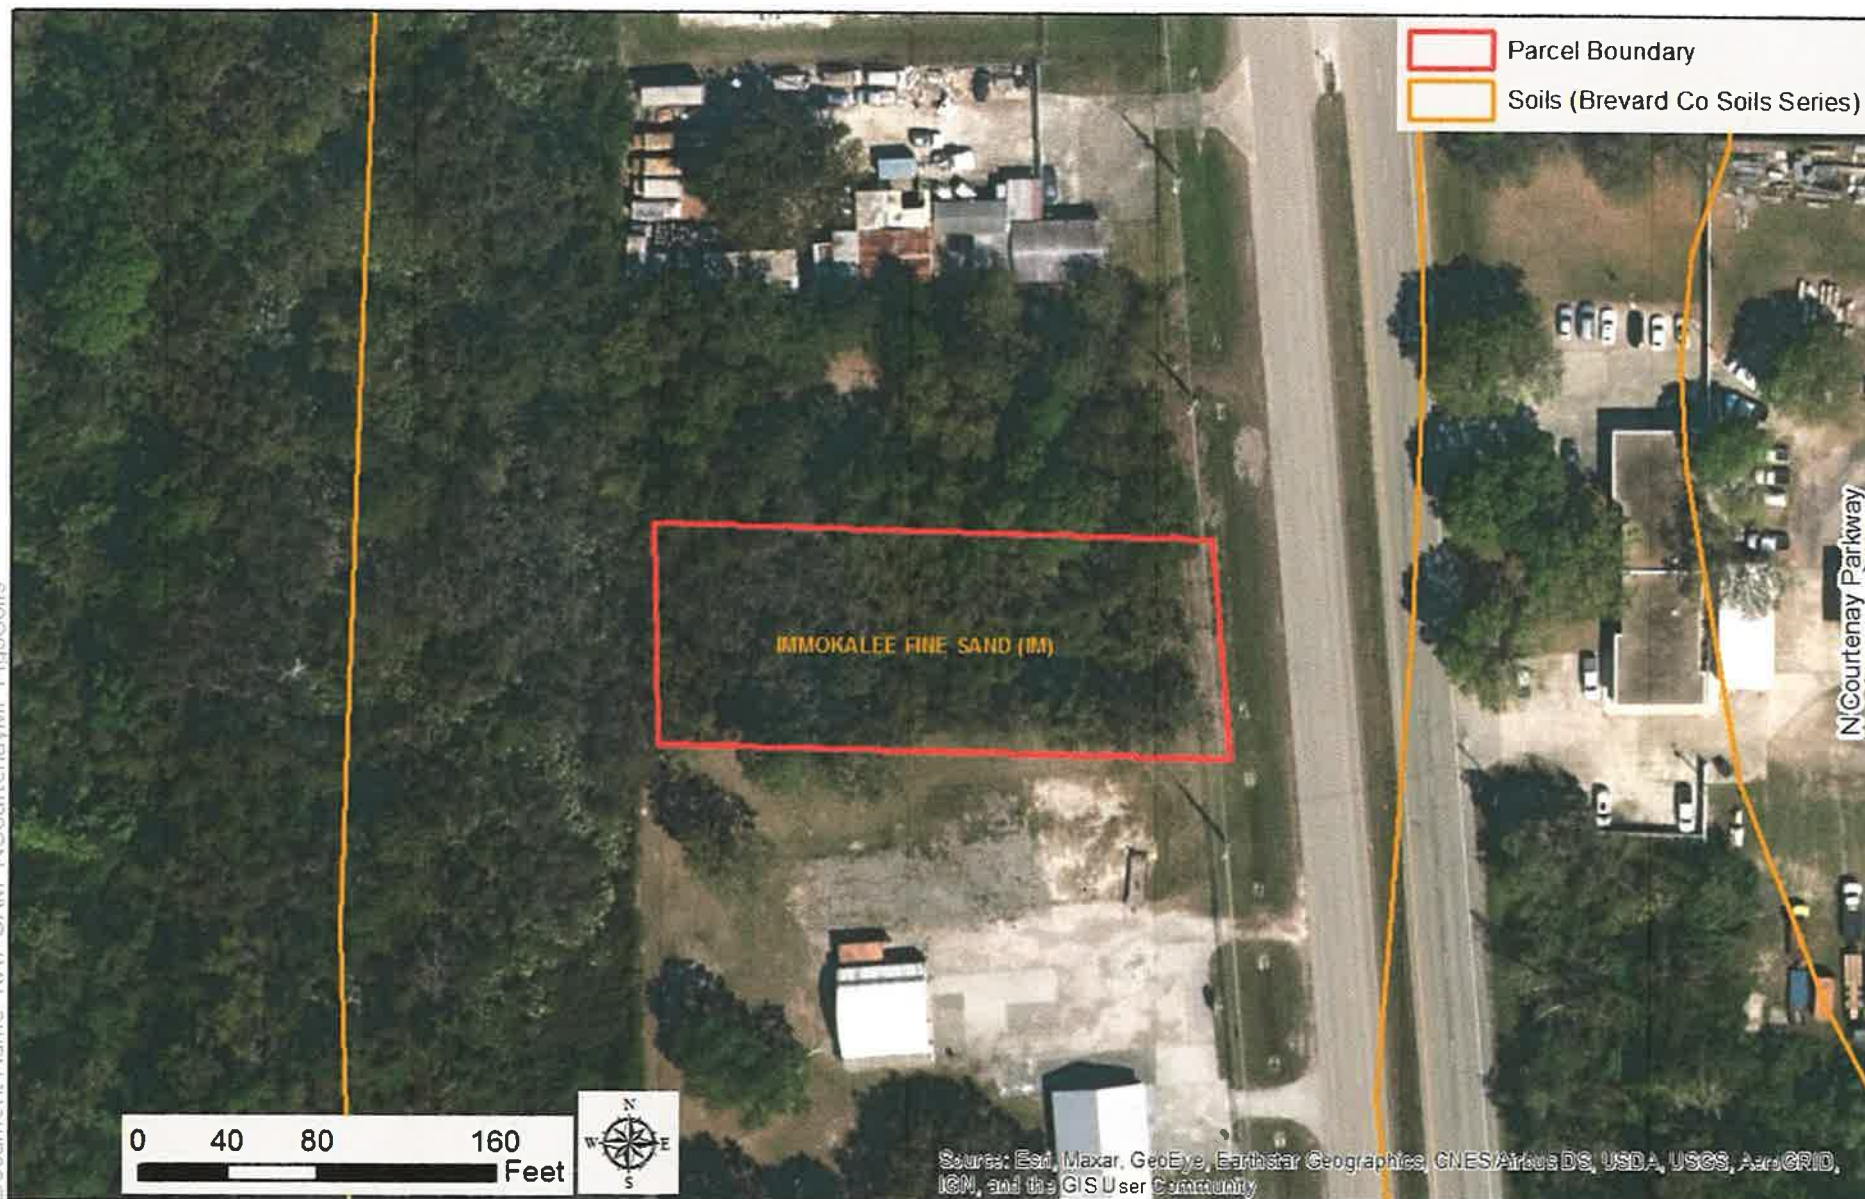
6

**SOILS** One soil series, Immokalee fine sand, occurred within the property (Figure 6). The soil characteristics derived from soil profiles were consistent to the soil descriptions for this soil within the Soil Survey of Brevard Co. (Huckle et al. 1974; [https://www.nrcs.usda.gov/Internet/FSE MANUSCRIPTS/florida/FL009/0/Brevard.pdf](https://www.nrcs.usda.gov/Internet/FSE_MANUSCRIPTS/florida/FL009/0/Brevard.pdf)). Soils on the parcel were light grey colored, mineral organic with less than 20% of the sand grains coated with organic material.

Title: Soils (0.59-acres)  
Address: N. Courtenay Pkwy, Merritt Island, FL 32953  
Parcel ID: 24-36-02-00-269  
Tax Account: 2410506  
Source: ESRI Basemap Imagery  
Notes: Locations approximate. Site visit 2/6/21
