North Merritt Island

HydroDEM Update Memo

prepared by Atkins, September 2020

Subject: **Draft North Merritt Island HydroDEM update**

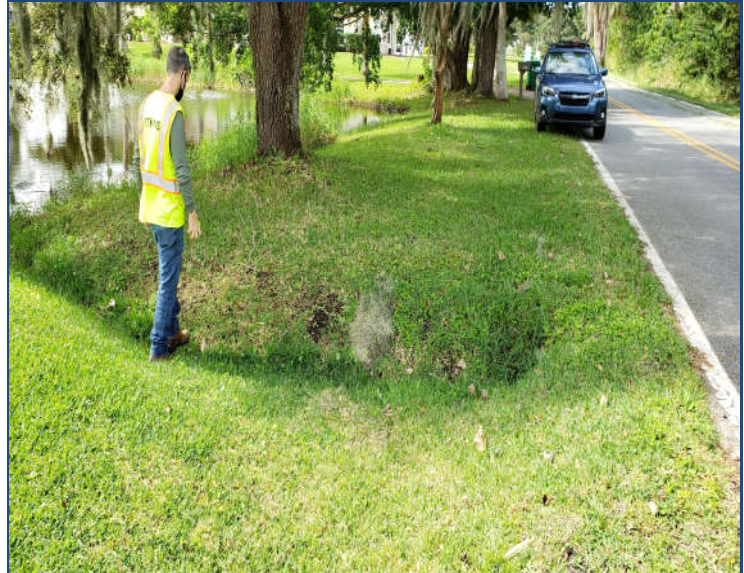
SWAMPid: In SWAMP wo Feature Code

Field Visit Notes: Culvert does not appear to be the control between the pond and ditch, rather a high point in swale leading to pond. Recommend regrading for proper function. Culvert is silted on the upstream side.

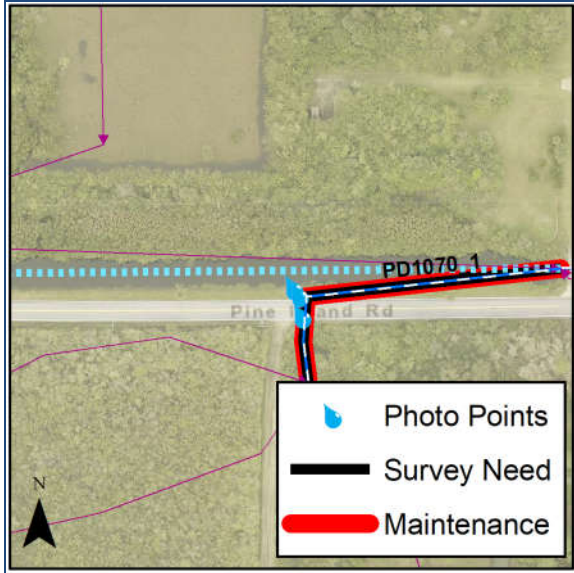
SWAMPid: 0000CU0000

Field Visit Notes: Tideflex product does not appear to be function optimally, the rubber appears still from oxidation. It is recommended that the manufacturer provide an opinion as to how well the structure will function in this condition. Upstream side is mostly silted. Estimate crown is 1 ft below roadway.

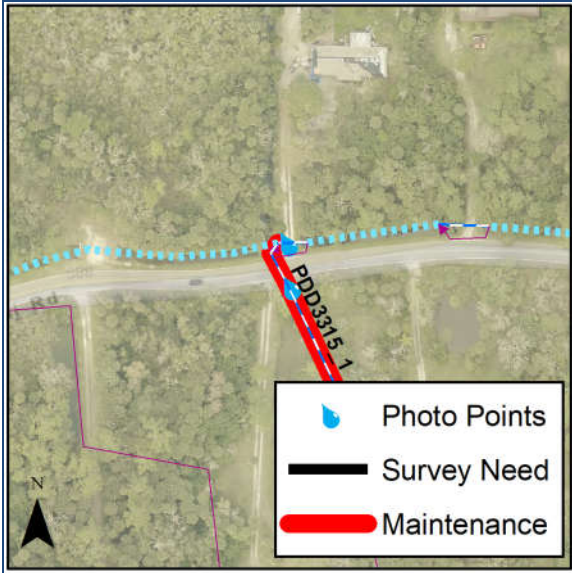
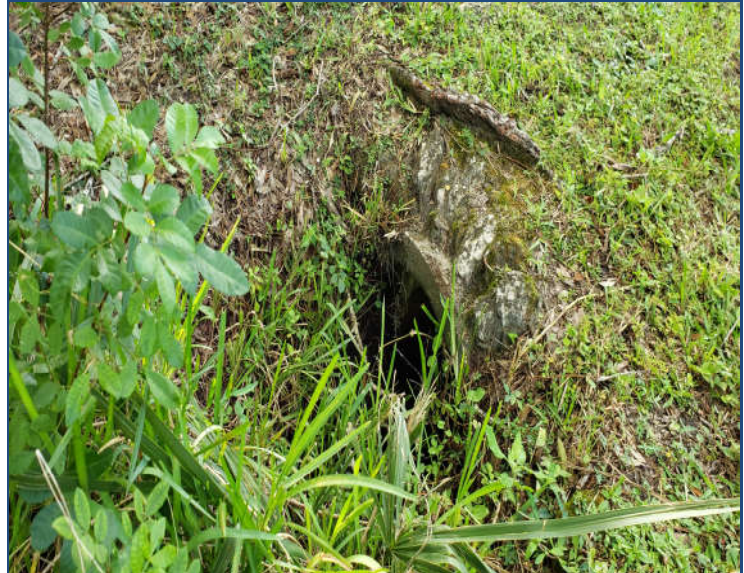
Field Visit Notes: Upstream end of culvert partially silted. Tideflex pipe end treatment. Tideflex product does not appear to be function optimally, the rubber appears still from oxidation. It is recommended that the manufacturer provide an opinion as to how well the structure will function in this condition.

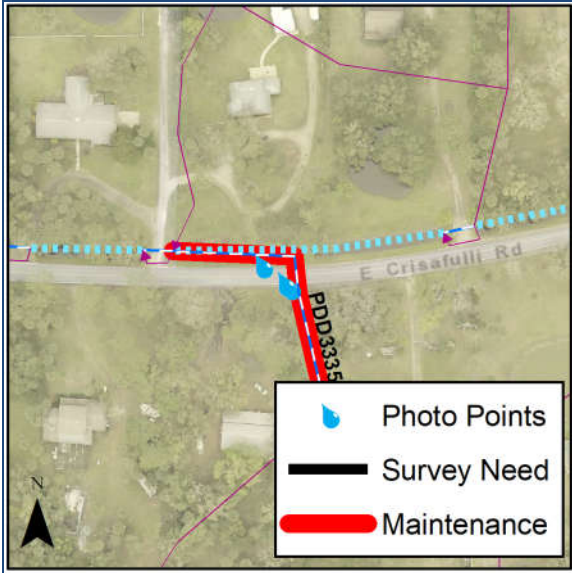
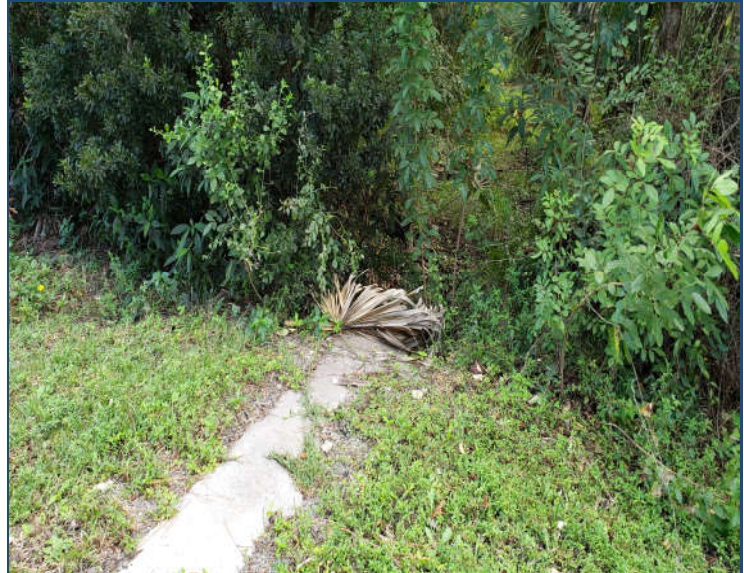
Field Visit Notes: Upstream end of culvert partially silted. Tideflex pipe end treatment. Tideflex product does not appear to be function optimally, the rubber appears still from oxidation. It is recommended that the manufacturer provide an opinion as to how well the structure will function in this condition.

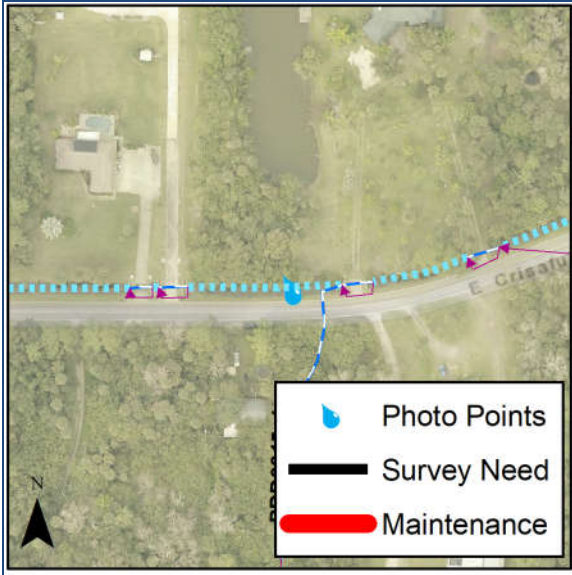
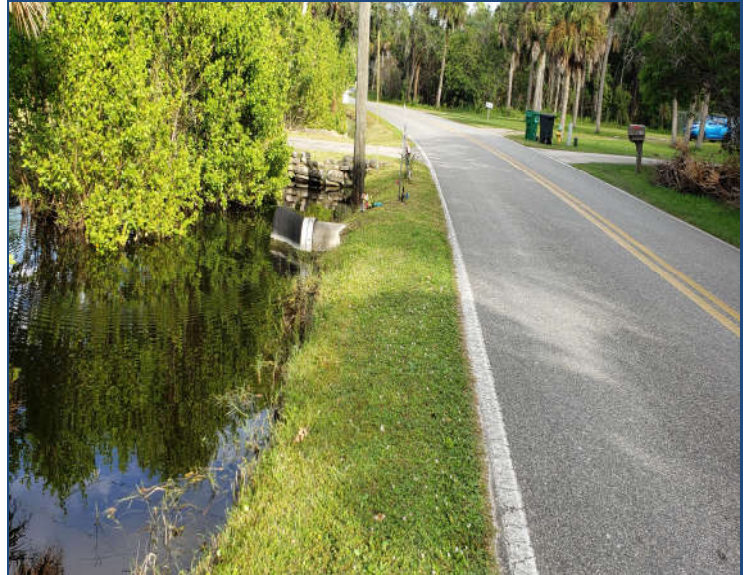
Field Visit Notes: Tideflex pipe end treatment. Tideflex product does not appear to be function optimally, the rubber appears still from oxidation. It is recommended that the manufacturer provide an opinion as to how well the structure will function in this condition.

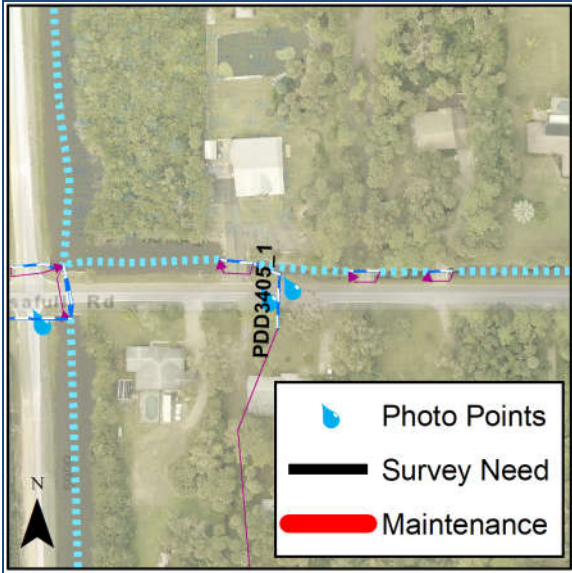
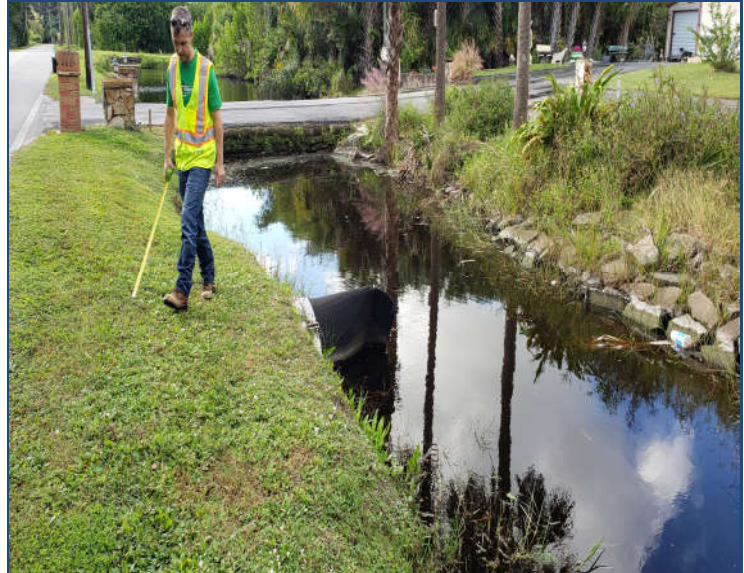
Field Visit Notes: Tideflex pipe end treatment. Tideflex product does not appear to be function optimally, the rubber appears still from oxidation. It is recommended that the manufacturer provide an opinion as to how well the structure will function in this condition.

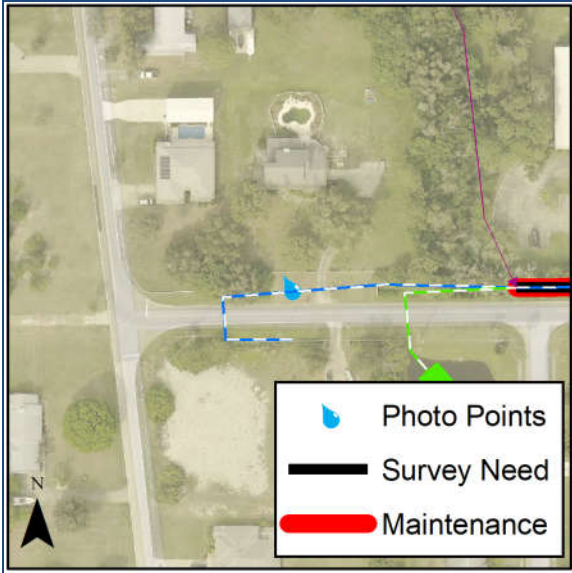
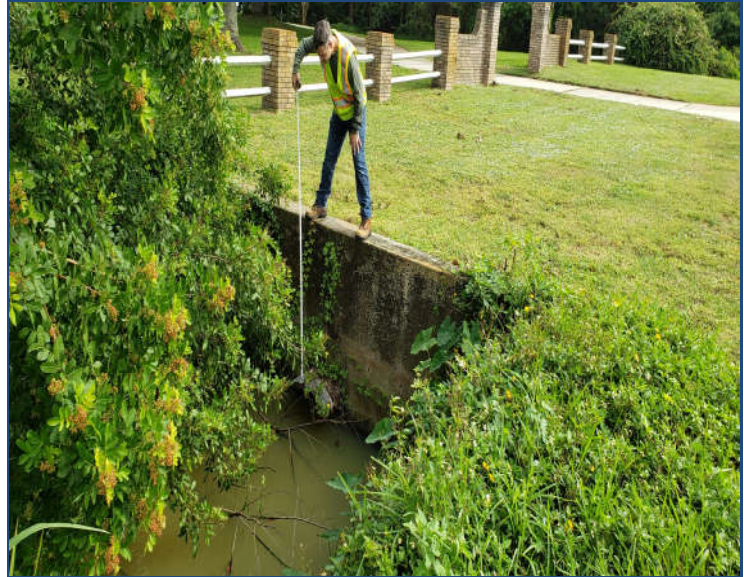
Field Visit Notes: As water flows north across Grant Road this link represents the controlling (first) culvert in a series of culverts that conveys water to the west. This culvert under a driveway at 210 Grant Rd is rusted and the channel is overgrown

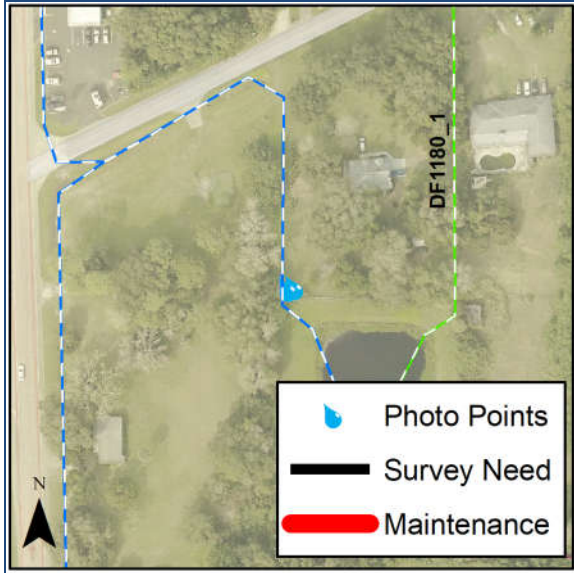
Field Visit Notes: FDOT pond 133 (ph 321-634-6100). SWAMP has elevations missing top dimension and orifice dimension. Field estimated as a Type C structure with a 3 inch orifice

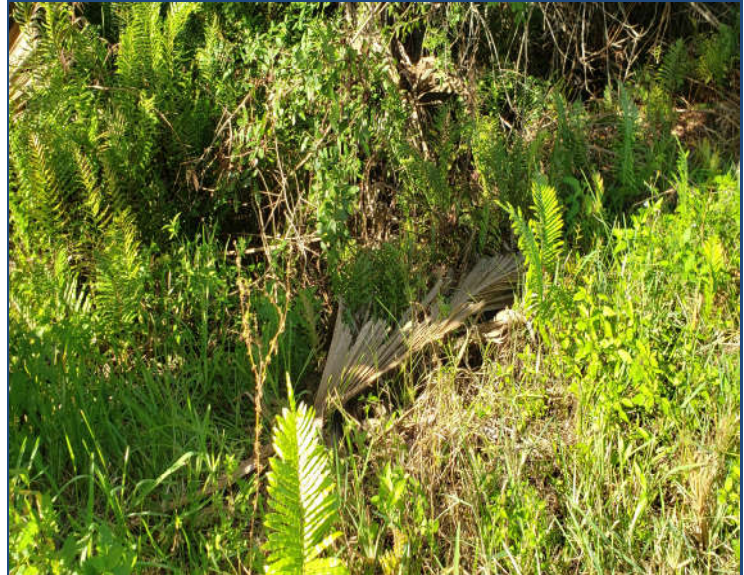
Field Photo

Field Visit Notes: Culvert is in SWAMP, but no evidence of the culvert was found in the field. It is likely that the culvert has been silted for many years and no longer functions as the primary outlet for this area. Maintenance to restore functionality of structure.

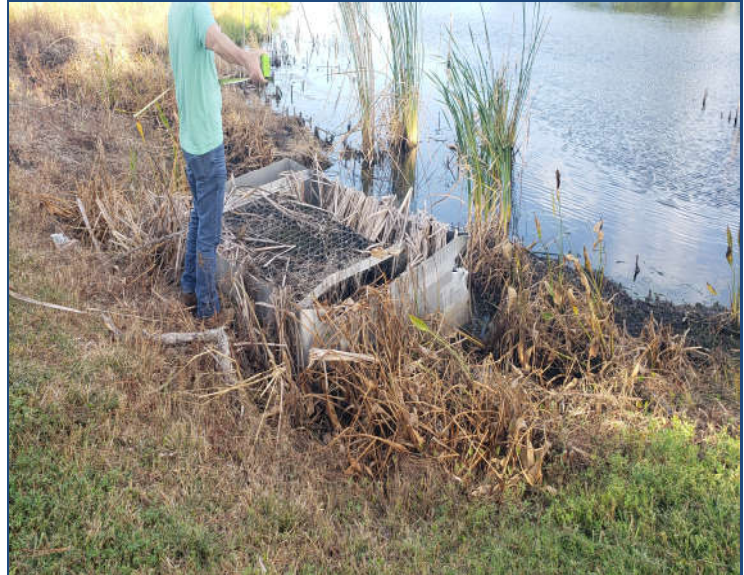
Field Photo

Field Visit Notes: The SWAMP database has structure elevations without specified dimensions. Dimensions collected in the field to incorporate into the model include: top 54x37; 3 slots 1 and 2 are 36x11.5 and 3 is 54x12.5. orifice is 3". Noted that the Skimmer was damaged and in need of repair or replacement.

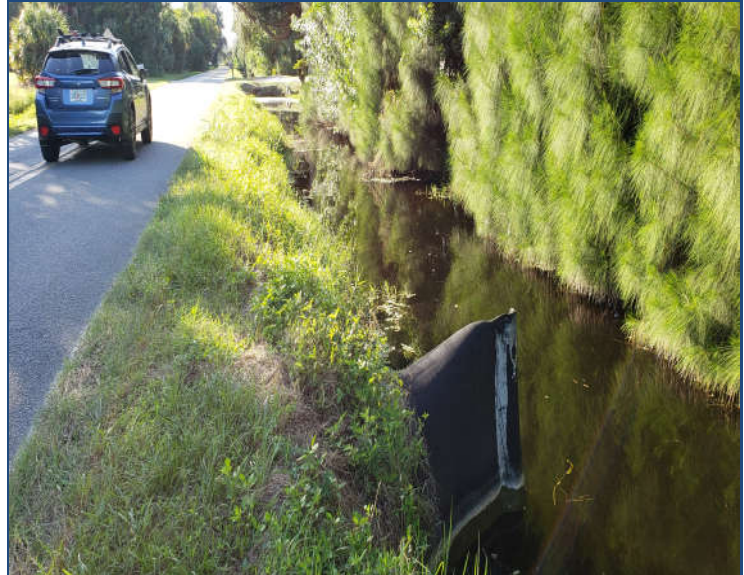
Field Photo

Field Visit Notes: Tideflex pipe end treatment. Tideflex product does not appear to be function optimally, the rubber appears still from oxidation. It is recommended that the manufacturer provide an opinion as to how well the structure will function in this condition.

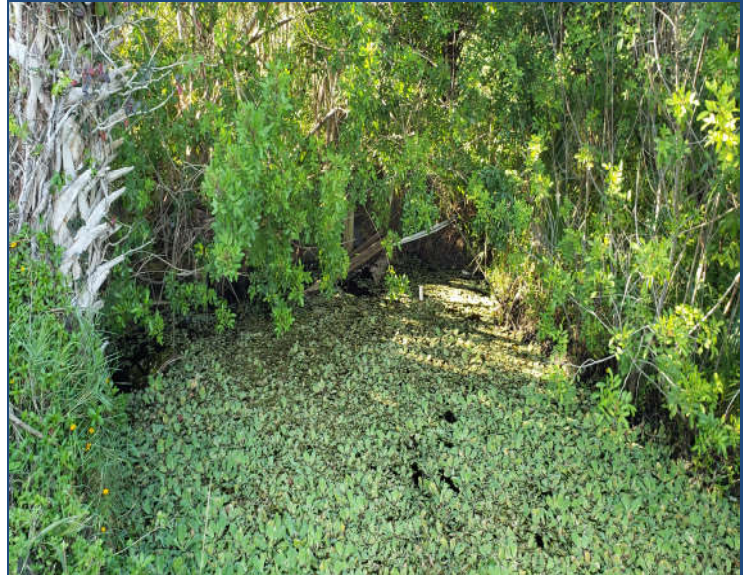
Field Photo

Field Visit Notes: Tideflex pipe end treatment, submerged at current water level. Tideflex product does not appear to be function optimally, the rubber appears still from oxidation. It is recommended that the manufacturer provide an opinion as to how well the structure will function in this condition.

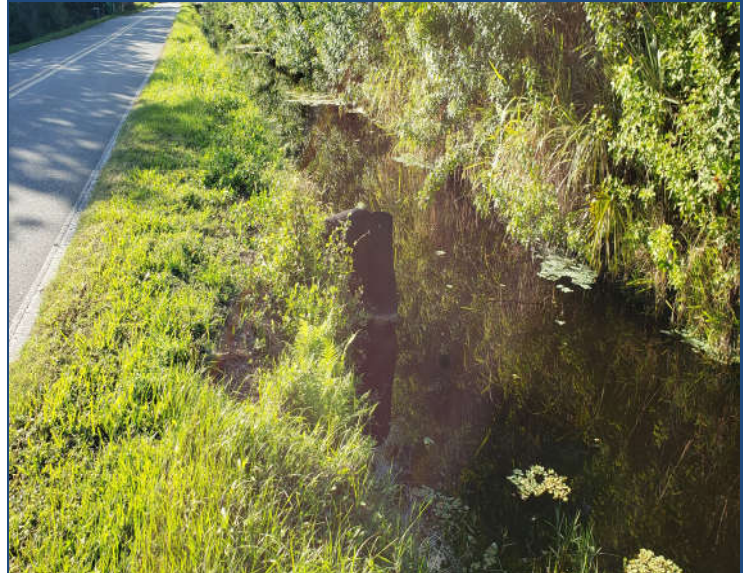
Field Photo

Field Visit Notes: Tideflex pipe end treatment. Tideflex product does not appear to be function optimally, the rubber appears still from oxidation. It is recommended that the manufacturer provide an opinion as to how well the structure will function in this condition.
