**Brevard County, FL
Bird Watching Tower 2
Structural Assessment**

TO: Brevard County Facilities Department
ATTN: Michael Dunlap – Facilities Construction Coordinator
FROM: Nikos Moschovakis E.I.
DATE: September 26, 2022
RE: Structural Inspection

Bird Watching Tower 2 – North East Tower
Viera Wetlands, West of 10001 N Wickham Rd,
Melbourne, FL 32940

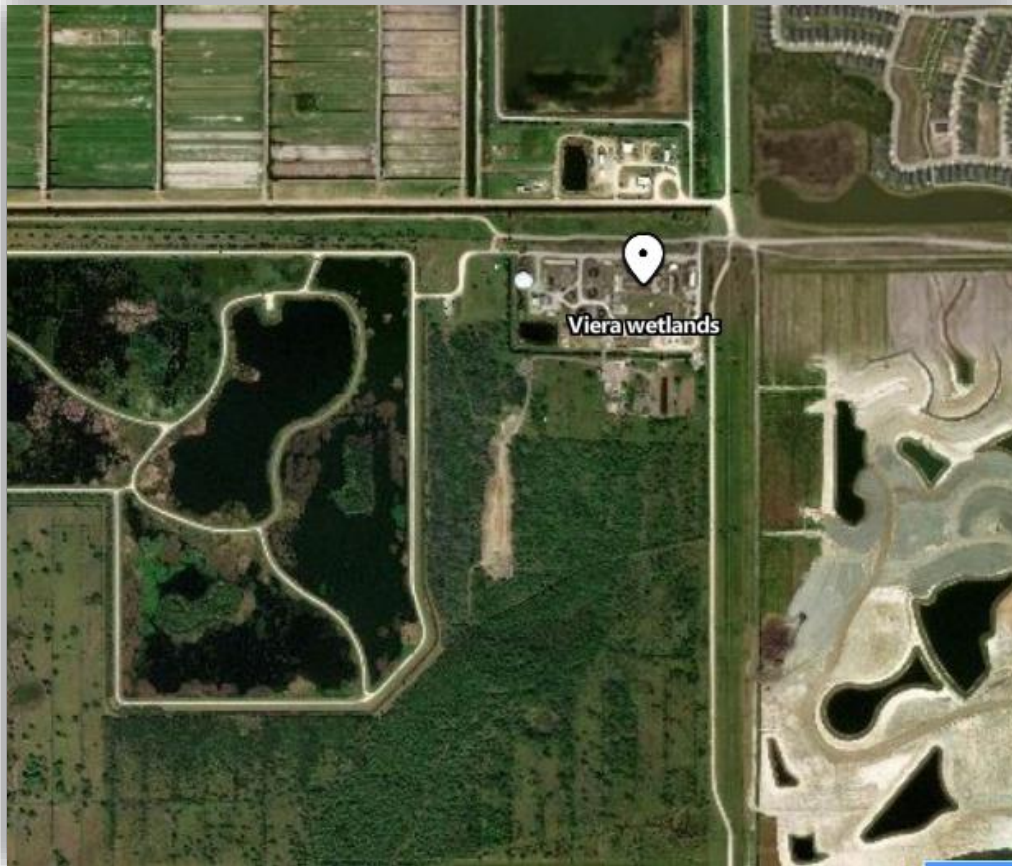
Inspection Map

Northeast bird watch tower

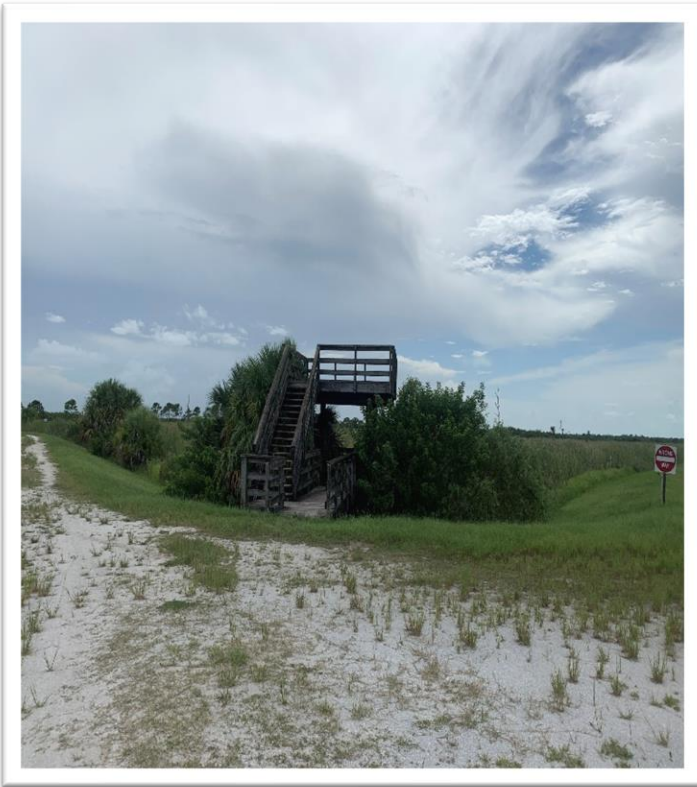
Conclusion

The structure must remain closed to the public in any case until further structural repair or replacement takes place. At this time the structure can cause a human injury or death. The structure might collapse in excessive vertical loads or in case of an extreme event.

The wood railing appeared unstable all around the building on both stories and on the wood stairs. Wood floor planks appeared damaged and in bad condition due to excessive moisture and weather. Multiple steel connections appeared rusted and inadequate in tensional forces. Some floor beams appeared damaged from moisture in addition to excessive visual deflection. Surface damage on the timber foundation piles and possible core cracks. Excessive deflection was recorded during the inspection, mainly on the stairs and second deck. Structural repairs or tower replacement is required in order to continue the operation of the birdwatch tower. Replace the superstructure with a new superstructure is recommended. Some members and connections appeared in better condition. These members might have been replaced recently.
