Environmental Impact Report

Terwilliger Apartments

FEC Job #22-210

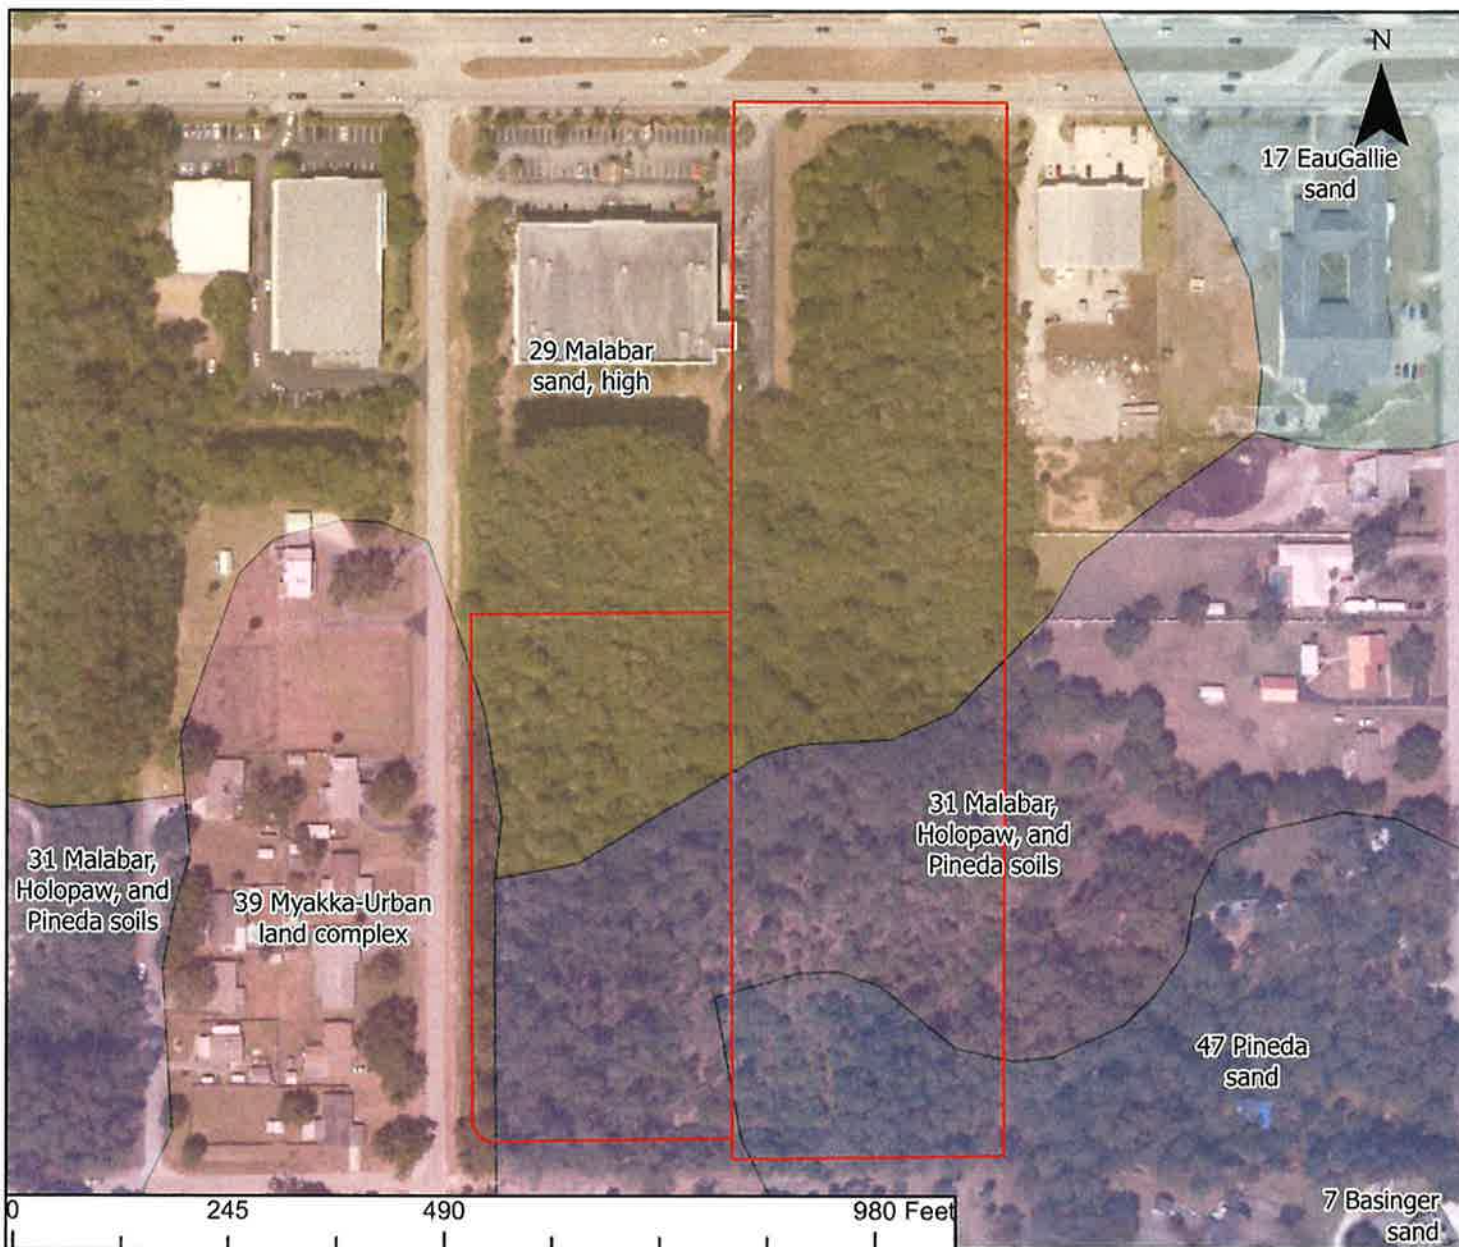
SOILS

According to the U.S. Department of Agriculture Natural Resources Conservation Service (NRCS) the property contains 4 major soil types more specifically described as:

Soil 29, *Malabar sand, high* characterized as poorly drained sand with a water table typically 6-18 inches below the surface with no typical frequency of ponding or flooding.

Soil 31, *Malabar, Holopaw, and Pineda soils* characterized as poorly drained sand with a water table typically 0-12 inches below the surface with no typical frequency of ponding or flooding.

Soil 39, *Myakka-Urban land complex* characterized as poorly drained sand with a water table typically 6-18 inches below the surface with no typical frequency of ponding or flooding.

Soil 47, *Pineda sand, 0 to 2 percent slopes* characterized as poorly drained sand with a water table typically 3-18 inches below the surface with no typical frequency of ponding or flooding.

Soils with water tables within 6 inches of the surface are suspected to support wetlands. Please see the soils map in the appendix of this report for the general location of these soils.

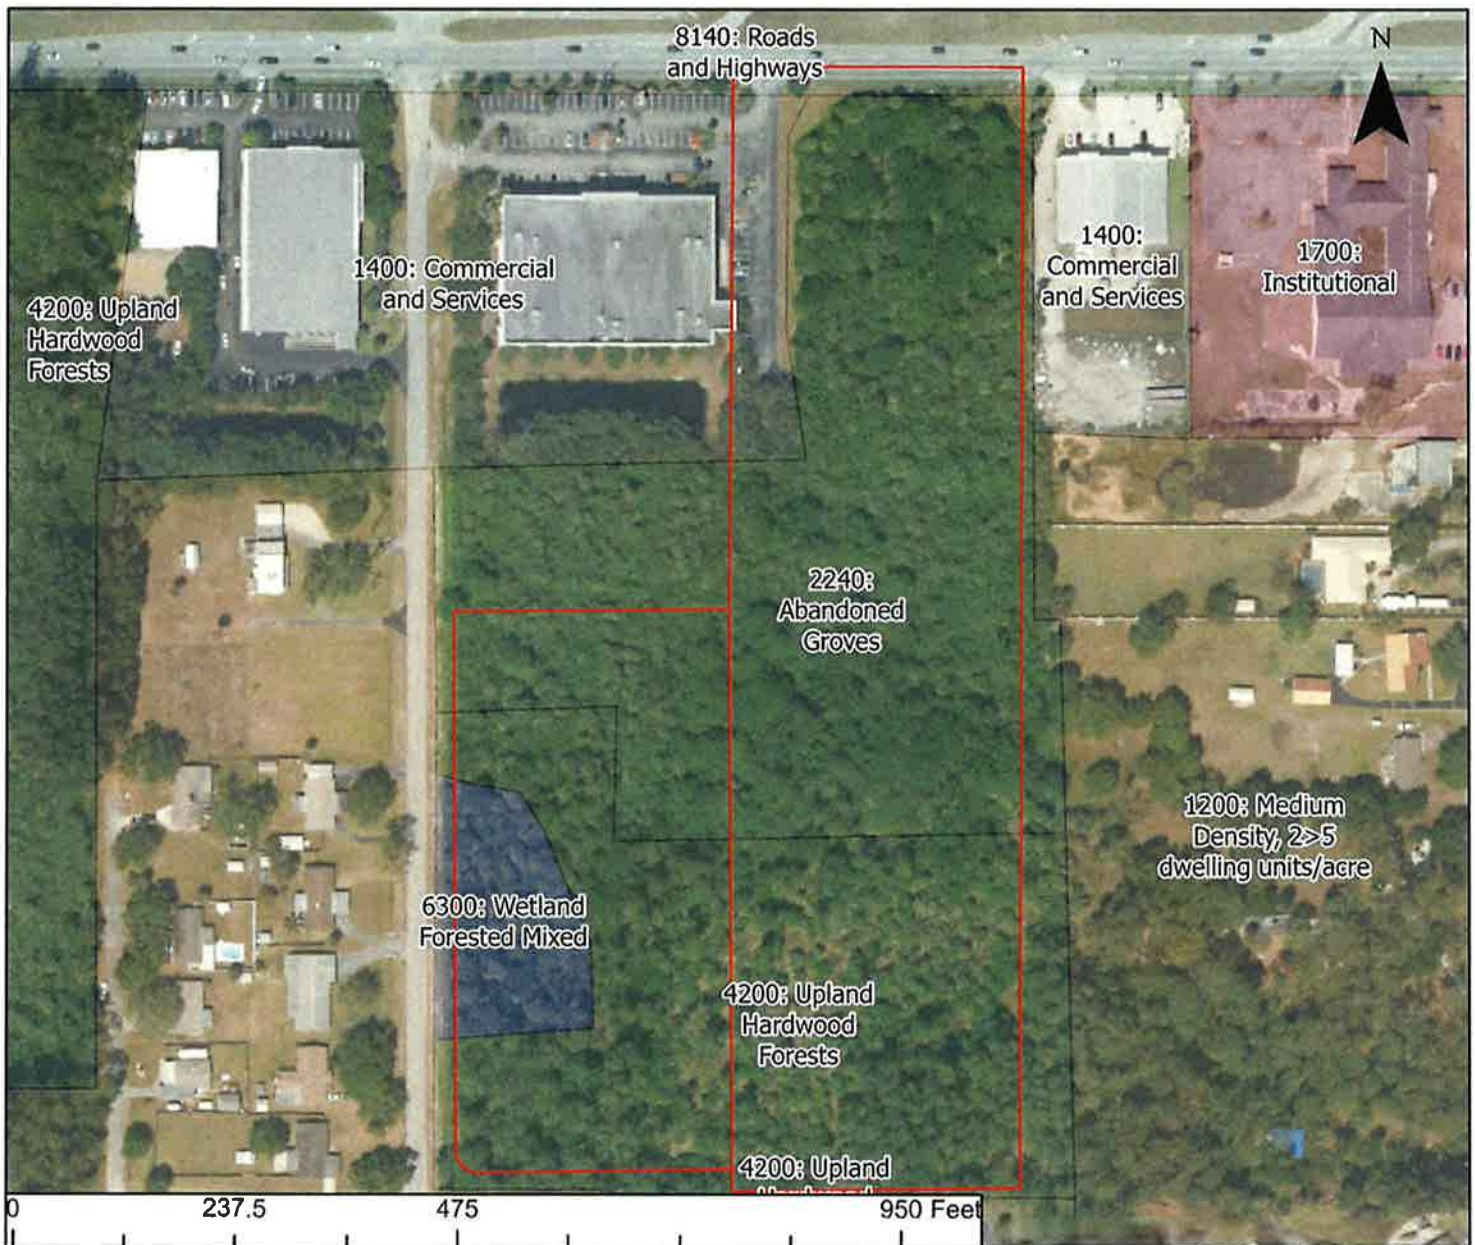
FIELD ADJUSTED LULC

As noted in the introduction the parcel is approximately 12.59 acres, most of which is historic grove that the Florida land classification system classified as 7.07 acres of LULC 4200: Upland Hardwoods; and 5.56 acres of LULC:4110: Pine Flatwoods. However, the current site conditions would be more accurately described as 6.83 acres of LULC 2240: Abandoned Grove, 5.46 acres of LULC 4200: Mixed Upland Hardwoods, and 0.75 acres of LULC 6300: Wetland Forested Mixed. Please see the Aerial LULC Map and Site Photos in the Appendix.

LANDUSE Field verified and adjusted August 2022

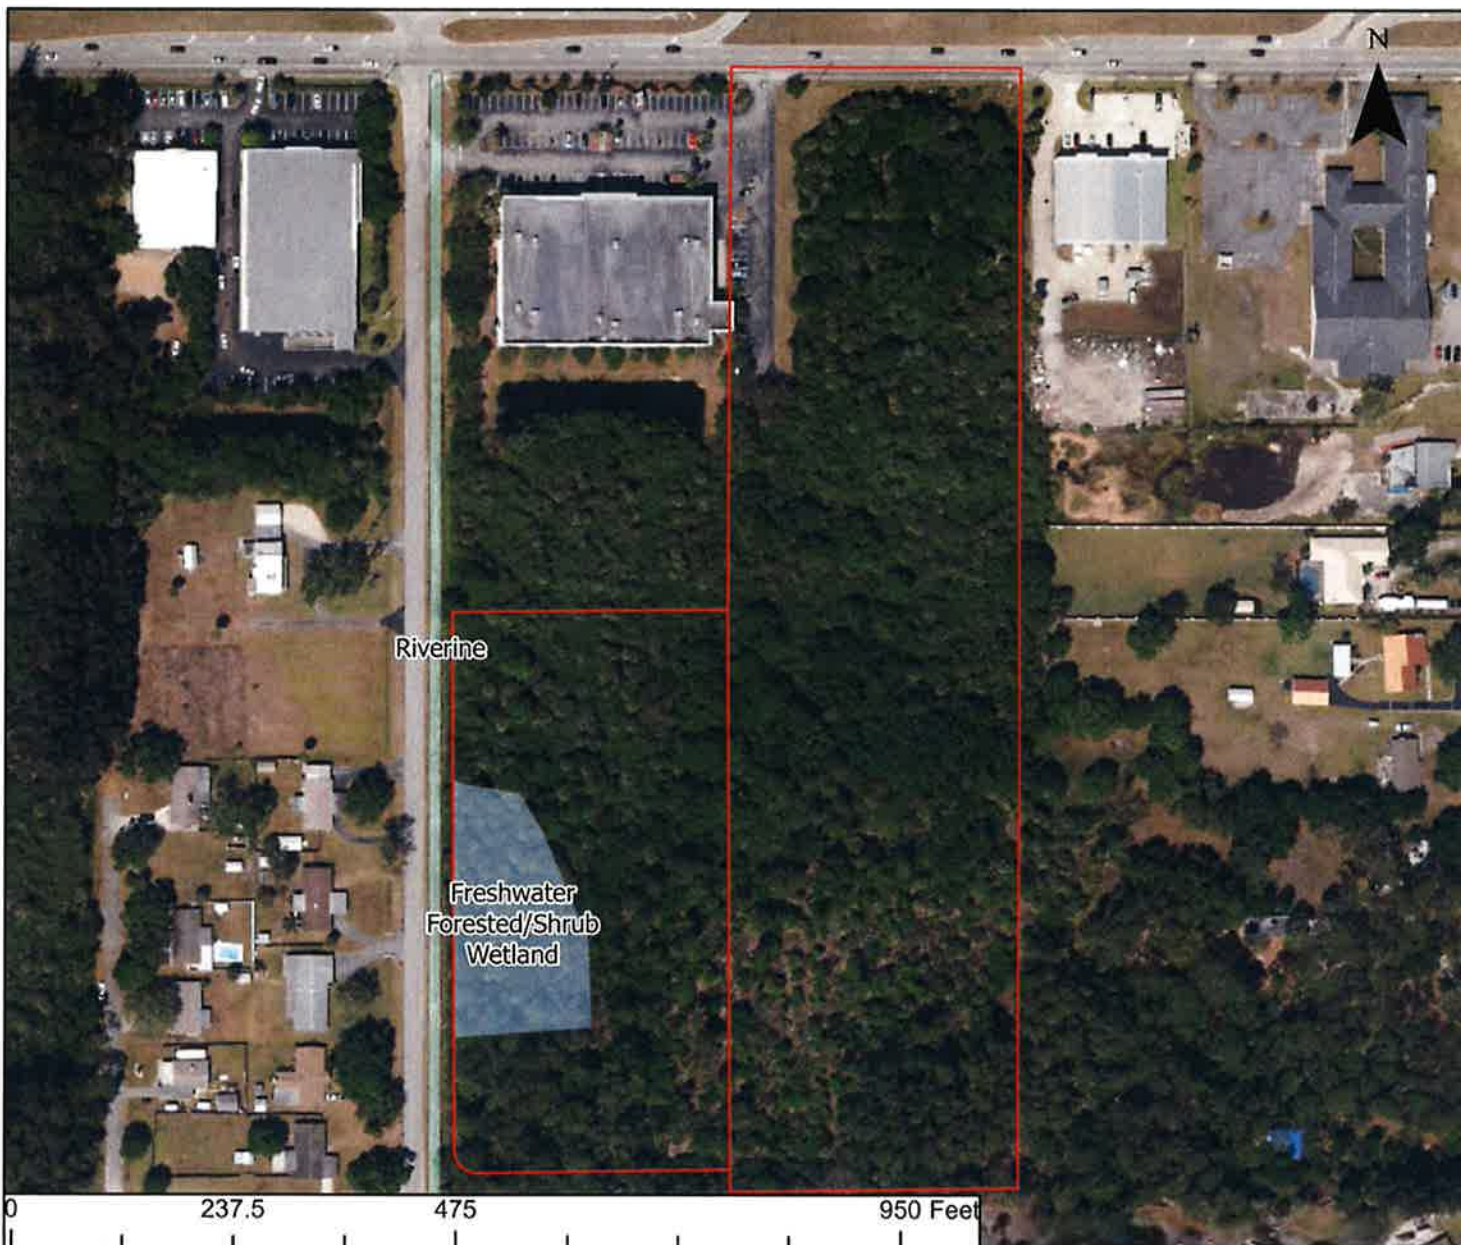
FIELD ADJUSTED NWI

Based on aerial interpolation and in conjunction with the topo map and soils survey publication describing the site soils as potentially hydric, wetlands were suspected. As such, approximately 0.75-acre Freshwater Forested Wetland was found on site via the presence of wetland vegetation, and hydric soils. However, there are some man-made swales and furrows on the property that would be classified as an 'other surface water' but will not require additional permitting or mitigation. Please see the National Wetland Inventory Map in the Appendix of this report.

FL Wetlands Field verified and adjusted August 2022

Finally, the site supports a Wetland Forested Mixed habitat which appears to be larger than 0.5 acres, and as such any impacts will require additional environmental permitting and mitigation. Based on the proposed site plan, offsite mitigation credits will be required from Mary A. Ranch Mitigation Bank. A formal wetland delineation and mitigation assessment will be required during the permitting process.
